Town of Arlington

Roads Maintenance Report 2020

**The Town of Arlington
Department of Public Works
Roads Maintenance**

FINAL PAVEMENT MANAGEMENT PROJECT REPORT

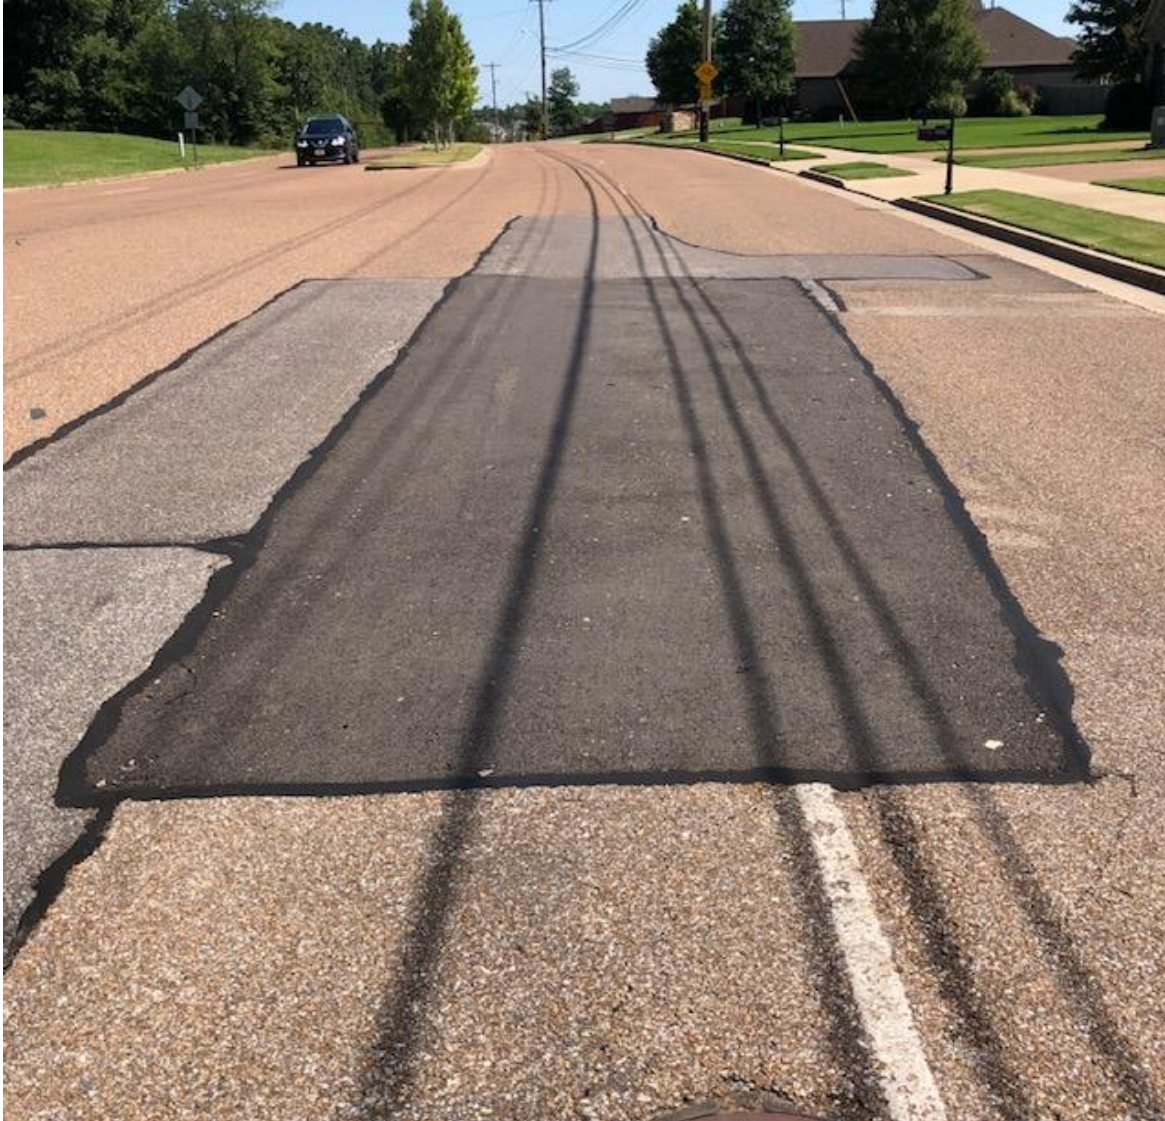
Patches with Crack Sealed Edges

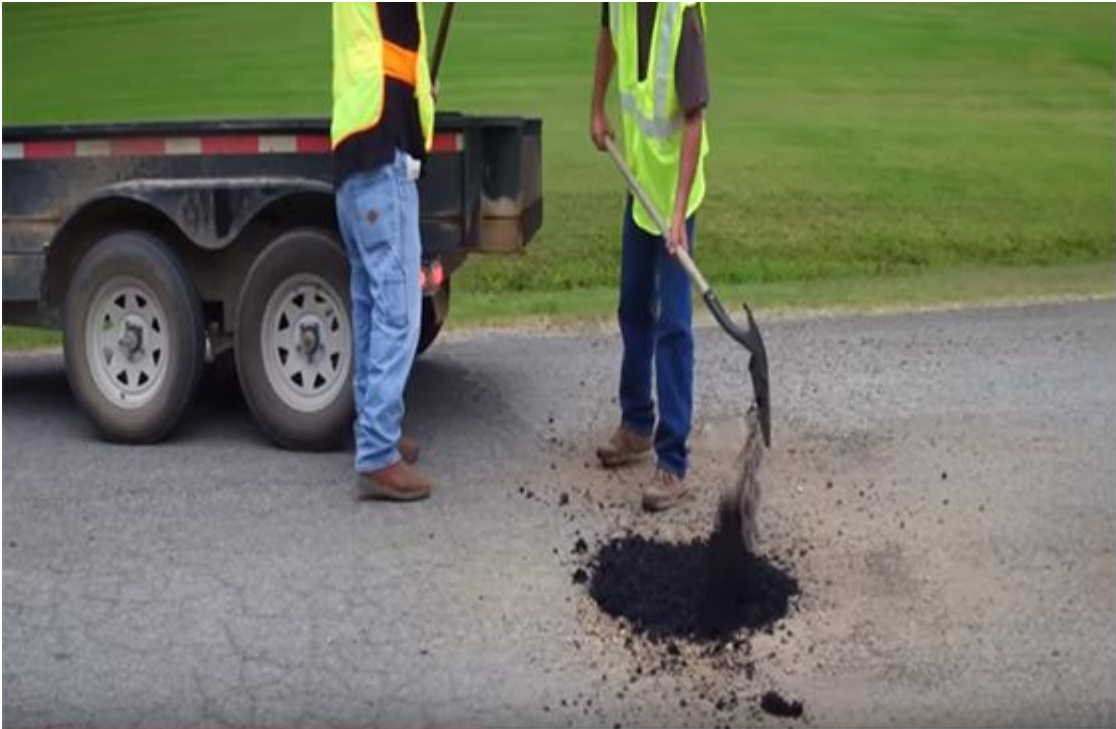
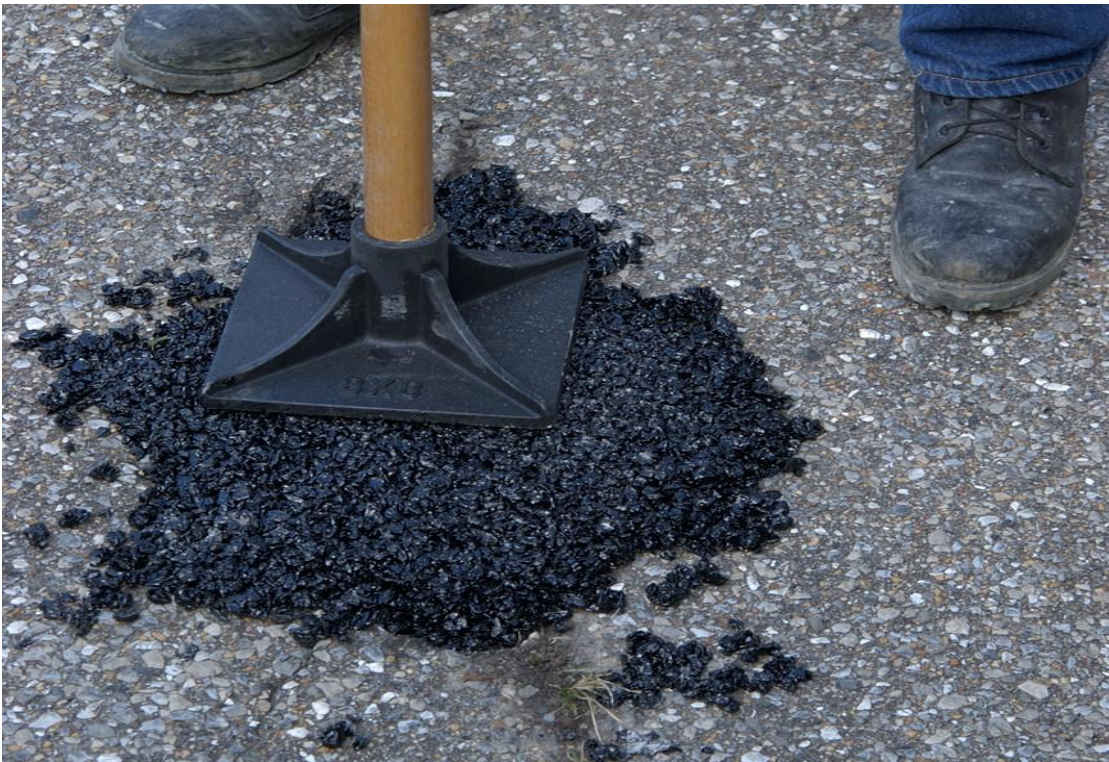
Filling and Tamping a Pothole

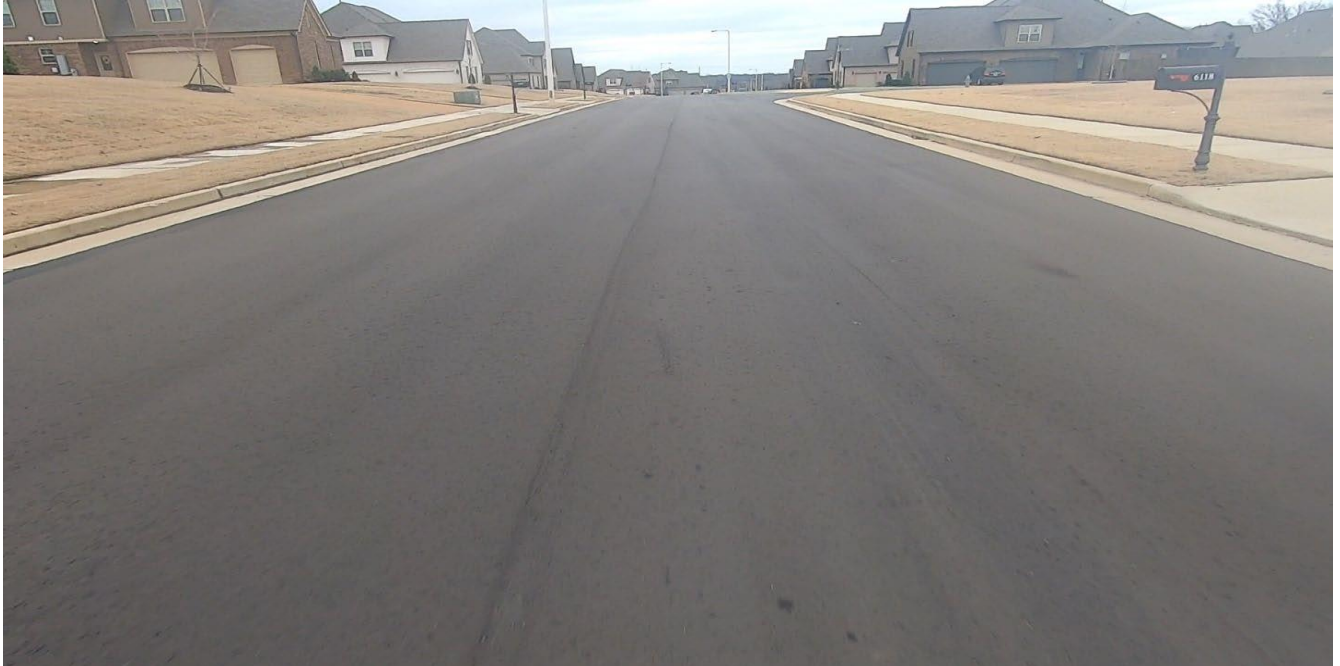
UPPER GRANGER CV | SECTION 01 | PCI 100

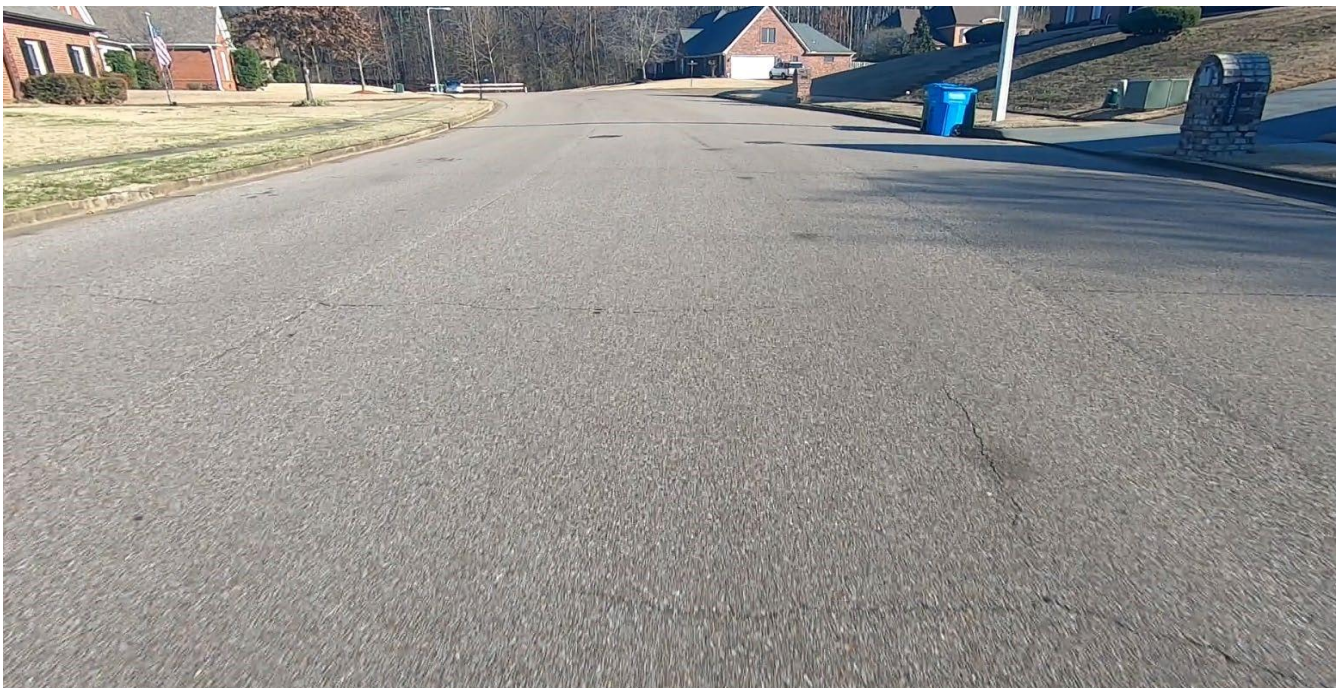
DARGIE DR | SECTION 05 | PCI 88

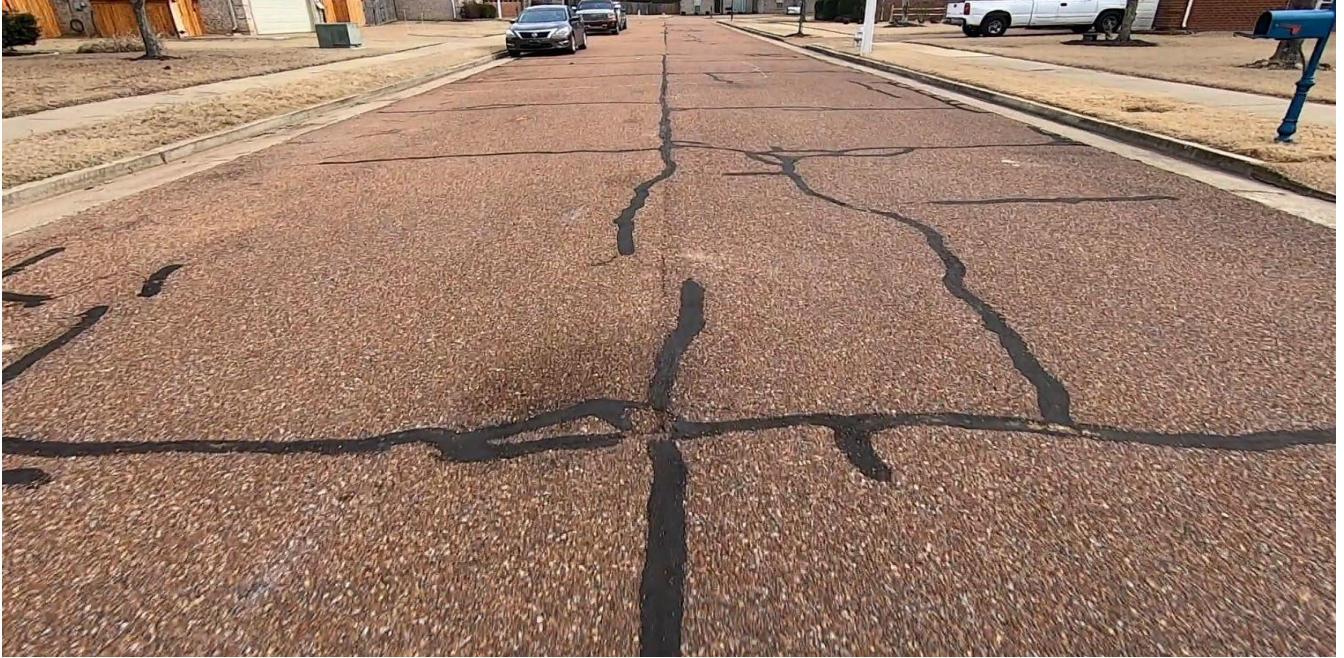
HIDDEN MEADOWS CV | SECTION 01 | PCI 72

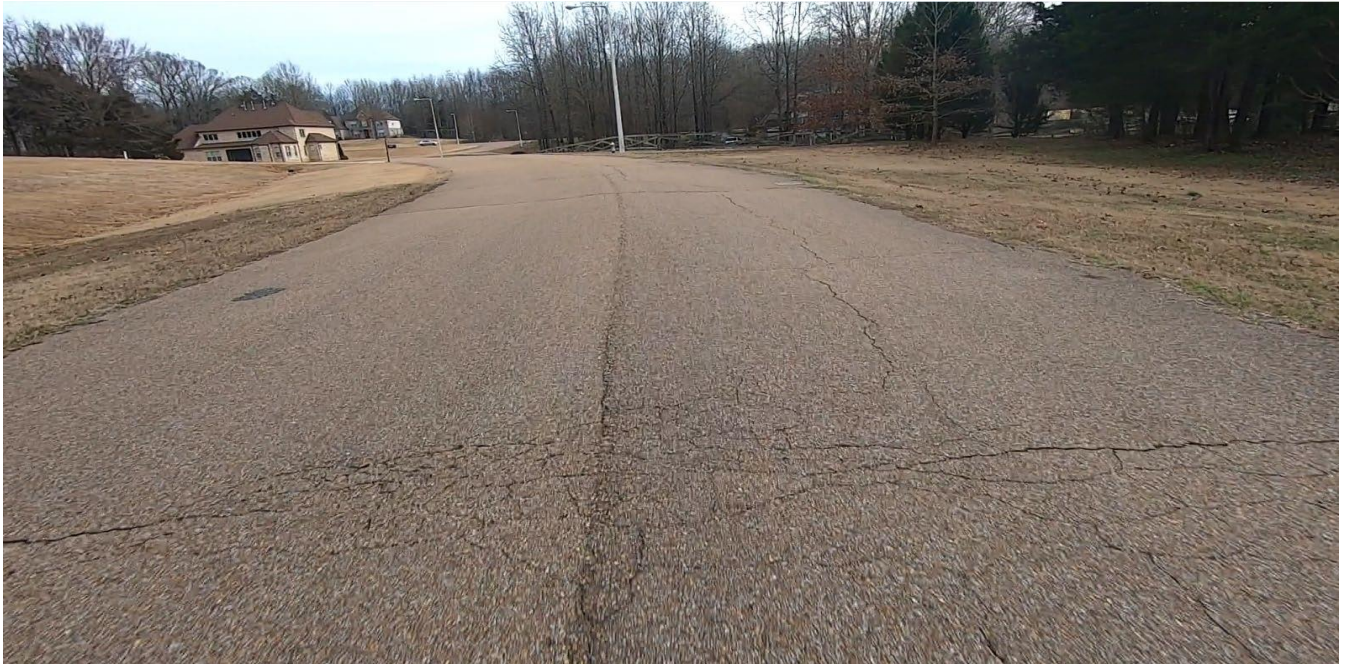
ROLLING FOREST DR | SECTION 01 | PCI 60

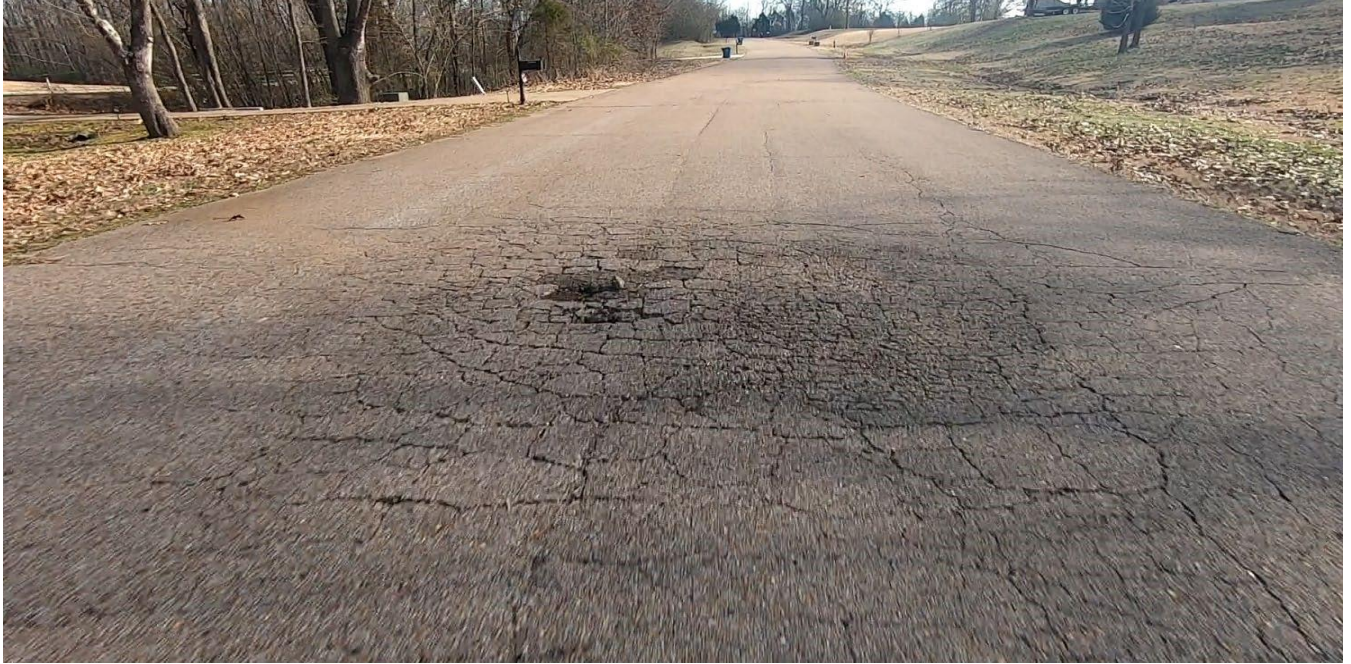
LUBOV RD | SECTION 02 | PCI 37
