# Report: Four Firefighters Injured In Lithium-Ion Battery Energy Storage System Explosion - Arizona

# Four Firefighters Injured in Lithium-Ion Battery Energy Storage System Explosion - Arizona

# Dispute Erupts Over What Sparked an Explosive Li-ion Energy Storage Accident > The April 2019 accident near Phoenix put plans on hold to further deploy battery-storage systems across Arizona

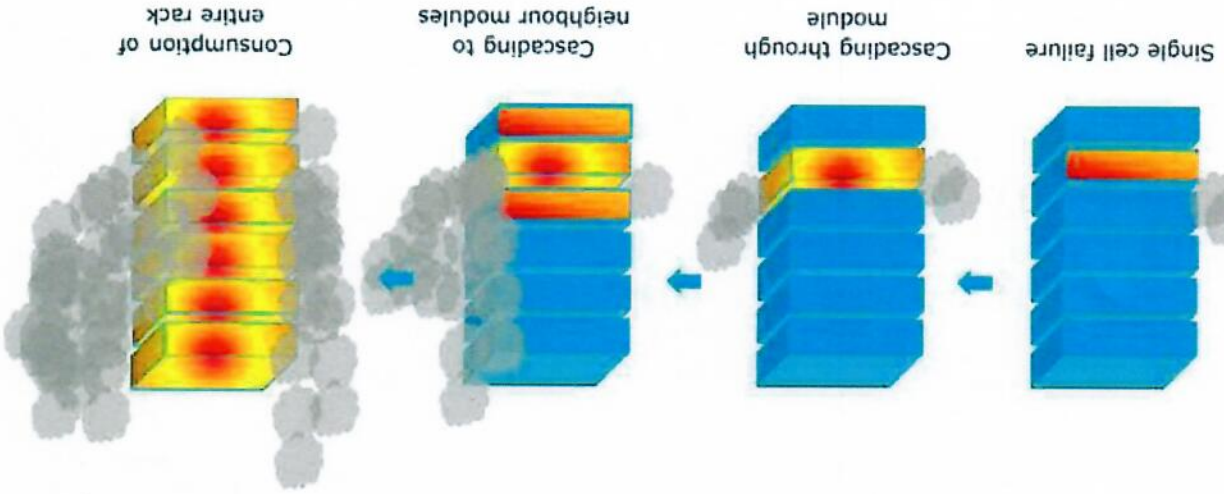
According to the APS report, a single cell failure propagated through Module 2, then consumed the whole rack, releasing a large plume of explosive gases. The report said this process could have occurred without

visible flame, which could explain why the gases were not burned as they were emitted. IMAGE: ARIZONA PUBLIC SERVICE

In its 78-page report [PDF], DNV GL said that what was first thought to be a fire was in fact an extensive cascading thermal runaway event within the BESS. That event was initiated by an internal cell failure within one battery cell, identified as cell 7-2 on Rack 15. The failure was caused by "abnormal lithium metal deposition and dendritic growth" within the cell, the report said.

Once the failure occurred, thermal runaway cascaded from cell 7-2 through every other cell and module in Rack 15 via heat transfer. The runaway was aided by the "absence of adequate thermal barrier protections" between battery cells, which otherwise might have stopped or slowed the thermal runaway.

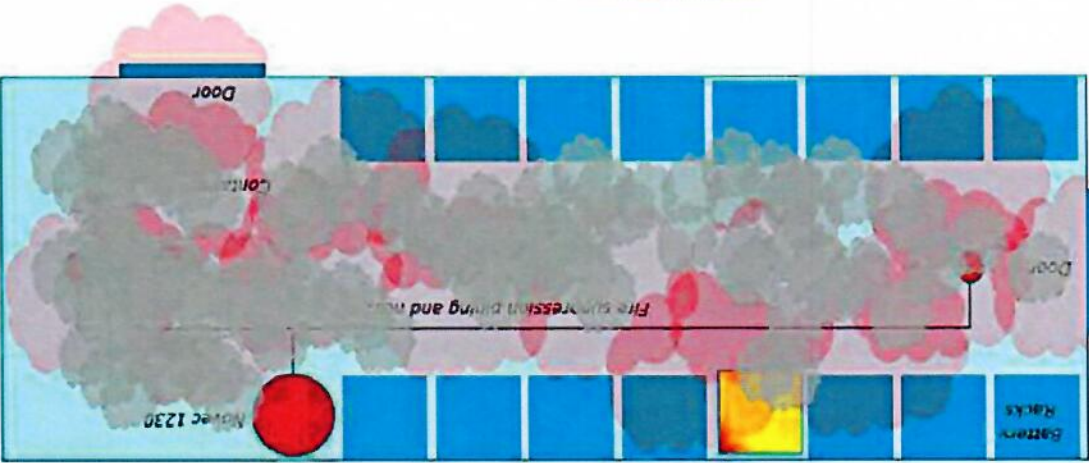
Novec 1230 was displaced from the container as thermal runaway cascaded and produced more gases

As thermal runaway moved through the rack, flammable gases continued to

concentrate. Fire suppression devices were ineffective on the event. IMAGE.

As the event progressed, a large amount of flammable gas was produced within the BESS. Lacking ventilation to the outside, the gases created a flammable atmosphere within the container. Around 3 hours after thermal runaway began, when firefighters opened the BESS door, flammable gases made contact with a heat source or spark and exploded.

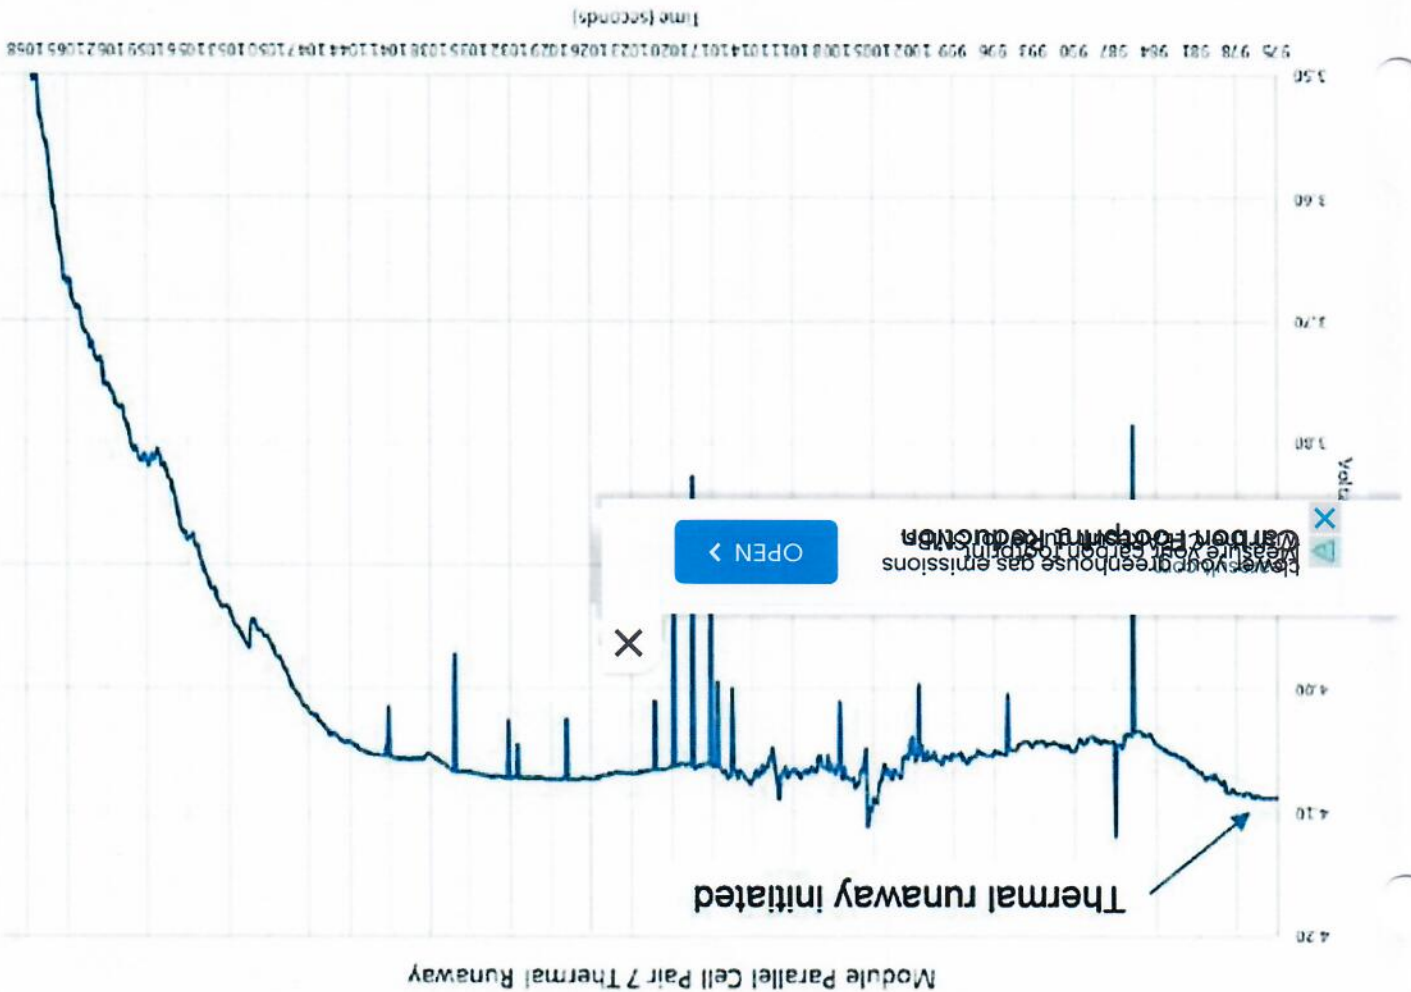
voltage excursion.IMAGE: LG CHEM

company to conclude it is unlikely that a single-cell failure caused the  
set up to match the pair damaged in the accident did not match, leading the  
of the Cell 7 pair during the thermal runaway event. A postincident test  
LG Chem's accident report included this chart showing the voltage profile

cell-failure theory. It did so by forcing a parallel cell configuration into thermal runaway. It then compared the resulting voltage profile to the voltage profile recorded during the incident. It found that the two did not match, leading to the conclusion that the explosion's cause was unlikely to have been "an internal short within a single cell."

The battery maker also said that data recorded during the incident showed a discharging current of 4.9 amperes present during the voltage excursion. It said that although the APS report acknowledged that the current flipped from -27.9 A charging to 4.9 A discharging, "it offered no explanation for the event." To LG Chem, however, the fact that the discharging current was at 4.9 A, instead of zero, "means the current indeed flowed to somewhere else," supporting what it said was a likely double-point electrical isolation failure and not an internal cell short.

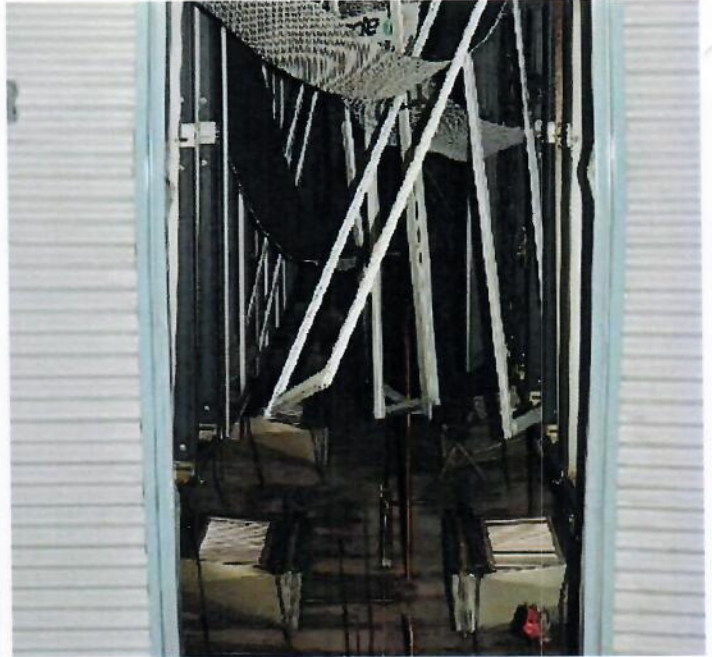
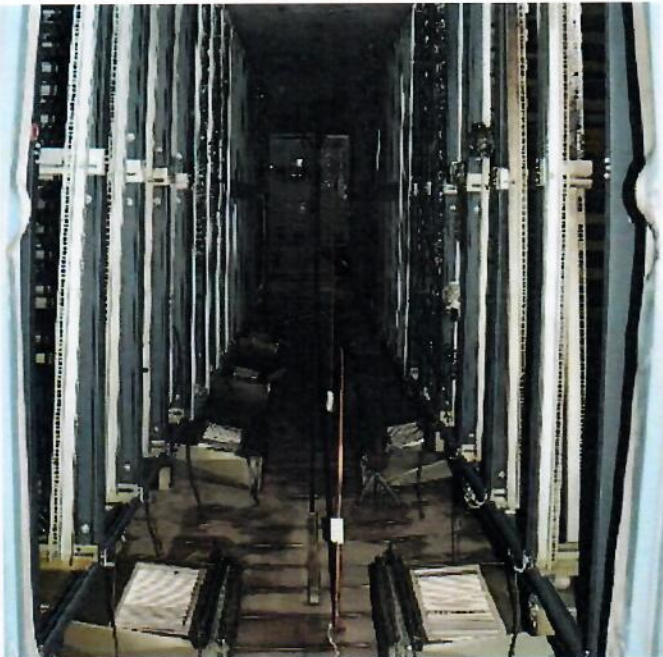
Interior damage to the BESS after the explosion [left], and after debris was removed to gain access to begin the forensics analysis [right].  
PHOTOS: ARIZONA PUBLIC SERVICE

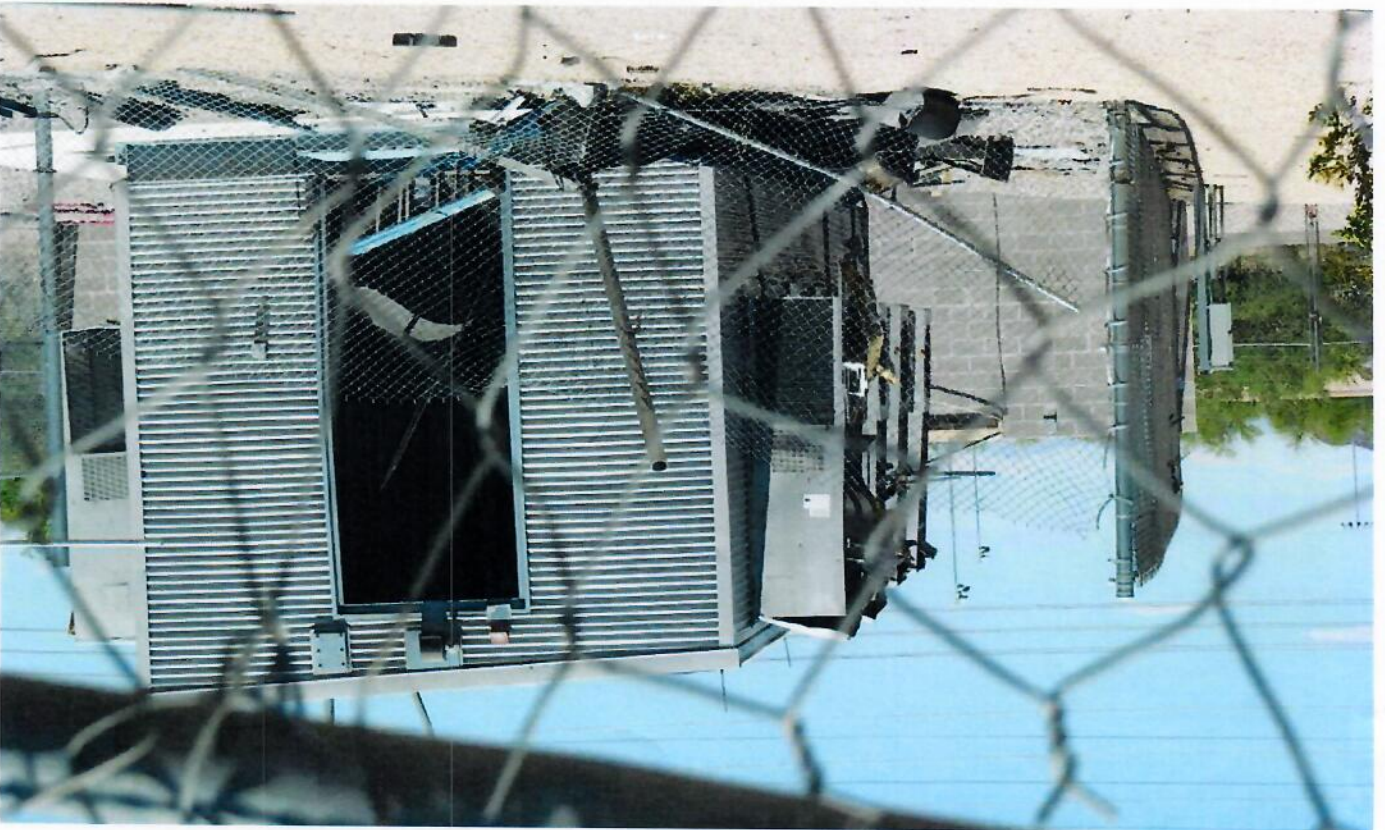
View of debris and damage to the rear door, HVAC systems, and the container. PHOTO: ARIZONA PUBLIC SERVICE

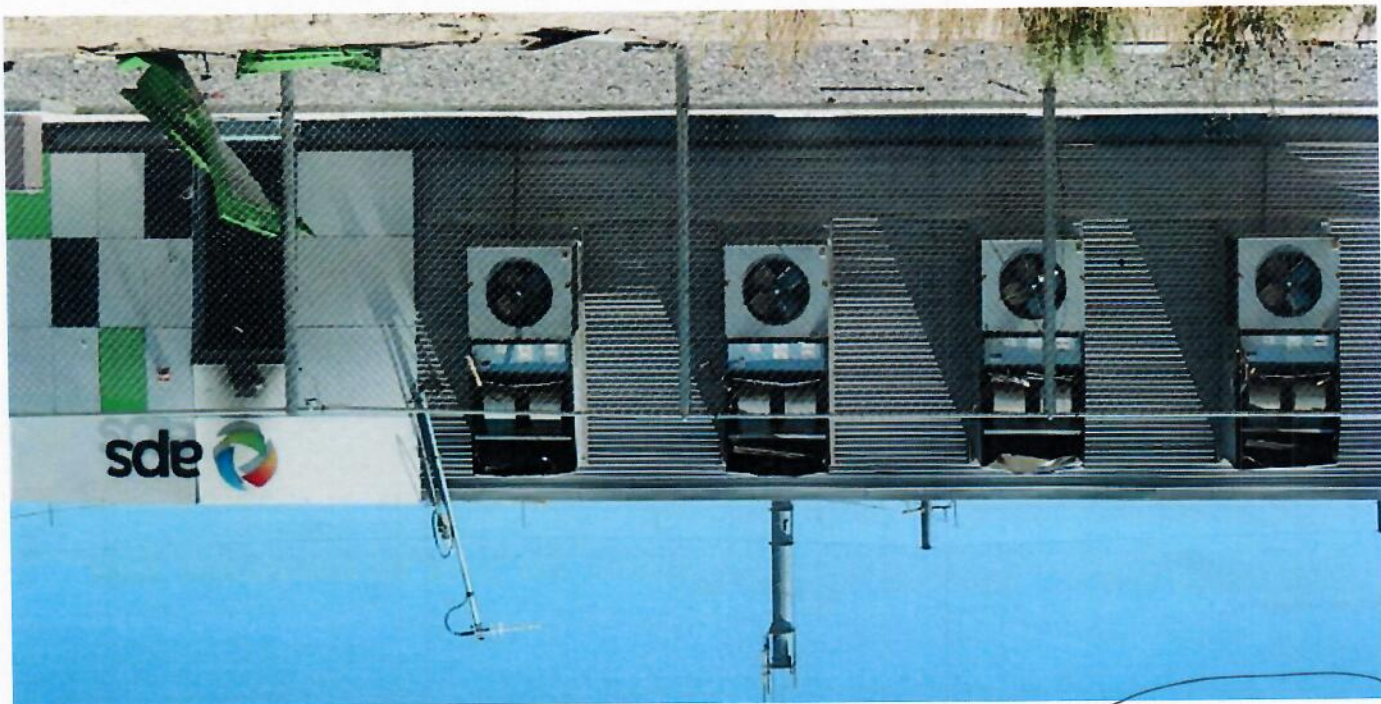
The side door to the McMicken BESS was ejected in the explosion and can be seen laying against the fence in the foreground. PHOTO: ARIZONA PUBLIC
