**Town of Ware
Self-Evaluation and Transition Plan
June 30, 2023**

**Center for Living & Working, Inc.
Michael Kennedy, ADA Access & Advocacy Coordinator
18 Chestnut Street – Suite 540, Worcester, MA 01608
and
James M. Mazik, AICP - Consulting Services
188 Lower Westfield Road, Holyoke, MA 01040**

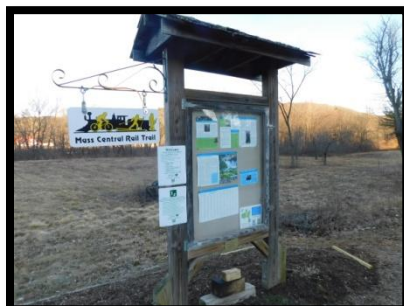
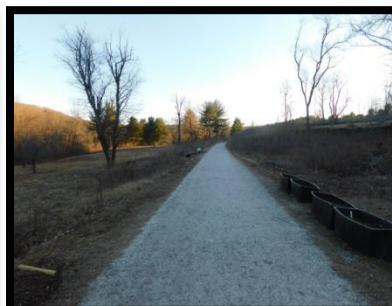
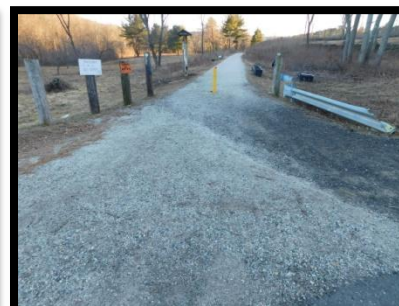
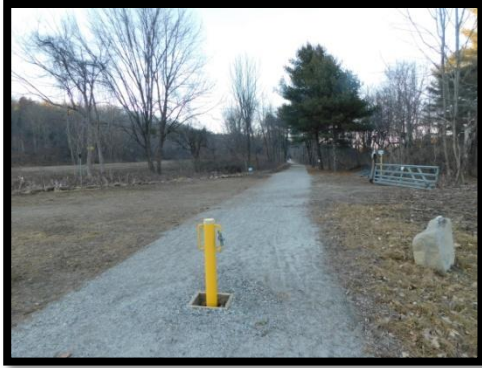
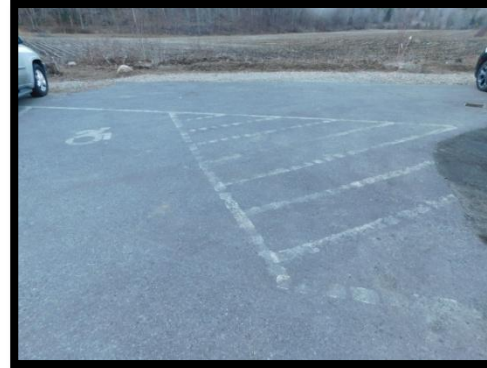
There is one designated accessible parking space which does not fully meet the required width for an access aisle, has excessive running and cross slopes, and lacks signage. There is no defined accessible route of travel to the trail. The surface of the trail consists of stone dust. Although the stone dust has been compacted, there are areas of loose stone which creates an unstable surface as well as a friction issue for non-motorized wheelchair users and for individuals using walkers or arm crutches.

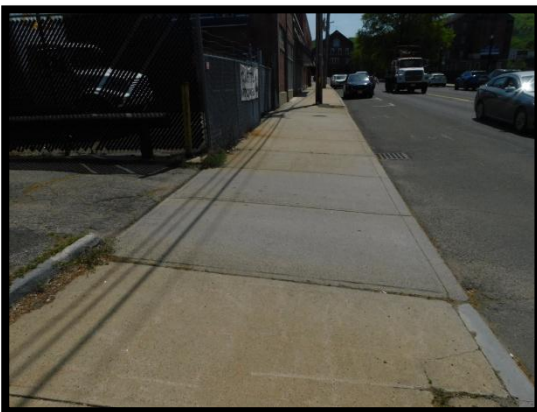
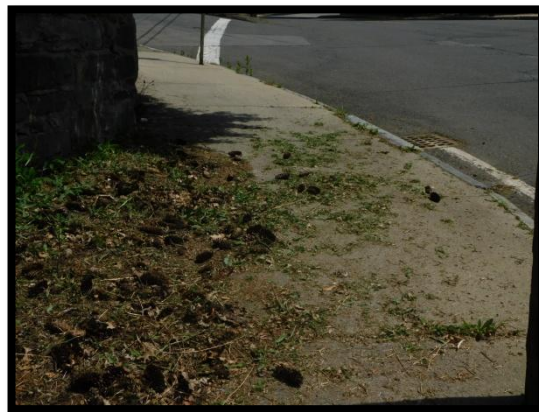
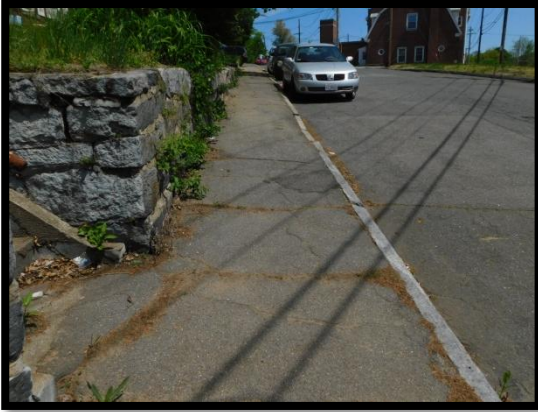
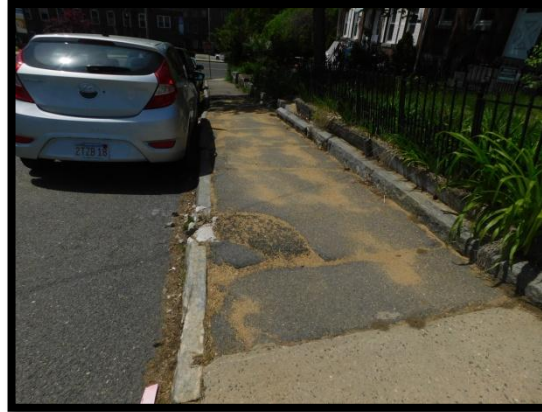
- The sidewalk past the former Wilson's Pharmacy to Cluett's has a cross slope of up to 5.2% for approximately 50 feet.
- The sidewalk in front of Dulak's Garage has a cross slope of 3.6% to 4.0% for approximately 28 feet.
- The sidewalk at the driveway/entrance to Dulak's and the rear of Gabe's has a cross slope on 4.0% for approximately 26 feet.
- The sidewalk at Park Street has considerable debris in the sidewalk.
- The Park Street sidewalk is initially concrete then asphalt with deterioration, heaving, and gaps in asphalt. Cross slopes vary up to 5.0%. The affected sidewalk segment is approximately 105 feet to Otis Avenue. The driveway and sidewalk past Otis Avenue has a cross slope of up to 8.5% for approximately 86 feet.

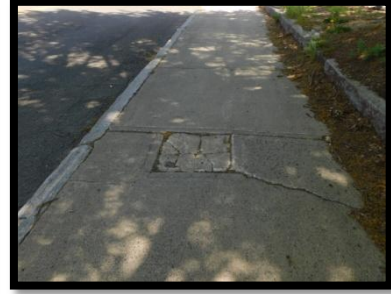
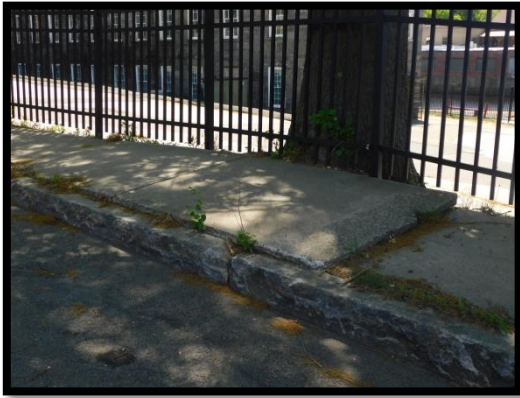
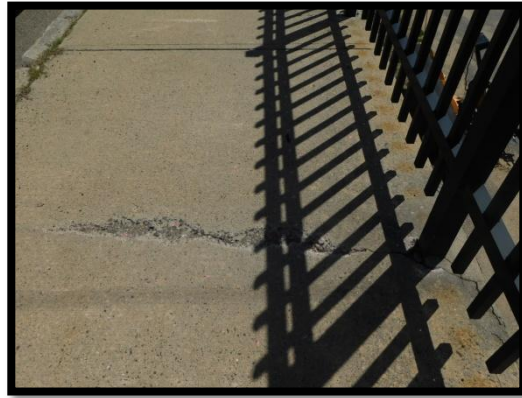
- The sidewalk at the Millyard driveway across from Canal Street has a cross slope of up to 5.0% for approximately 34 feet. There are also abrupt changes in level surface of up to 3" and surface deterioration.
- The sidewalk at the Galaxy Industries Driveway has a cross slope of up to 5.0% for 30 feet to 40 feet.
- The sidewalk in front of the bollards at the Mill Complex has a cross slope of up to 6.0% for approximately 30 feet. There is also a ½" abrupt change in level surface, deteriorated concrete, and heaving.
- There is severe concrete pad heaving in front of Stone Mill Antiques with up to a 2" abrupt change in level surface on one side and up to a 5" abrupt change in level surface on the opposite side. There are also cross slopes of up to 8.0%. There are also general areas of deterioration and abrupt changes of up to ½" for the remainder of the sidewalk to South Street.

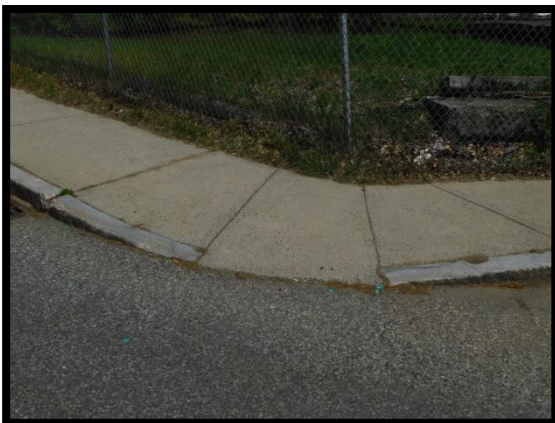
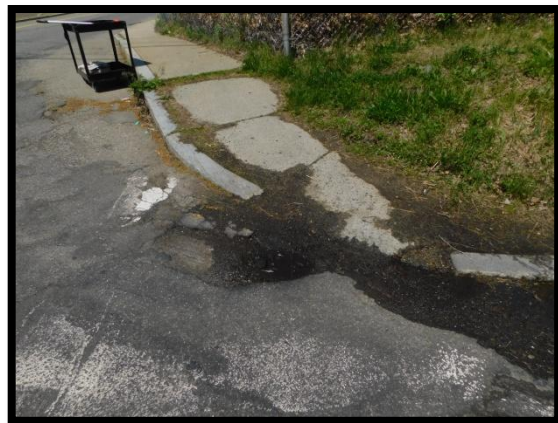
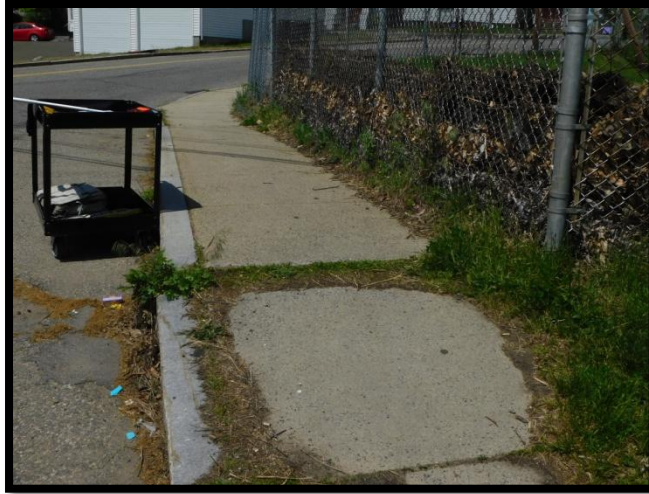
- The curb ramp near the canal at East Main and Park Streets lacks a detectable warning strip, has an 8.8% running slope, and lacks a level landing.
- The curb ramps with the crosswalk across East Main Street has faded striping. The curb ramps lack detectable warning strips and level landings. The curb ramp on the Canal Street side has a running slope of up to 12.0%, severe deterioration at the ramp base with 1"+ abrupt changes in level surface, and a 3" abrupt change in level surface at the top of the curb ramp.

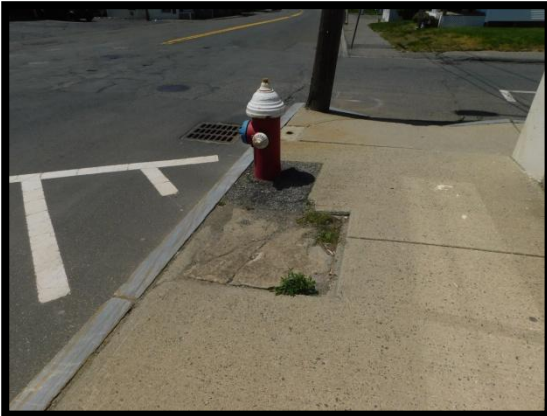
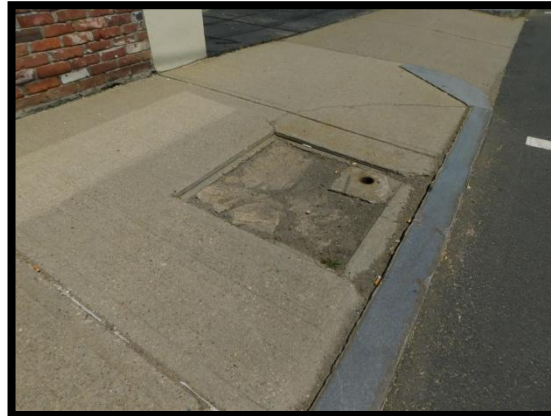
- The sidewalk in front of the laundromat has 3 areas of missing concrete with up to 2" of abrupt changes in level surface. The sidewalk also has cross slopes of up to 8.0% for approximately 30 feet.

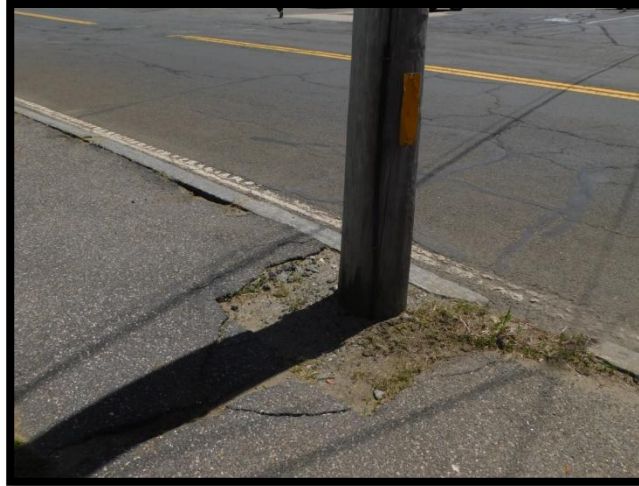
- The sidewalk at telephone pole #4/5 has deteriorated asphalt, a 2" abrupt change in level surface, up to a 4" gap, and clear width that is reduced to only 32".

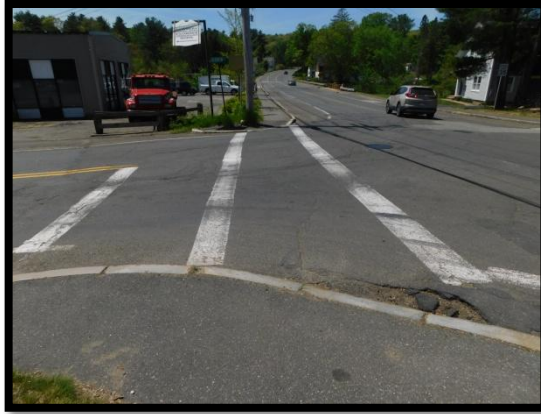
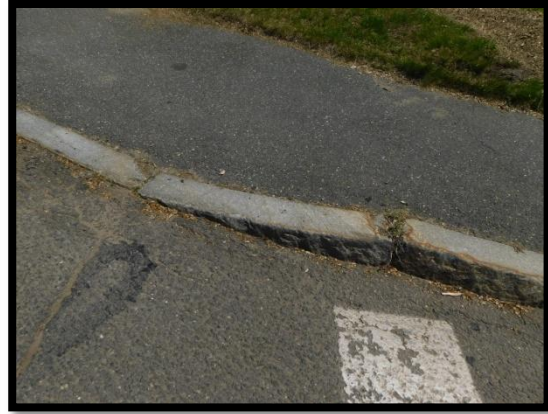
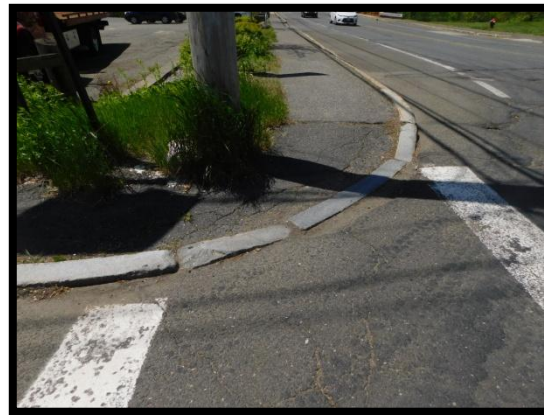
- The curb ramps at Vernon Street lack detectable warning strips, lack level landings, have abrupt changes in level surface of up to 1" at the transition from asphalt to granite, and deteriorated asphalt.

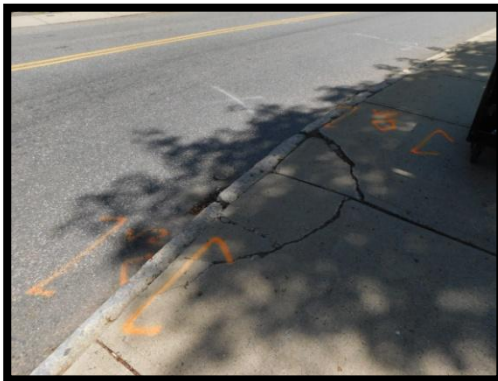
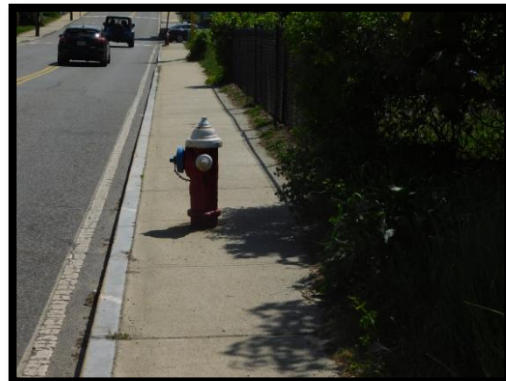
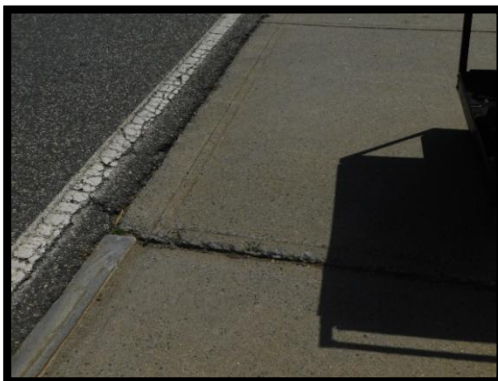
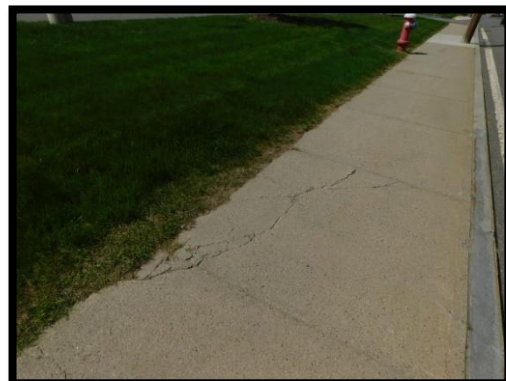
- The sidewalks overall are in good condition with some areas of deterioration, abrupt changes in level surface, excessive cross slopes, and reduced clear width.
 - There is concrete deterioration near the bridge.
 - There are up to ½" abrupt change in level surface near the former convent, near Clifford Avenue, and in front of Cedar Brook Housing. There is also some concrete deterioration in front of Cedar Brook.
 - The sidewalk clear width is restricted to only 29" near Gilbert Court due to a fire hydrant and vegetative overgrowth.
 - Sidewalk cross slopes vary from 2.4% to 4.4% at the driveways (2) to Country Bank and American Athletic; segments of sidewalk in front of St. Mary's Church; and segments of sidewalk in front of Cedar Brook (approximately 100 feet).

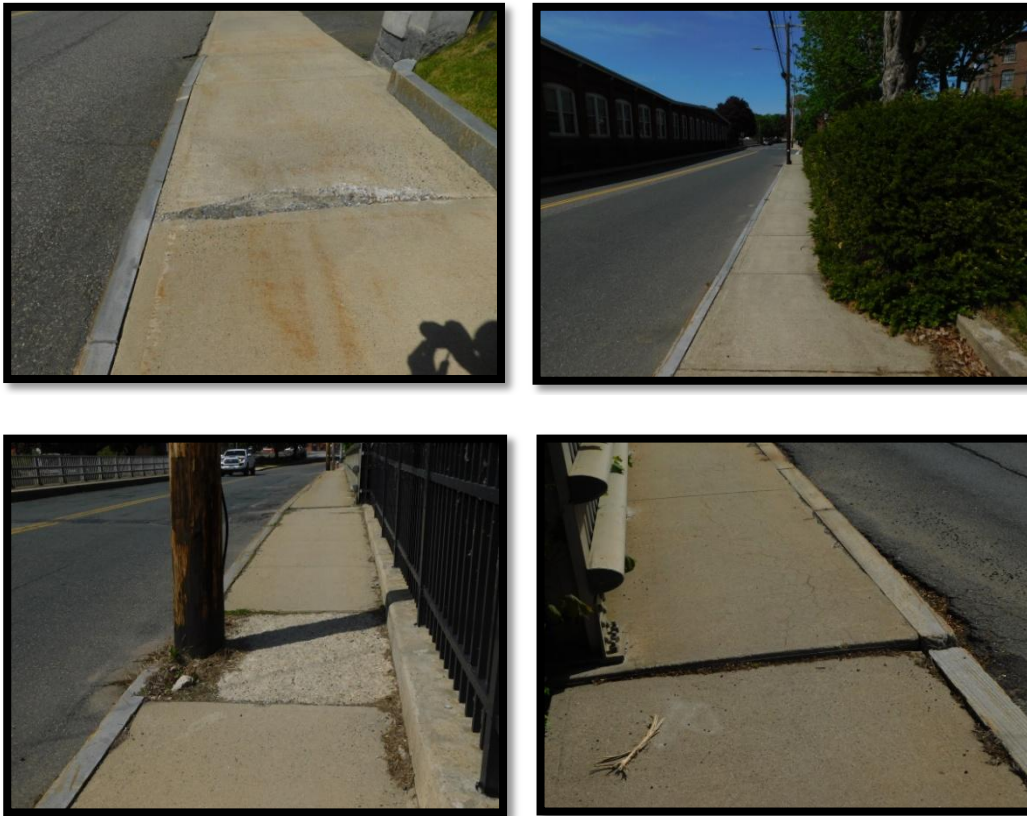
- Sidewalk cross slopes vary from 2.2% to 5.8% at segments of sidewalk in front of #76, segments of sidewalk in front of Cebula Funeral Home, St. Mary's Rectory driveway, segments of sidewalk in front of #54, at driveway #50/52, driveway on South Street to Maple Street multi-family apartment building, and segments of sidewalk at #8 South Street.

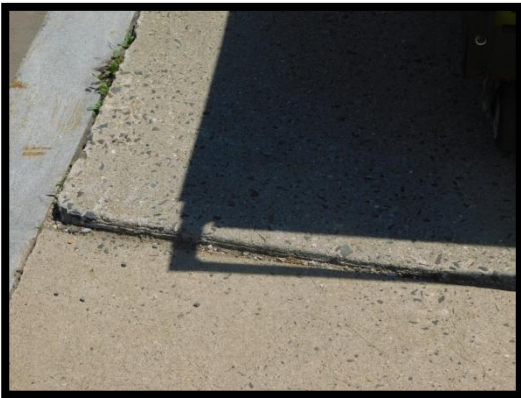
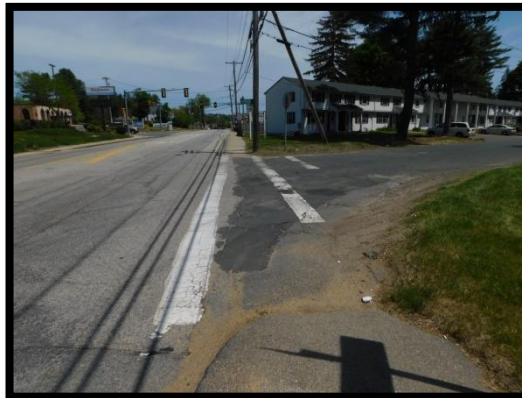
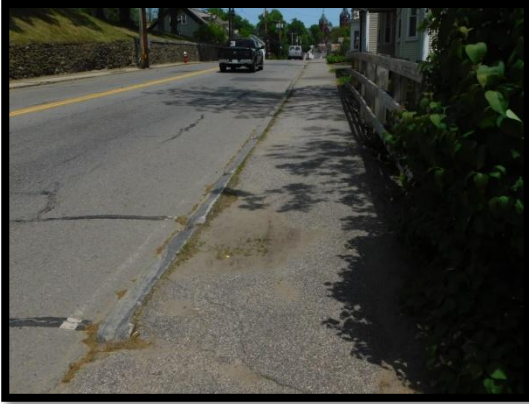
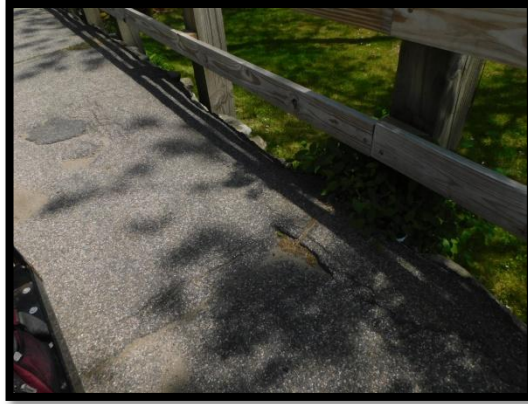
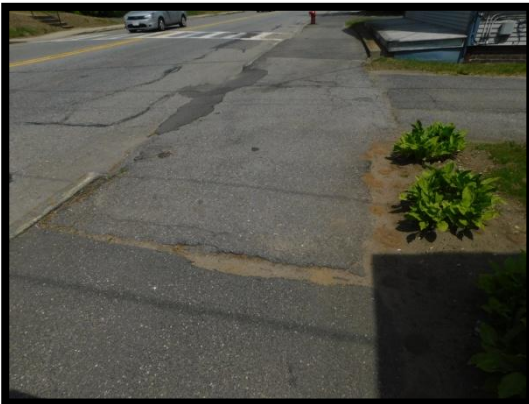
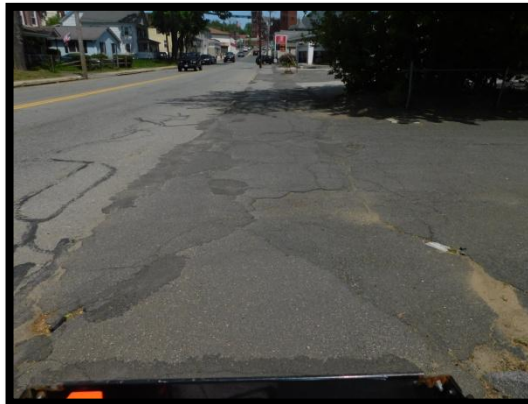
- The sidewalks overall are in fair to poor condition with areas of deterioration, abrupt changes in level surface, excessive cross slopes, and reduced clear width.
 - There are up to 1" abrupt changes in level surface at Crystal Springs due to a raised concrete pad and near Taco Bell at the transition from asphalt to concrete.
 - There is surface deterioration and/or gaps near Taco Bell, in front of #96, from #96 to Pulaski Street with more severe deterioration near Speedway and Rohan's.
 - Sidewalk cross slopes vary from 2.4% to 9.6% at segments of sidewalk in front of #86 and #64, and driveways for #110, #96, Jane Alden (2), Speedway, and the vacant lot next to Speedway.

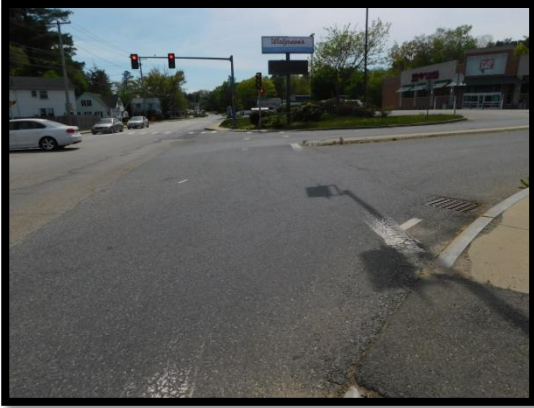
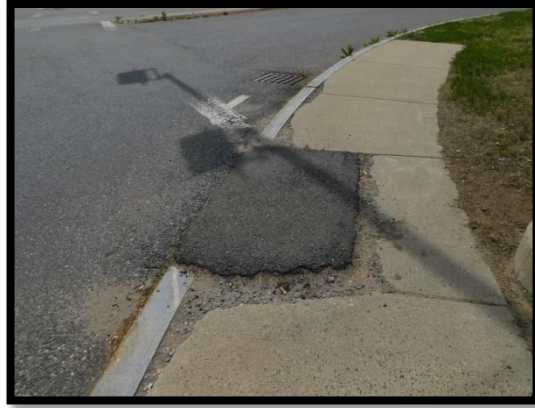
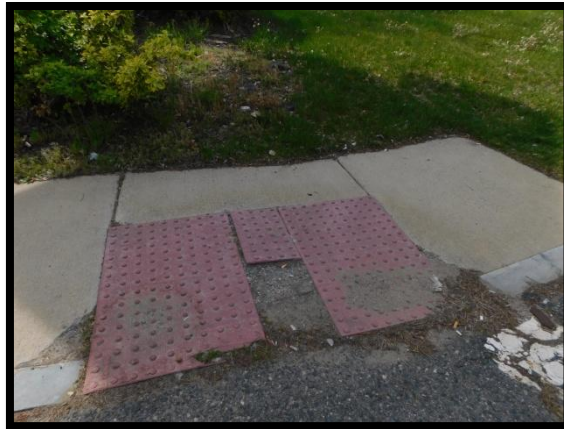
- The curb ramp at Vernon Street has up to a ½" abrupt change in level surface at the transition to asphalt and concrete on the cemetery side.
- The curb ramps (2) and crosswalk at the Walgreens and USPS driveway have up to 1" abrupt changes in level surface at the curb ramp transitions and no level landings. The detectable warning strip on the USPS side is paved over and is deteriorated on the Walgreen side. The crosswalk striping is faded.

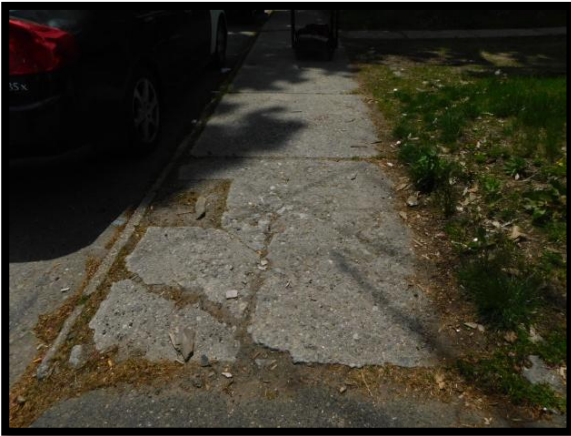
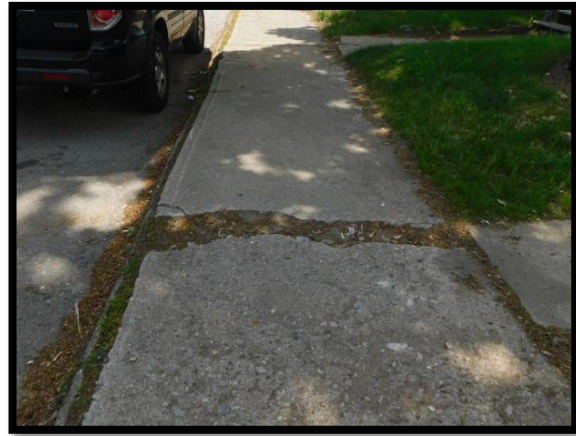
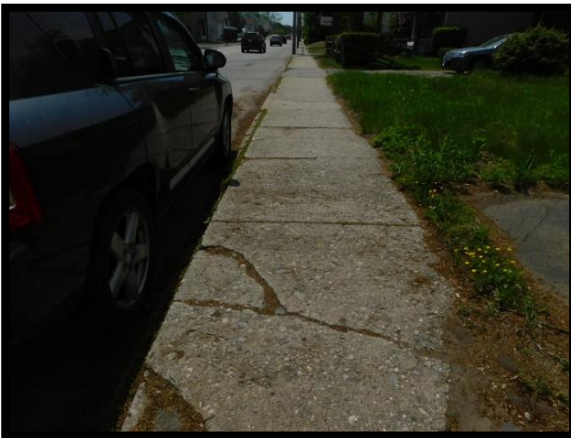
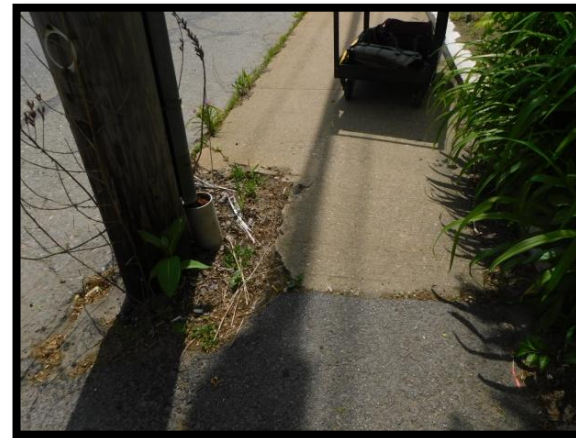
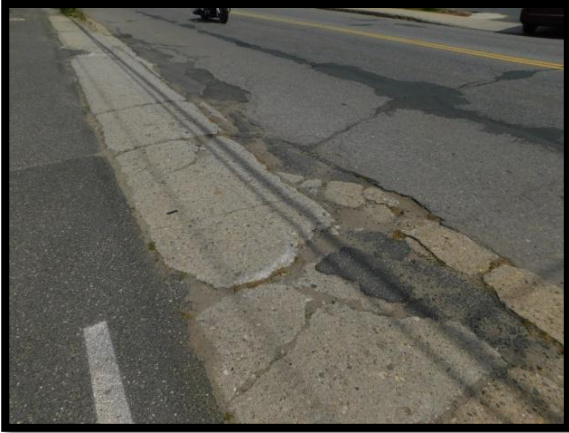
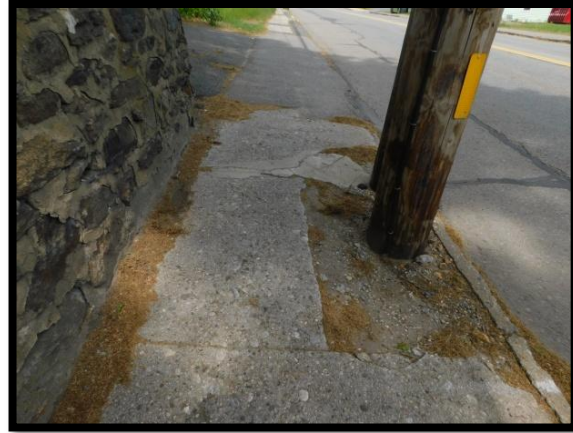
- Sidewalks at the following location are deteriorated, have gaps in asphalt or concrete and in general poor to very poor condition: near Bruso's Liquors and #9, #23.5 to #35, sidewalk/driveway at Robert's Garage, #61 to #65, and McDonald's driveway/sidewalk.
- The transitions from driveway to sidewalk have excessive running slopes at the following locations: McDonalds (9.0% and 18.5%), Dollar General/Moulton's Insurance (8 locations up to 9.6%), Colonial Village Apartments (up to 11.5%).
