## **Ware Millyard Redevelopment:**

Existing Site Utility Summary, East Main Street Millyard &  
Existing Conditions Review of Building #9 – Turbine Room  
Ware, MA

**Existing Site Utility Summary, East Main Street Millyard - Ware, MA**

**To:** Rebekah Cornell, Town of Ware Director of Planning & Community Development  
**FROM:** Craig French, PE, Principal Structural Engineer  
**DATE:** November 6, 2020

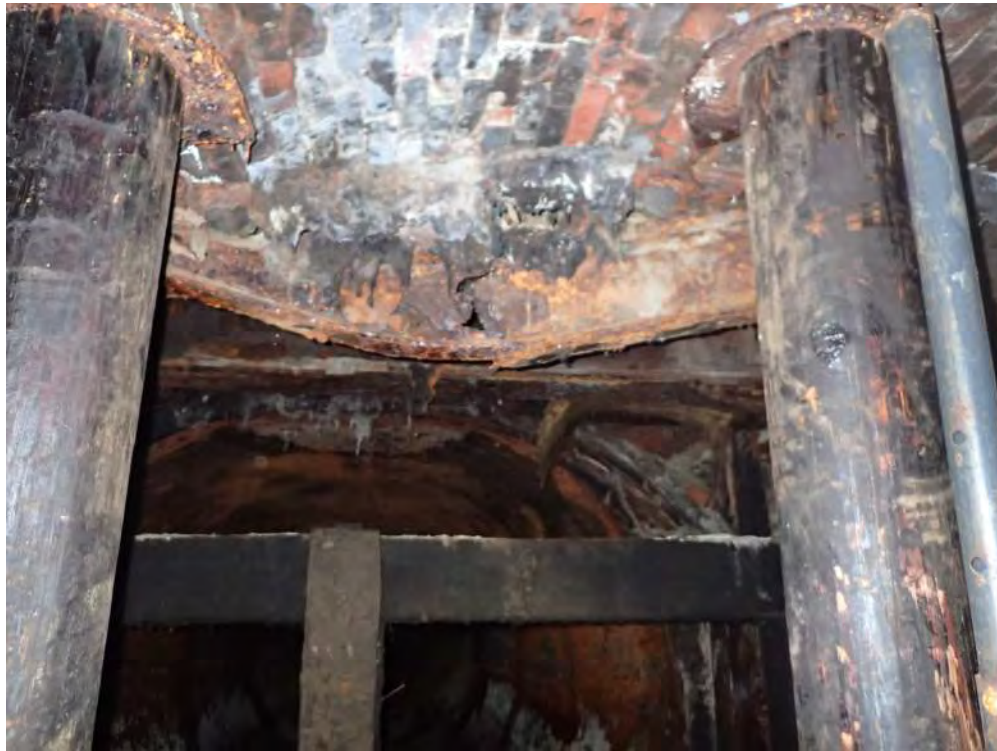
The culvert was approximately 95 feet from the entry point and was visually observed from the main tunnel and was not entered due to heavy section loss that was observed at the culvert inlet and active running water draining from the main tunnel into the culvert. Where the culvert connects to the main tunnel the overhead spandrel beam along the opening exhibited substantial section loss and structural failure. To support the load from the brick segmented arch roof assembly, that was once carried by the spandrel beam, heavy timber columns bearing on cylindrical concrete footings have been installed at the spandrel beam ends (**Photo 01**). Additionally, adjustable steel shoring posts have been positioned mid span of the roof beams to assist in supporting the masonry and steel roof assembly above.

Photo 01: Supplemental Support at West End Culvert Intersection

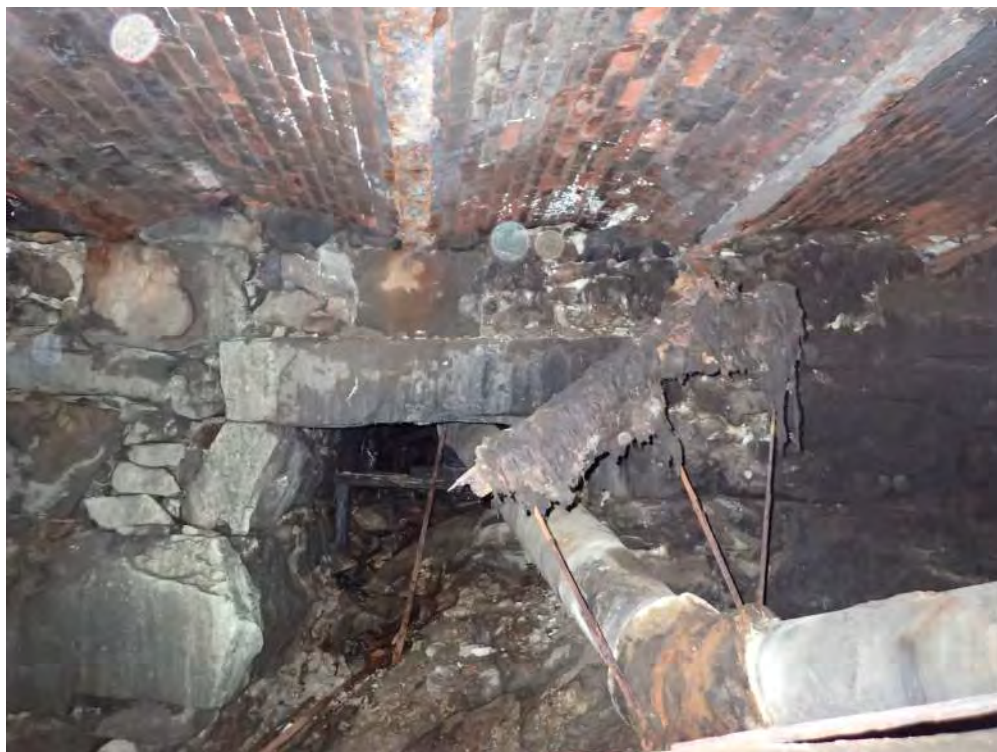
Looking at the north wall of the tunnel, approximately 70 feet west from the entry point, another connecting stone tunnel heads north from the main tunnel. The stone tunnel was small in size, a few feet tall and similarly wide. At the time of observation, it was deemed unsafe to enter the tunnel, due its small confined size, and conditions (**Photo 02**). In addition, a 12-14" diameter pipe from within the main tunnel exits and heads north up through the stone tunnel. This pipe was believed to be asbestos pipe based on observations by Tighe & Bond's asbestos inspector. The stone header of this rubble tunnel and stones adjacent to it were observed to be heaving out of plane with the northern wall, towards the main tunnel.

Photo 02: Stone Tunnel on Northern Wall, West of Entry Point

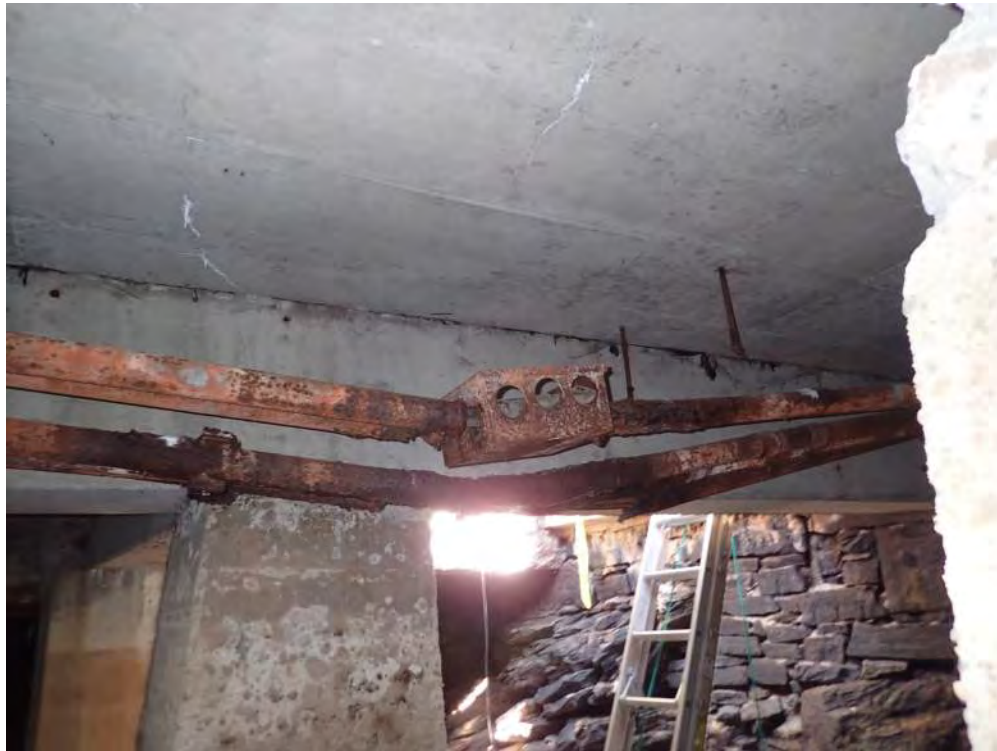
East of the entry point the construction of the tunnel ceiling changed from brick segmented arches to tapered concrete piers supporting concrete beams and an elevated concrete slab for about 50 feet east of the entry point (**Photo 03**).

An electrical conduit was observed running north to south through the tunnel ceiling near the entry point. The conduit was severely corroded and failed due to section loss and was sagging

into the tunnel. It appeared that the failed conduit was being supported by the cables originally held within it.

Photo 03: Tunnel Roof Construction – East of Entry Point with Electrical Conduit

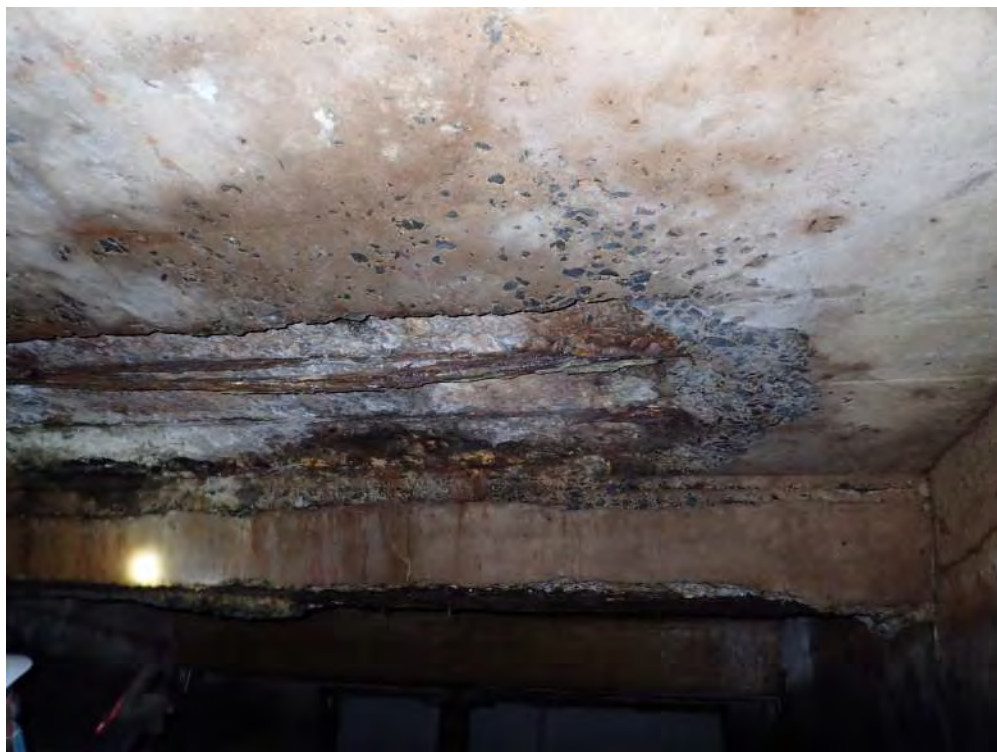
Continuing east the next 50 foot long section of the tunnel was constructed of concrete encased steel beams supporting an elevated concrete slab. A similar 8 foot floor to ceiling height was observed as well as the rocky / muddy ground base. The elevated concrete slab in this area had isolated areas of exposed reinforcement. Section loss of the encased steel members was also observed, causing the concrete encasement to spall off (**Photo 04**).

Photo 04: Exposed Concrete Reinforcing with Steel Beam Showing Section Loss

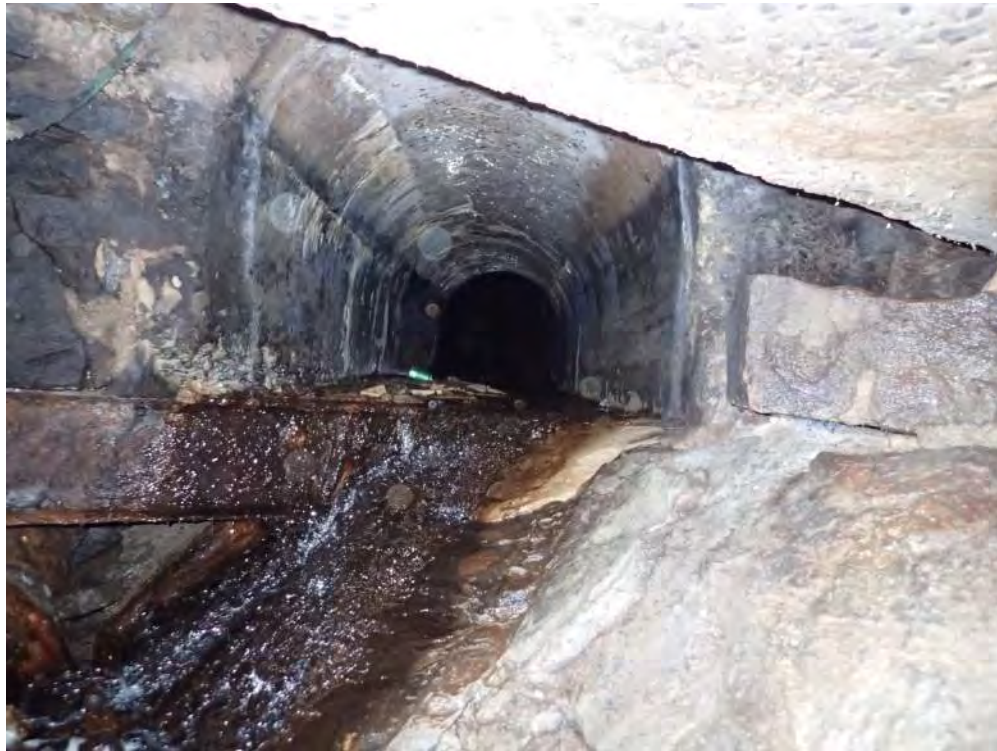
Water was observed flowing into this section of the tunnel from a small inaccessible tunnel about 3 feet high by 3 feet wide on the north side of the tunnel wall (**Photo 05**). Three other tunnel penetrations were observed in this area including a 24" diameter pipe entering the main tunnel, a vertical riveted steel open pipe draining into the tunnel as well as a small opening for an 8" pipe in the upper north eastern corner of the tunnel section. Water flowing from the northern tunnel was observed to be pooling at the southern end of the tunnel and draining west towards the previously observed culvert.

Photo 05: Formed Concrete Tunnel – North Side of Main Tunnel – Active Water Flow

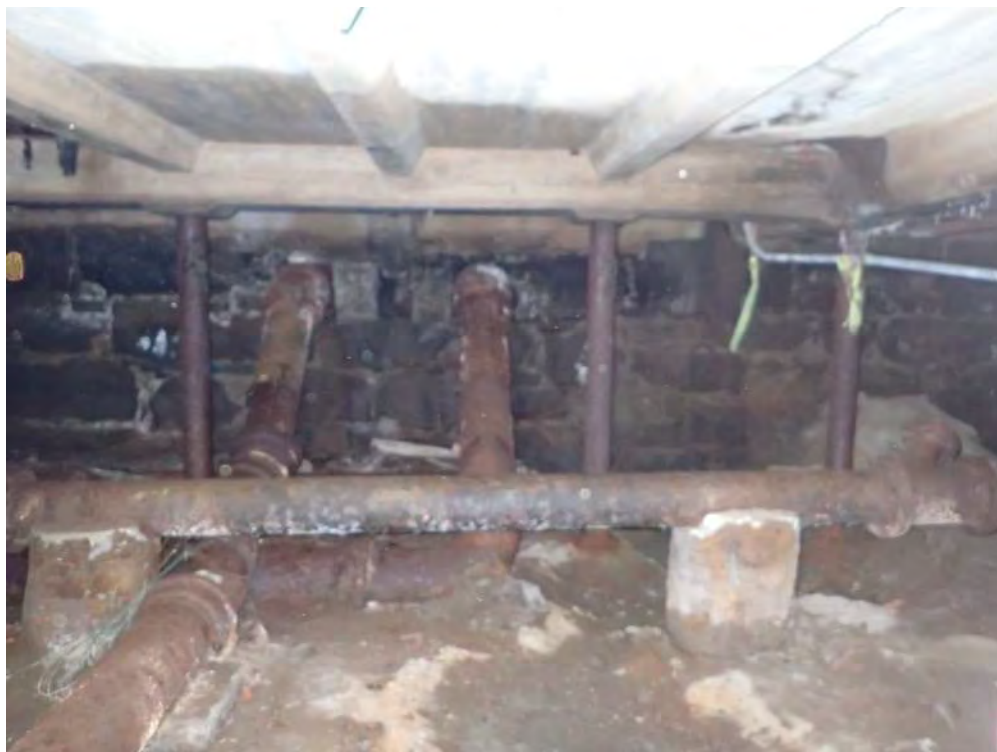
Three ductile iron pipes run through this section of the tunnel. The northern most pipe enters the tunnel through the northern wall and elbows east where it meets up with the larger 24" diameter pipe through a reducing section near the primary water flow source described previously. Two other smaller diameter pipes, approximately 8", pass through this area from the northern most sections of the tunnel and lead down to the far western portion of the tunnel near the large steel culvert (**Photo 06**).

Photo 06: Existing Pipes in Tunnel (Approximately 50' West of Turn)

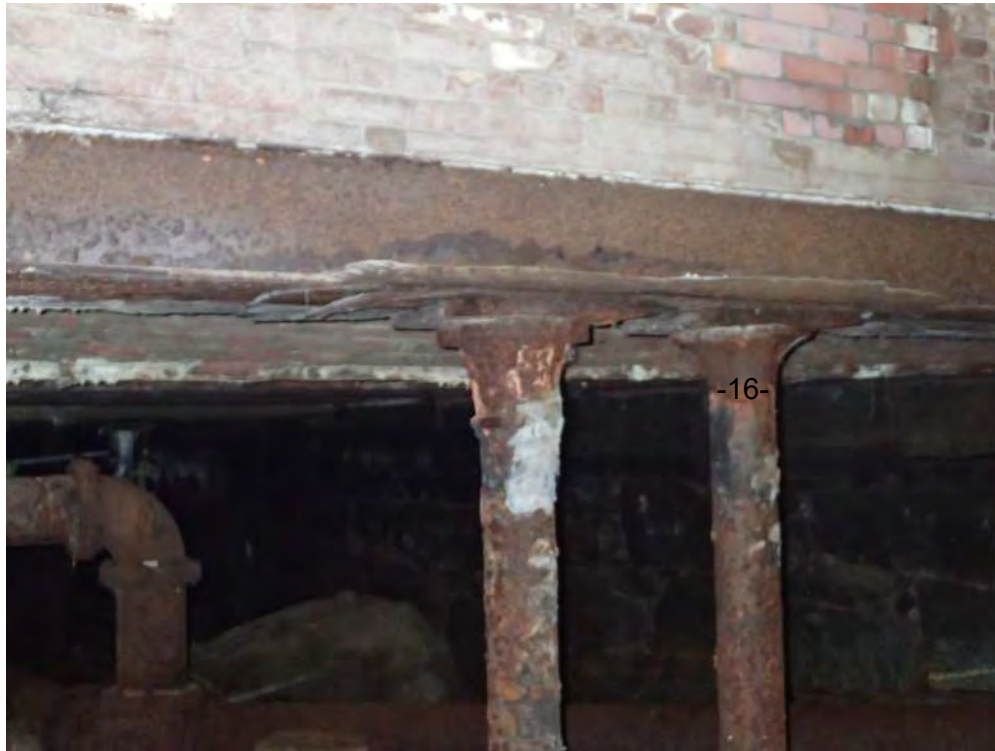
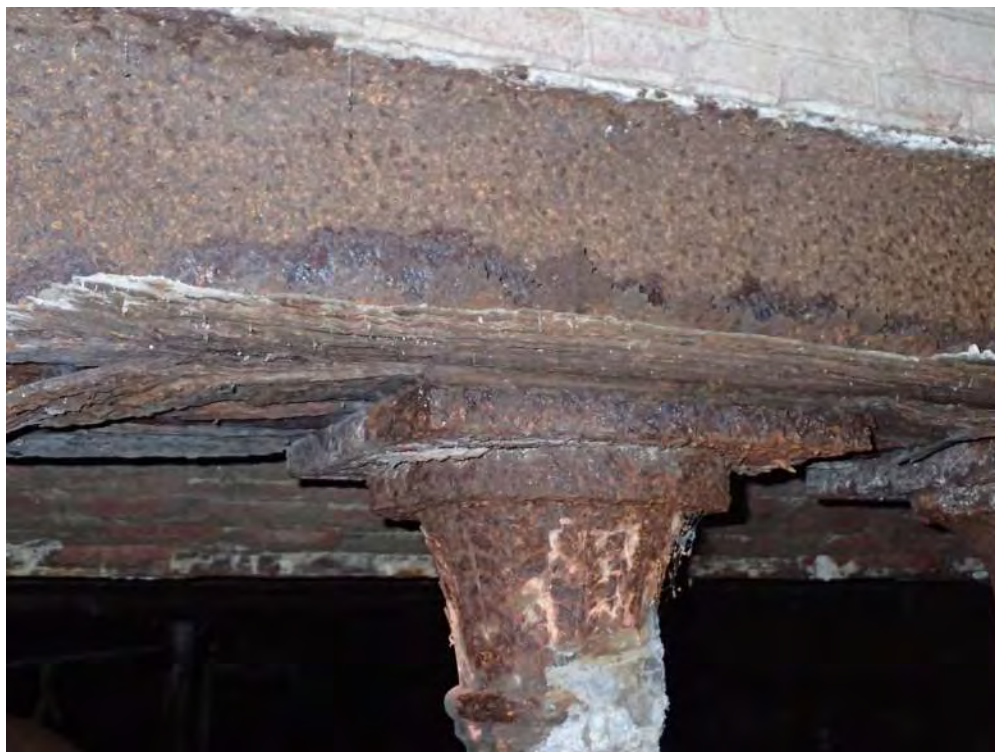
As the tunnel turns North the main support beam across the tunnel is supported by two cast iron columns at mid span. At these bearings the beam had delaminating corrosion of the bottom flange (**Photos 07 & 08**). Brick segmented arch ceiling construction continues in the tunnel as it heads north, however the span of the roof is now east to west, perpendicular to the tunnel direction. In this area a built up beam section supported by cast iron columns supports the segmented arches at their midspan. The base of these columns was covered with a thick buildup of material that did not appear to be soil. The material was built up on top of the rocky / muddy tunnel floor base (**Photo 09**).

Photo 07: Support Beam and Columns at Tunnel Turn to the North

Photo 08: Support Column Deterioration at Tunnel Turn to the North

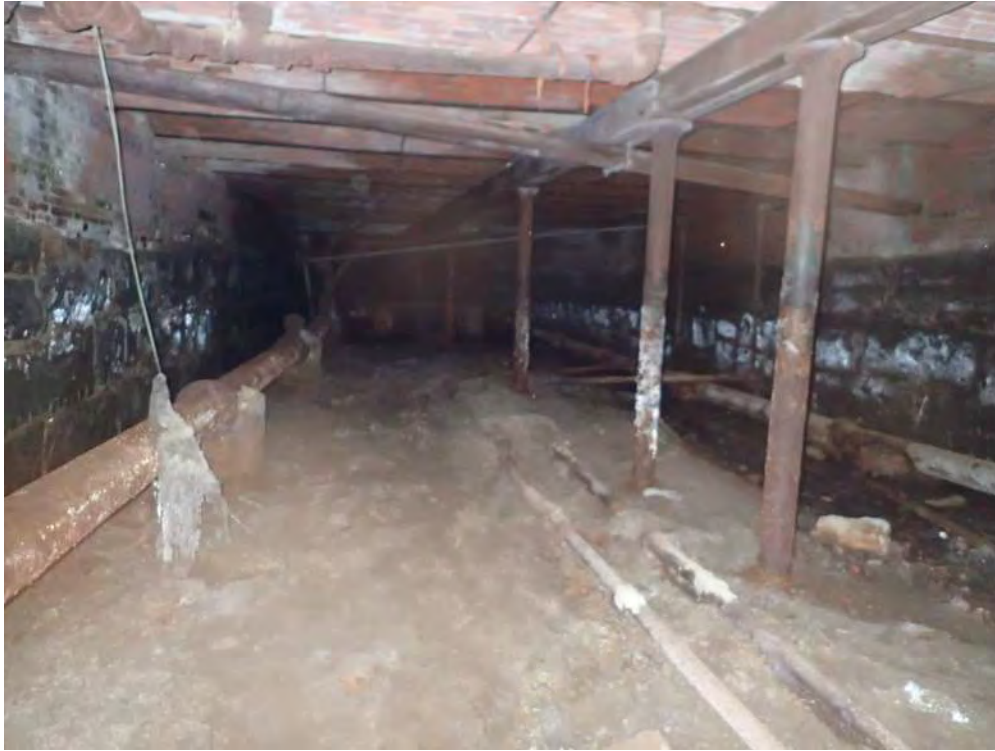
Photo 09: Center Line of Support Columns Along Northerly Portion of Tunnel

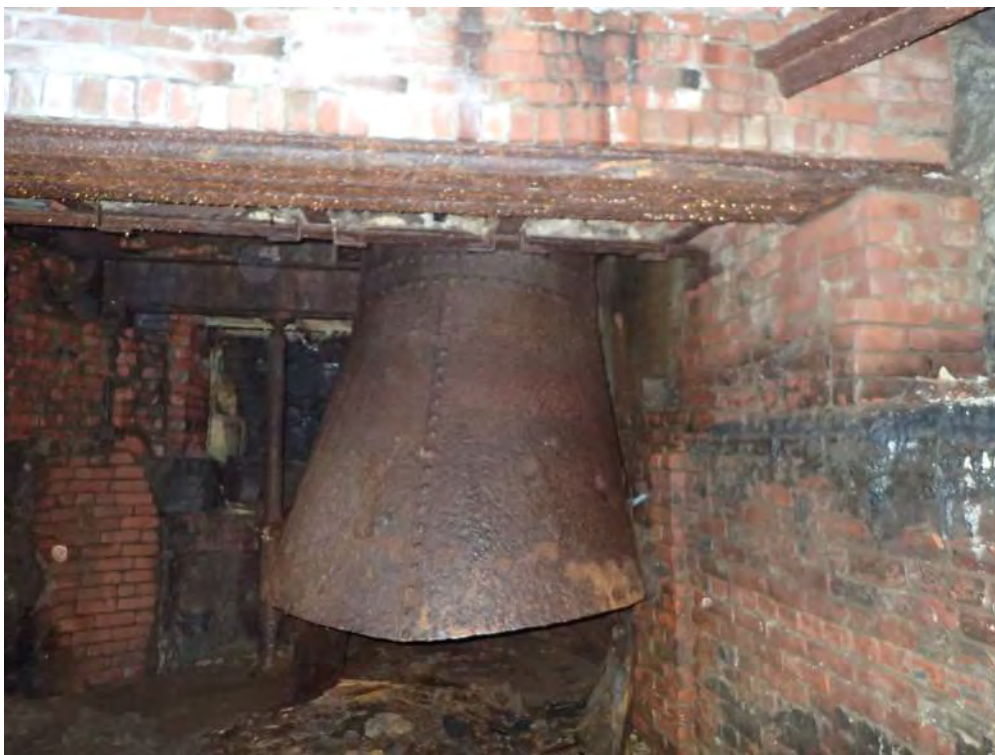
diameter orientated vertically and terminating a few feet above the ground surface. There was no flow out of this structure at the time of the inspection. The steel was heavily corroded and exhibiting delamination in large sheets (**Photo 10**).

Photo 10: Alcove in Northern Portion of Tunnel with Steel Drain

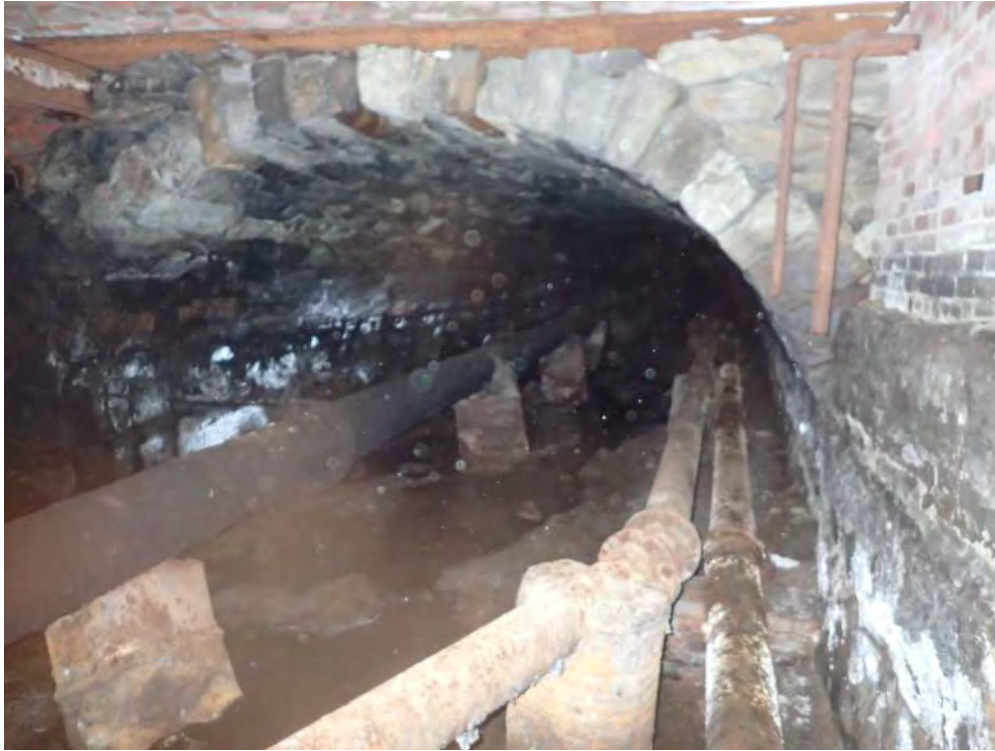
The tunnel continues north past the alcove and large diameter drain, however the tunnel width narrows and the construction changes to dry stacked granite arches for approximately 60 feet. The 6" and 8" diameter ductile iron pipes observed throughout the tunnel continue through the granite arch portion on its east side while on the west side a new 12" DI pipe is observed that appeared to have been connected with one of the smaller lines near the large drain area but has since been disconnected (**Photo 11**).

Photo 11: Granite Arch Portion of Tunnel

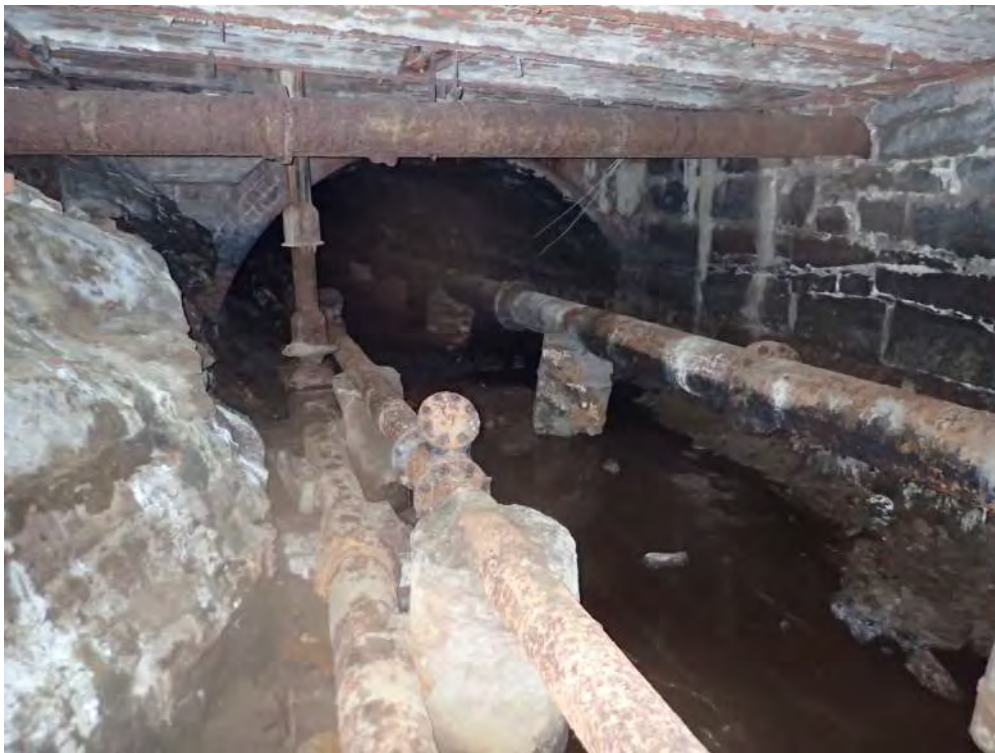
The tunnel roof transitions back to brick arch type construction approximately 60' north of the alcove. The roof in this section had numerous holes from either pipe penetrations or isolated partial failures. The west wall of this section was the typical granite and field stone while the east wall appeared to be bedrock. The 6" & 8" diameter pipes terminate into the east wall near the bedrock before the tunnel turns 90 degrees west (**Photo 12**).

Photo 12: Bedrock Sidewall with Pipes Continuing Through Tunnel

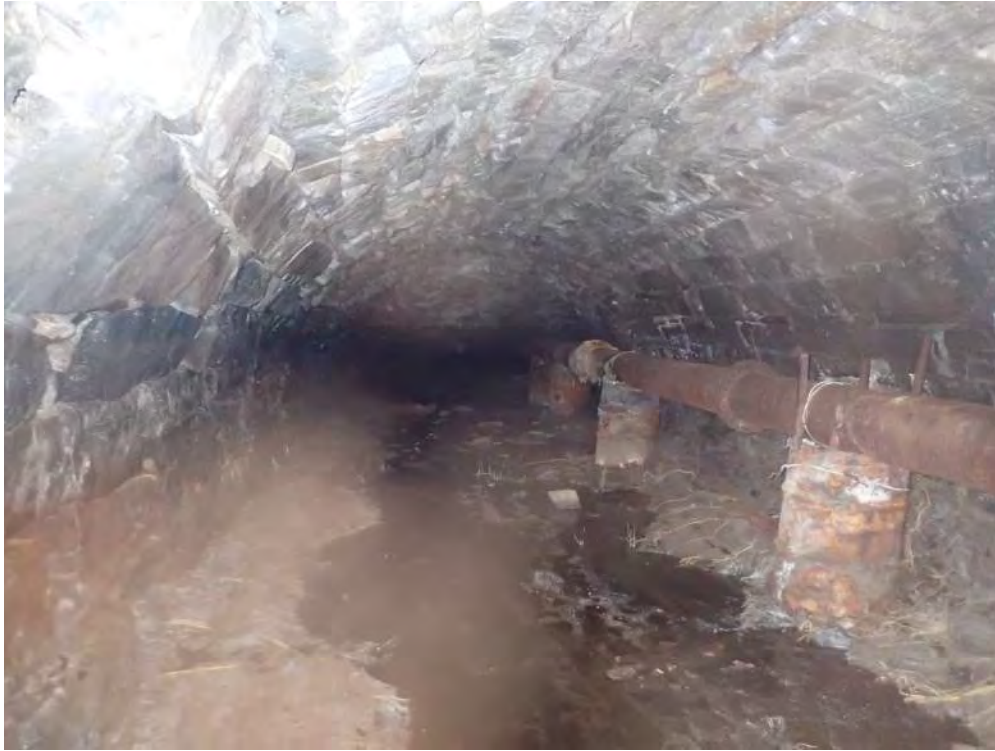
This next section of the tunnel measured approximately 60 feet long and transitioned back to granite arch construction (**Photo 13**). There are isolated areas of dislodged stones in the arch face.

Photo 13: Second East – West Tunnel Portion – Stone Arch Construction

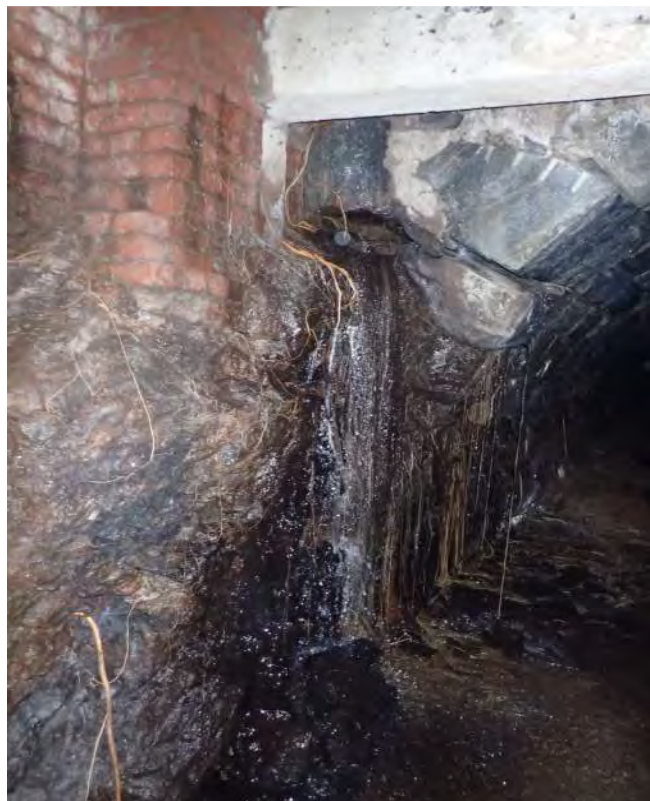
The granite arch tunnel opened up to a brick masonry space that featured a central brick tower. Water was making its way into this space through a crack in the northern wall with an active light flow (**Photo 14**). Water levels in this area around the tower appeared to be 1 foot or greater so observations of the tunnel were terminated at this point. An open hatch, with an old wooden ladder, to what was presumed to lead to the surface, was noted. The ladder was missing rungs and appeared severely deteriorated, therefore it was deemed unsafe to attempt to use it (**Photo 15**).

Photo 14: Transition from Stone Arch to Brick Masonry Construction – with Active Water Flow

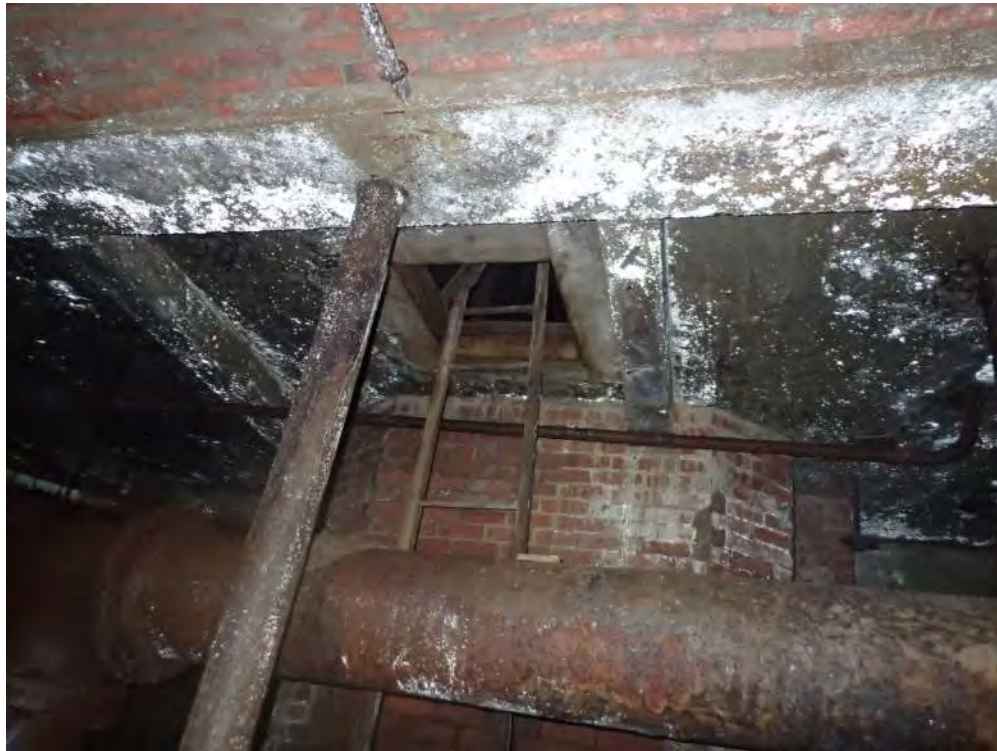
Photo 15: Open Hatch with Wooden Ladder at End of Tunnel

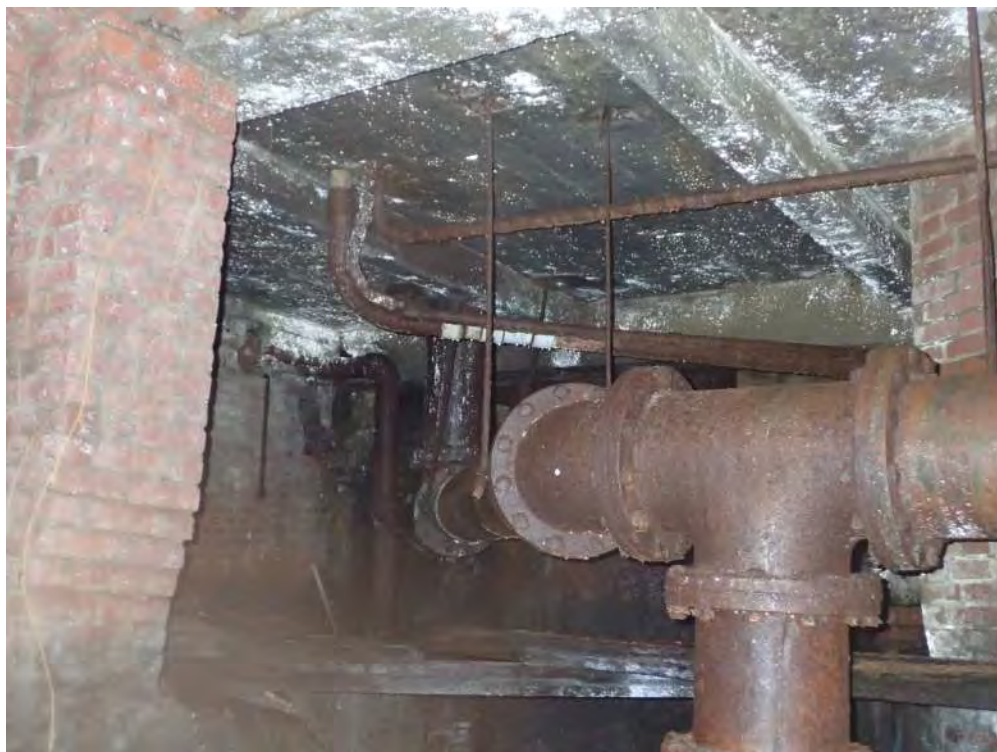
The 12" diameter pipe teed off and elbowed up into the floor above one north and one south of the central brick tower. There were also two large diameter steel riveted open drains in this location similar to those observed in other areas of the tunnel (**Photo 16**).

Photo 16: Pipe Extents and Brick Tower at End of Tunnel
