## Existing Conditions Review of Building #9

**To:** Rebekah Cornell, Town of Ware Director of Planning & Community Development  
**FROM:** Craig French, PE, Principal Structural Engineer  
**DATE:** January 11, 2021

**Estimate of Probable Construction Cost**  
**Town of Ware - East Main Street Millyard**  
**Building #9 - Turbine Building Costs to Stabilize the Building**

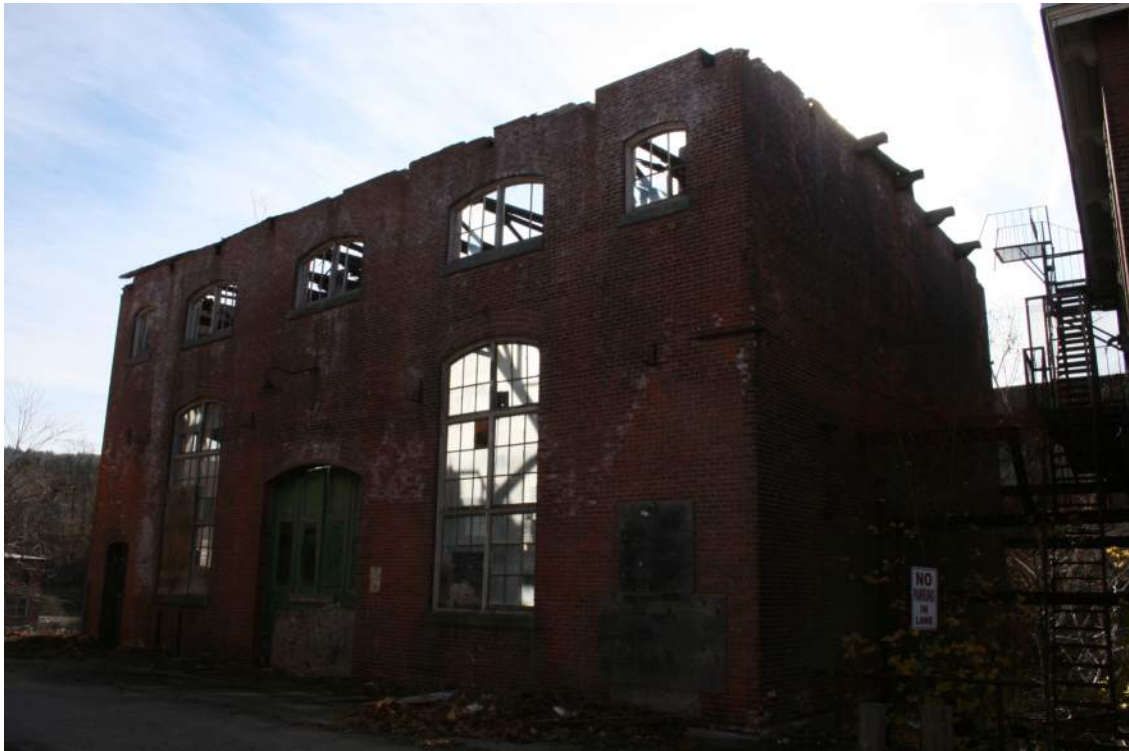
According to the existing mapping information, Building #9 is approximately 40'x60'. The main level of the building is at grade, and the building is two stories above grade and one story extending down to the river level (**Photo 01**).

Photo 1: Building #9 – The Turbine Building

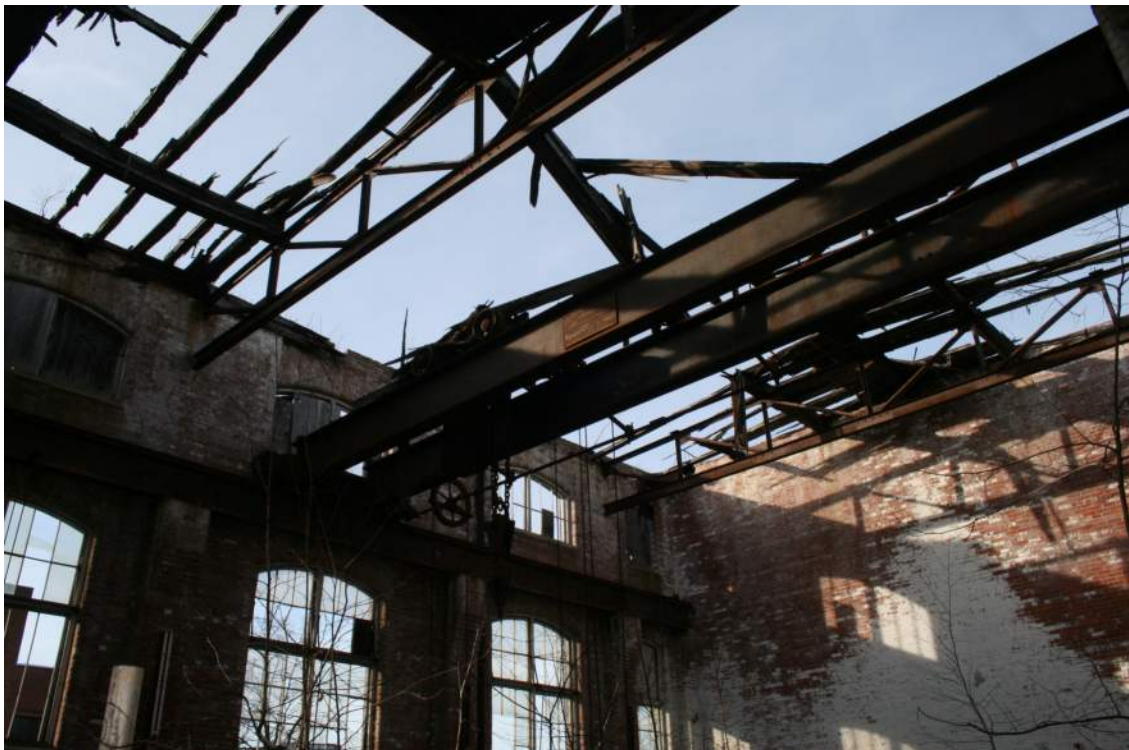
The building is constructed of multi-wythe brick walls around the exterior with what appeared to be a wood roof deck and steel trusses for the roof structure. The entire roof deck has deteriorated and failed (**Photo 02**). Although the roof is providing no protection from the elements, the exterior brick masonry walls appear to be in fair condition below the top 2 to 3

Photo 2: Failed Roof Deck of Building #9

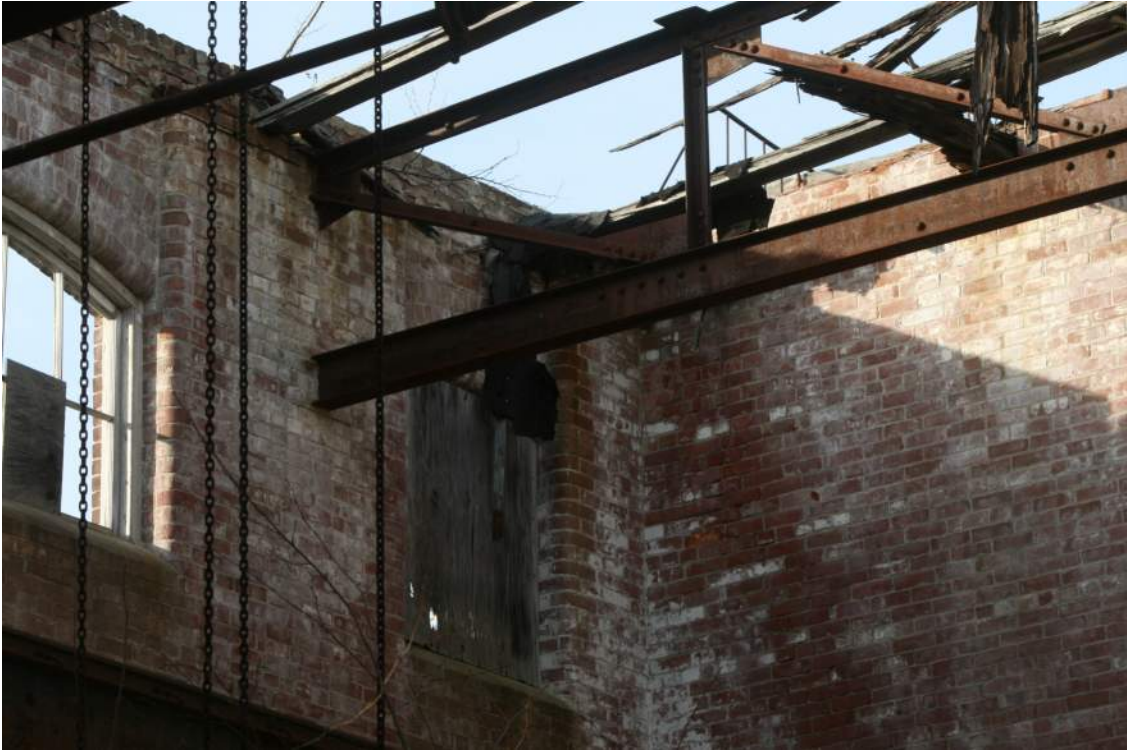
feet (**Photo 03**). Significant efflorescence was noted throughout the walls, however, the brick units themselves and the mortar joints appeared to remain in place. We were unable to inspect the upper portion of the walls hands on; but the lower section of mortar was hard and sound.

The exterior masonry walls appeared to be in relatively fair condition. The upper 2 to 3 feet is showing signs of deterioration and isolated failures, however the remaining portions appear in tact and sound. A more detailed review of the walls will be required before knowing if they would have adequate capacity to remain in service. The roof of the building is non-existent, as the entire wood roof deck has failed. This condition, if left unchanged, will ultimately cause the rapid acceleration of the deterioration of the steel members and the masonry walls. Constant exposure to water and freeze/thaw conditions will eventually leave the steel and masonry beyond the point of repair.

Photo 3: Upper Portion of Masonry Walls and Steel Roof Members

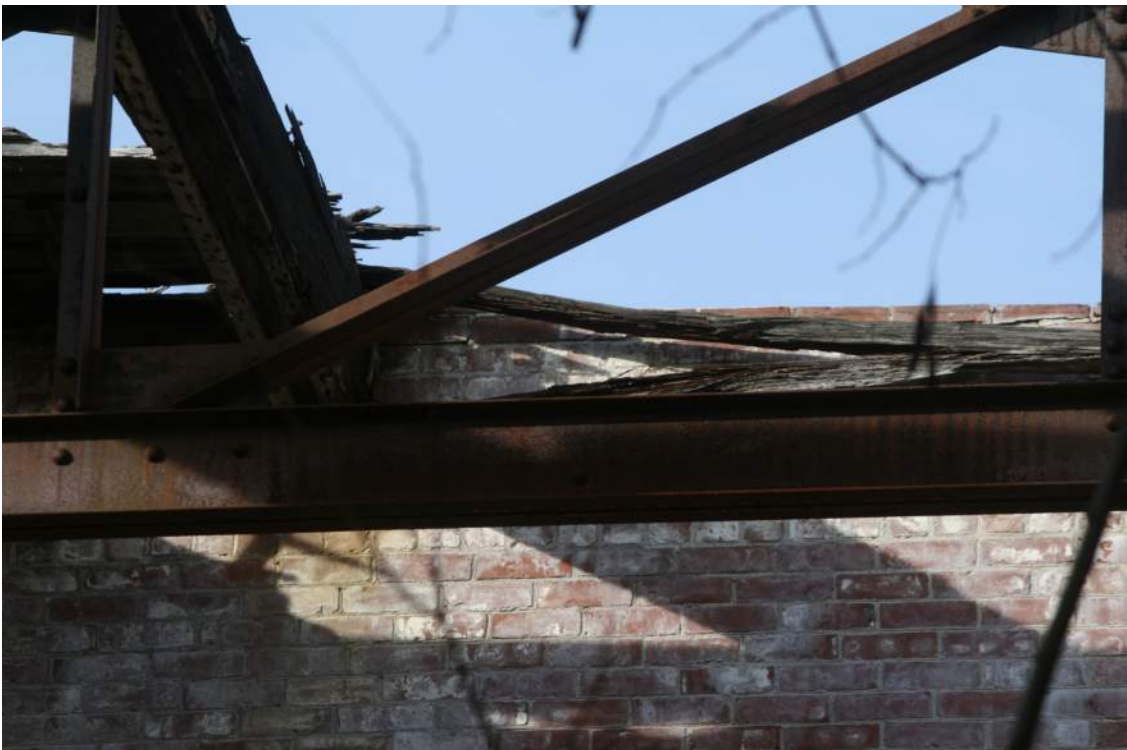
Although the steel roof members have been exposed to the weather for an unknown period of time, only surface rust was noted on most members. We did not identify widespread advanced deterioration of the steel members or significant section loss (**Photo 04**).

Photo 4: Surface Rust on Steel Roof Members

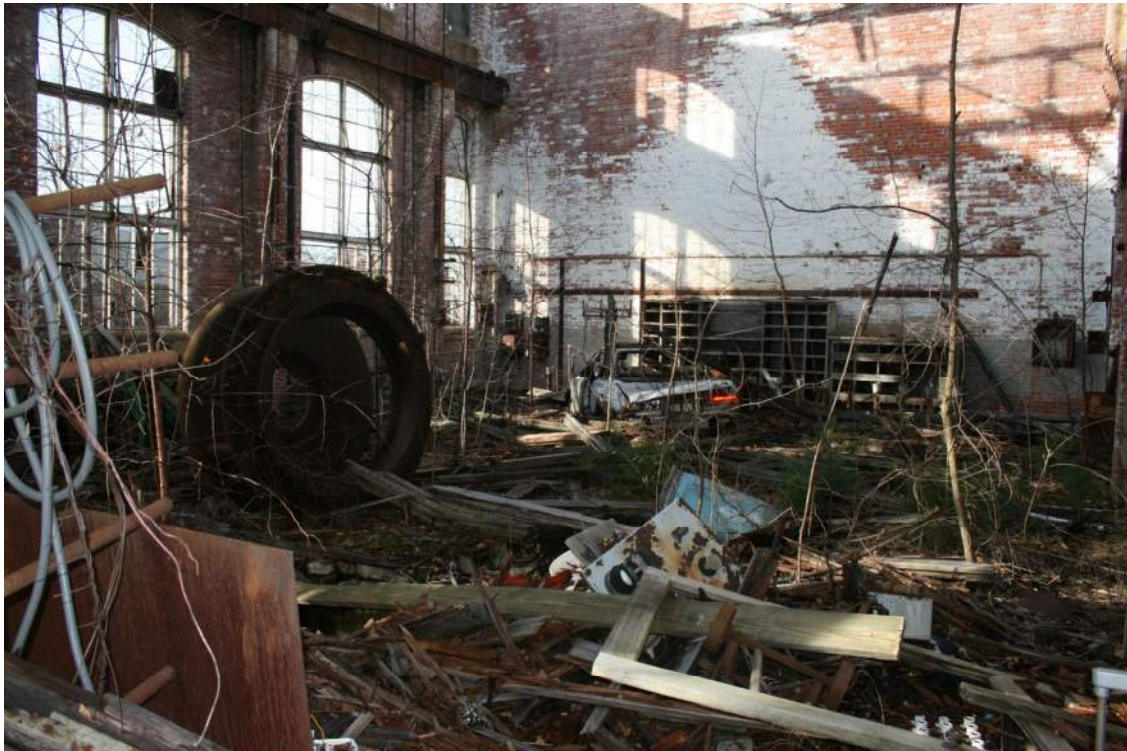
The at grade floor level could not be reviewed due to the excessive amount of debris on the floor (**Photo 05**). It appeared from isolated spots reviewed the floor system is cast-in-place concrete. The exterior of the building also seems to transition to cast-in-place concrete below the ground floor level (**Photo 06**). Similar to most concrete structures of this vintage, the concrete was not air entrained, and thus shows signs of freeze thaw deterioration (**Photo 07**).

The at grade floor diaphragm showed signs of numerous holes. Due to the amount of debris on the floor, we could not verify if these were framed openings or failed portions of the floor. It is likely there are a mixture of both. There appeared to be a significant amount of weight on the floor with the presence of an abandoned vehicle and a large steel member (**Photo 08**), without a collapse. This may indicate that the at grade floor is in fact cast-in-place reinforced concrete, with a high allowable load capacity.

Photo 5: Debris Across at Grade Floor Level

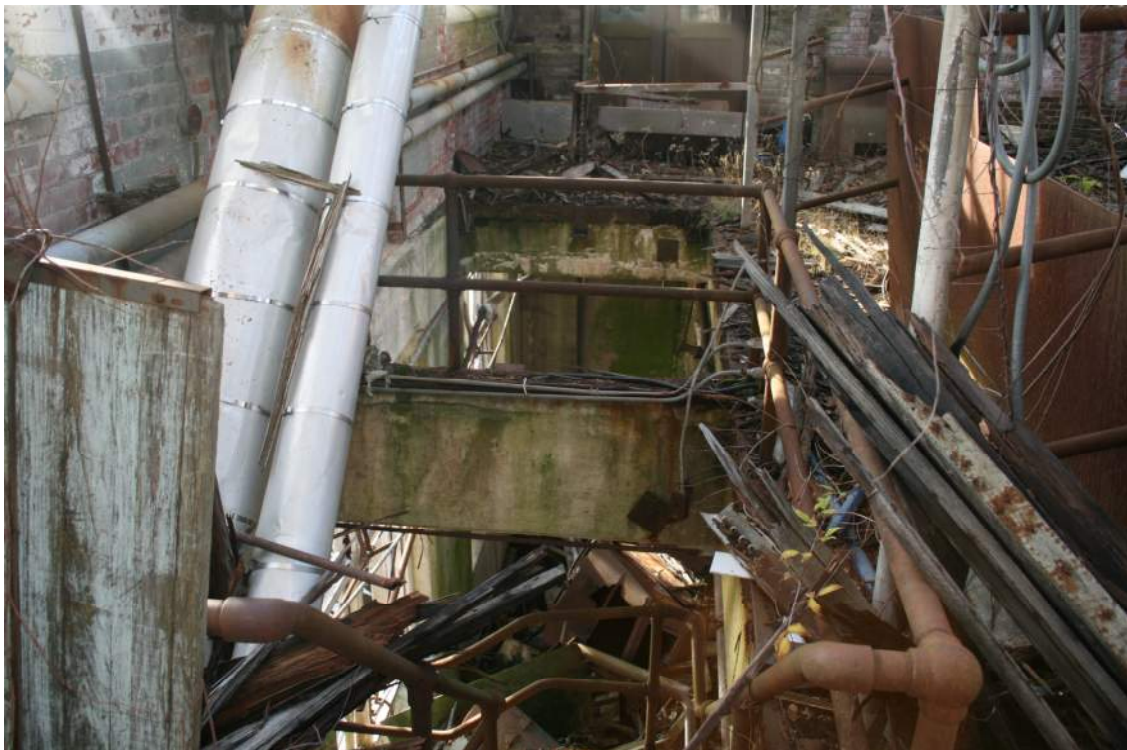
Photo 6: Evidence of Cast-in-Place Concrete Floor System

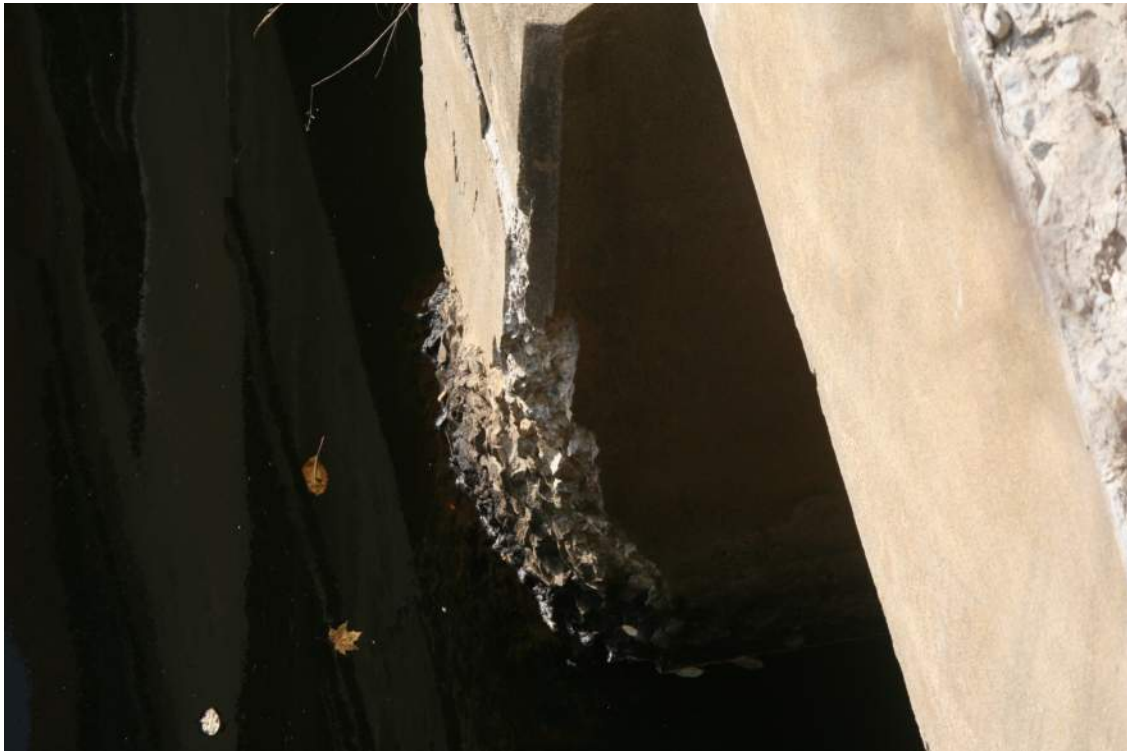
Although the exterior masonry walls and structural steel roof framing appear to be in fair overall condition, the building potentially has some significant structural issues. The deteriorating cast-in-place concrete could require substantial repairs or even partial replacement. We could not access the concrete foundation at the time of our review without a boat, but the widespread spalls are an indication of unsound concrete. The concrete pilasters are also being subjected to scour from the running water and pressure from ice at the river's water line.

Photo 7: Deteriorated and Spalled Concrete Pilaster

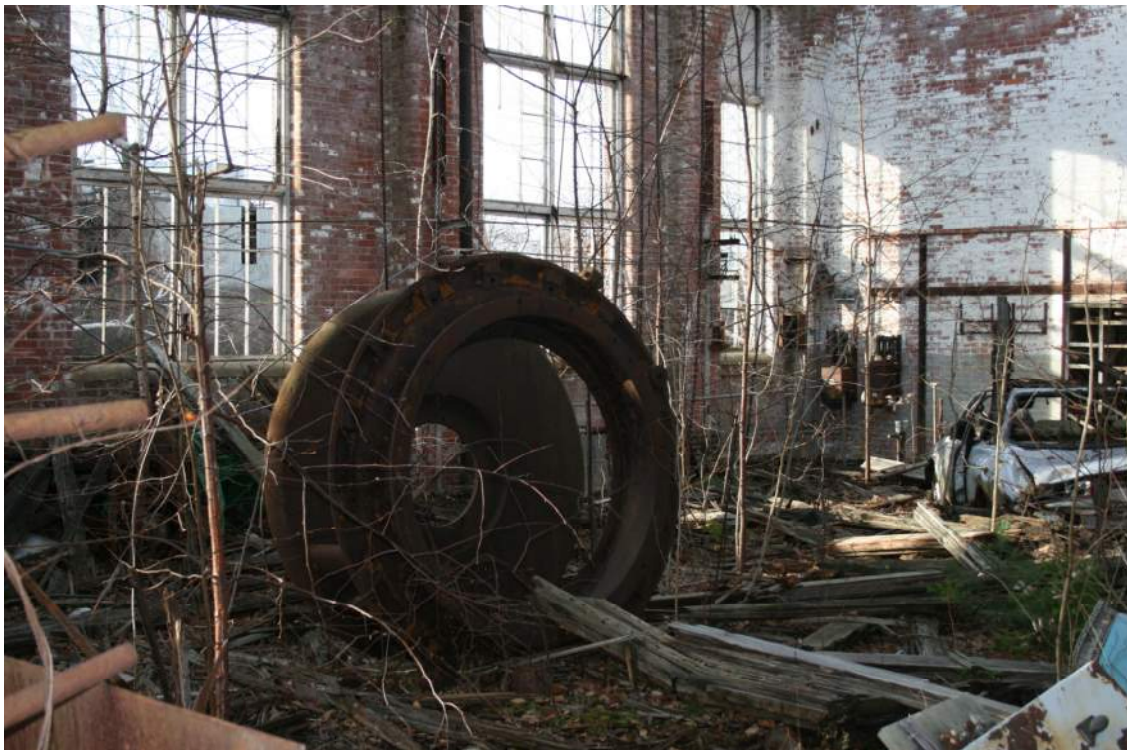
Photo 8: Abandoned Vehicle and Large Steel Section Supported on Floor
