CAMP ELLIS

ARCHITECTURAL SURVEY AND CLIMATE RESILIENCY OPTIONS

AUGUST 2022

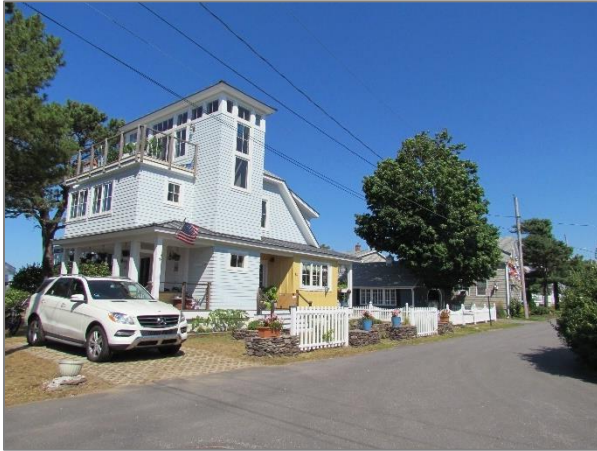
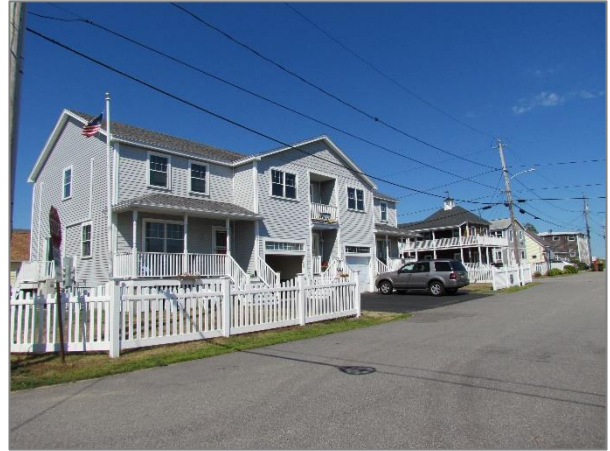
Examples of new construction that do not match the scale of the surrounding area:

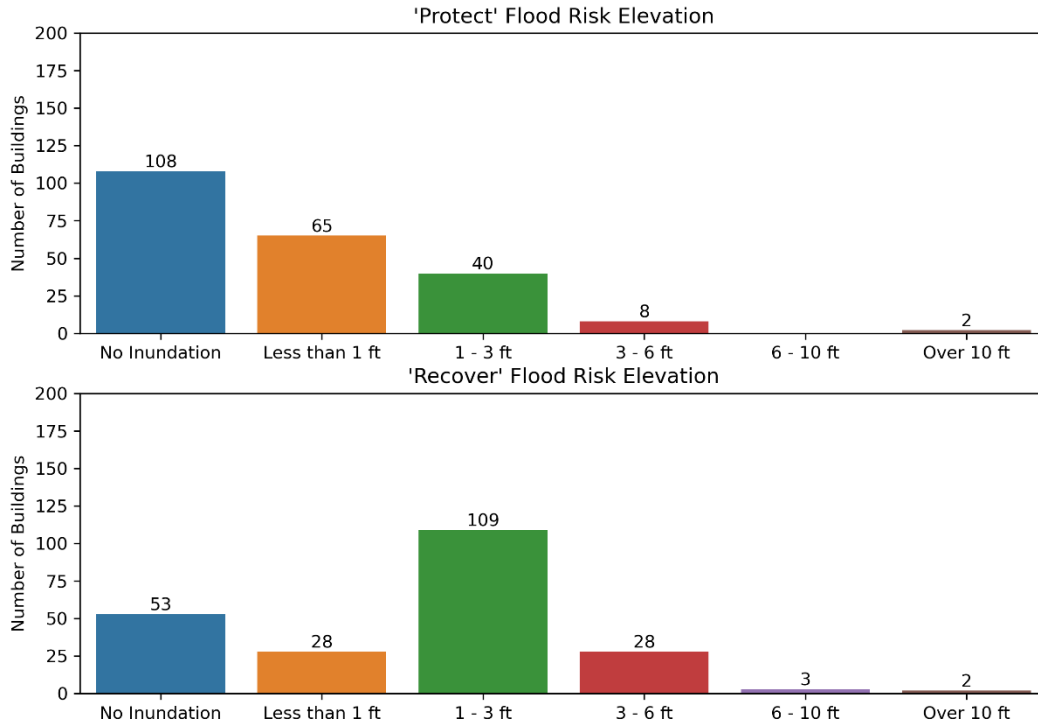
Figure 2: Inundation above grade at [Upper] the "Protect" flood risk elevation (10% annual chance EWL + 1.5 feet sea level rise); [Lower] the "Recover" flood risk elevation (1% annual chance EWL + 1.5 feet sea level rise).

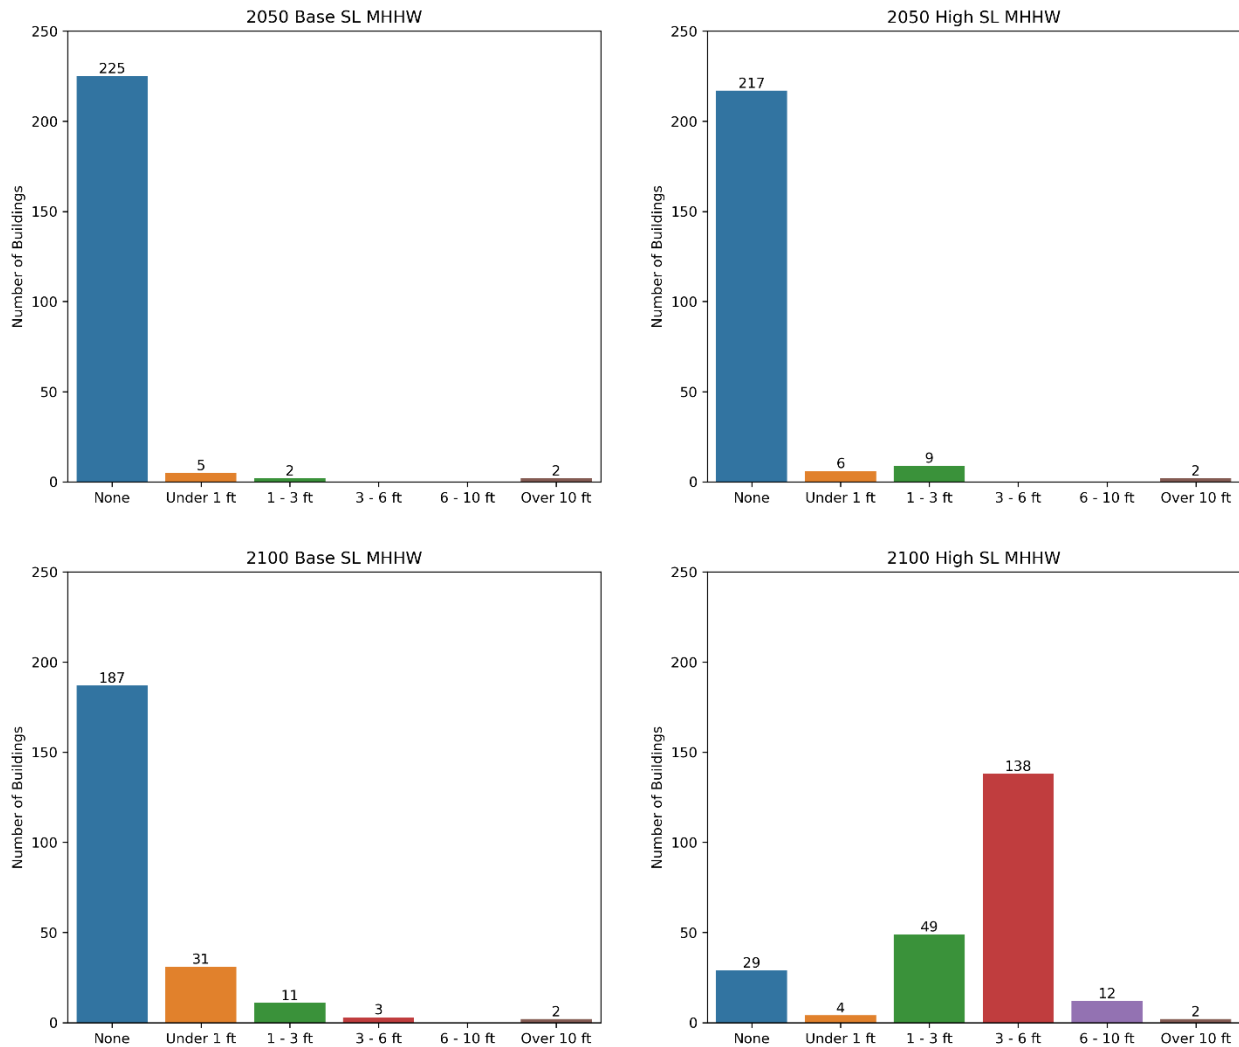
Figure 3: Depth of water above grade during MHHW, 2050 and 2100 base and high sea level rise scenarios.

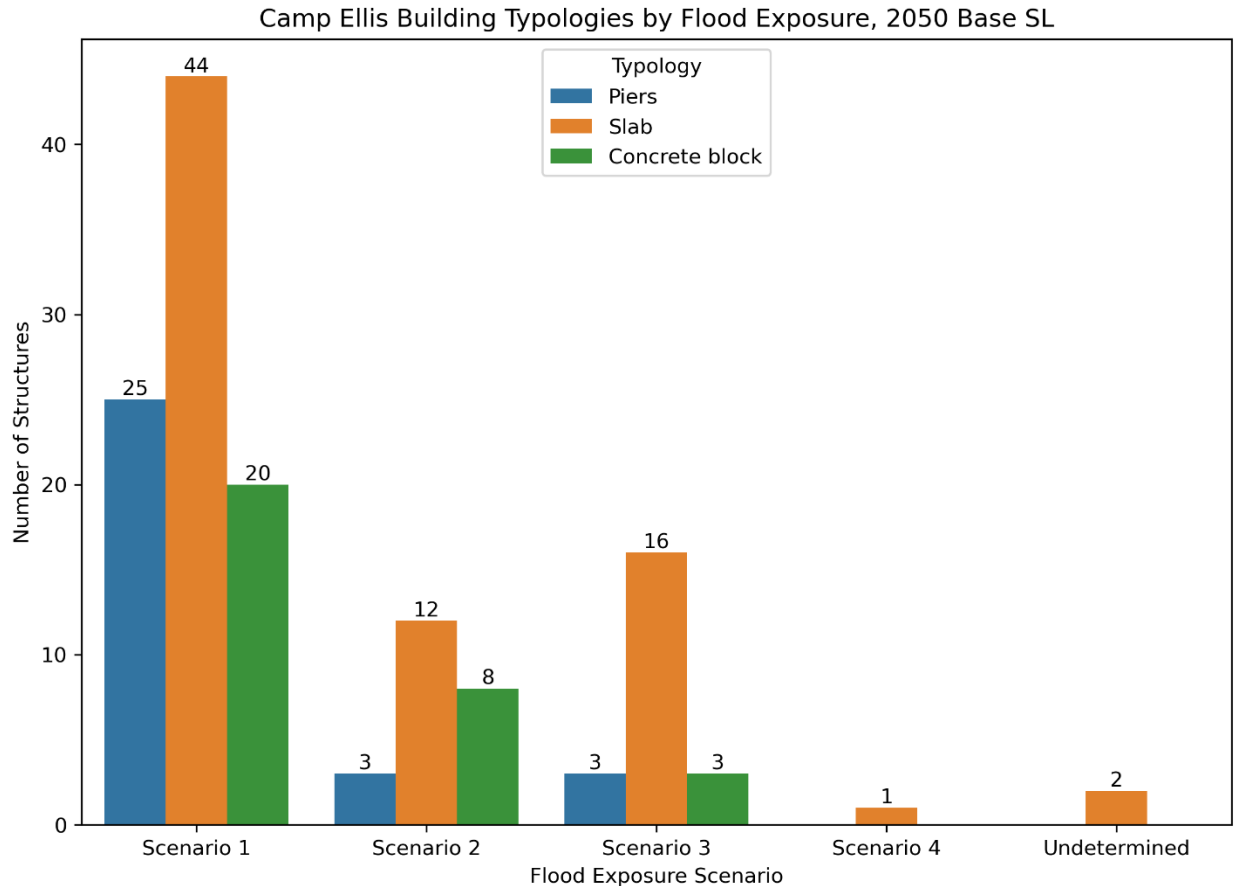
Figure 4: Camp Ellis structures by building typology and flood exposure scenario. Structures with “Undetermined” flood exposure scenario did not have an identified first floor elevation in the architectural survey.

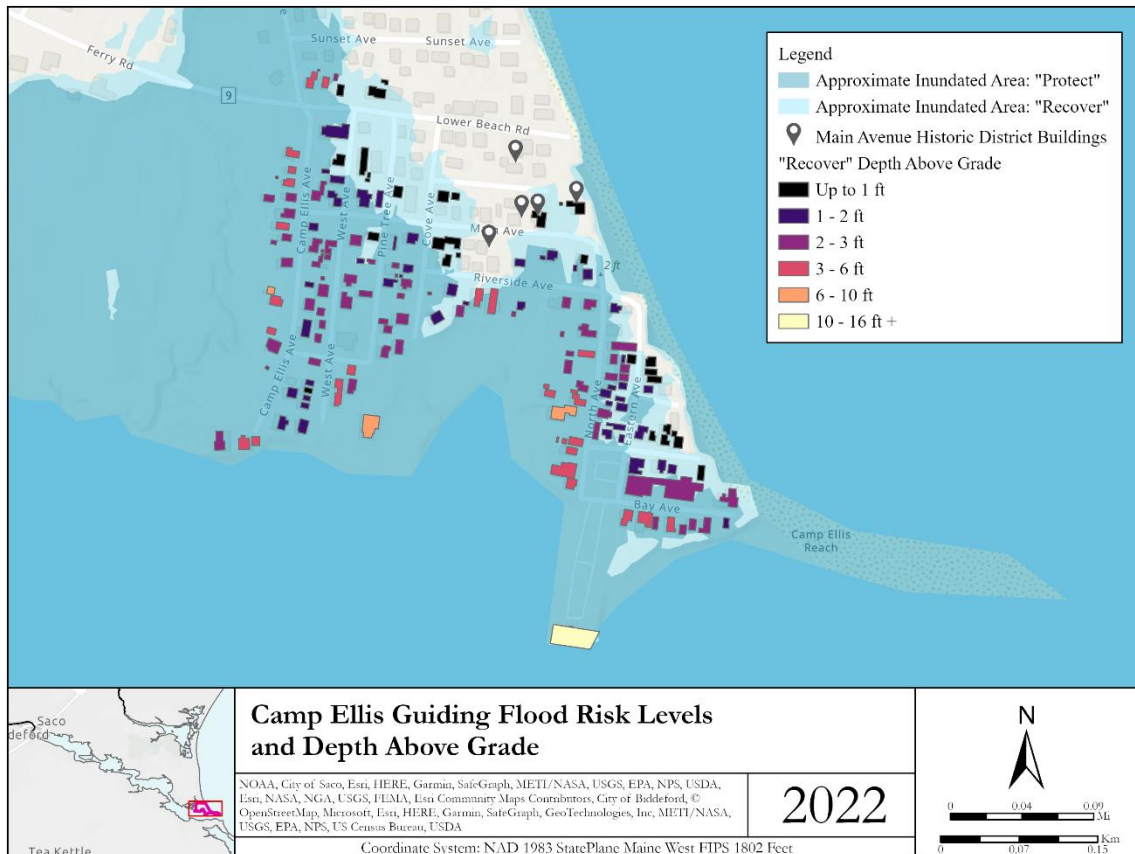
Figure 6: Approximate Inundated Extent for both "Protect" and "Recover" scenarios
