PASCO COUNTY MPO

Bus Stop Accessibility & Connectivity Study

Final Report

December 2012

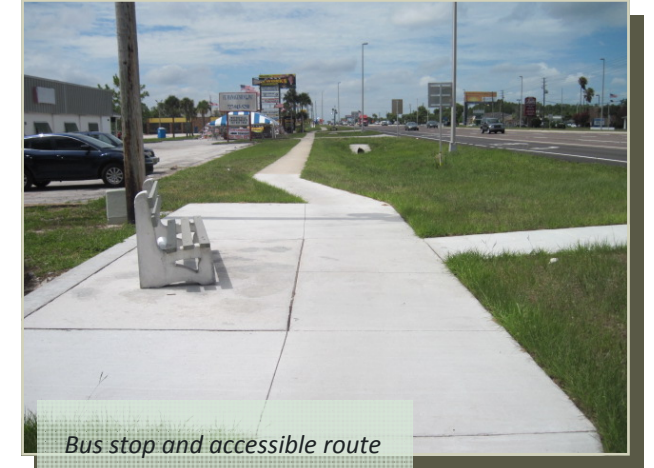
PAR deficient slope

Bus stop and accessible route

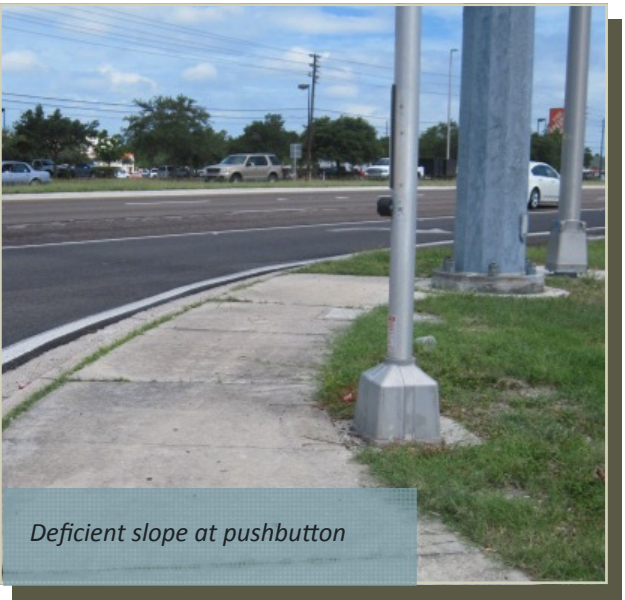
Deficient slope at pushbutton

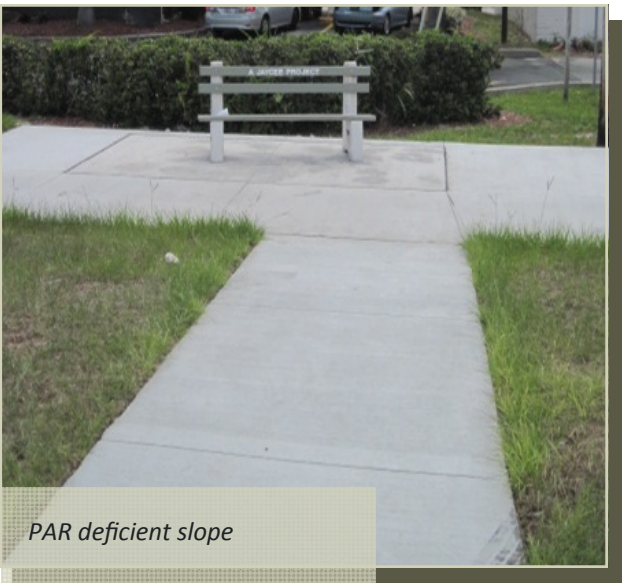
PAR deficient slope

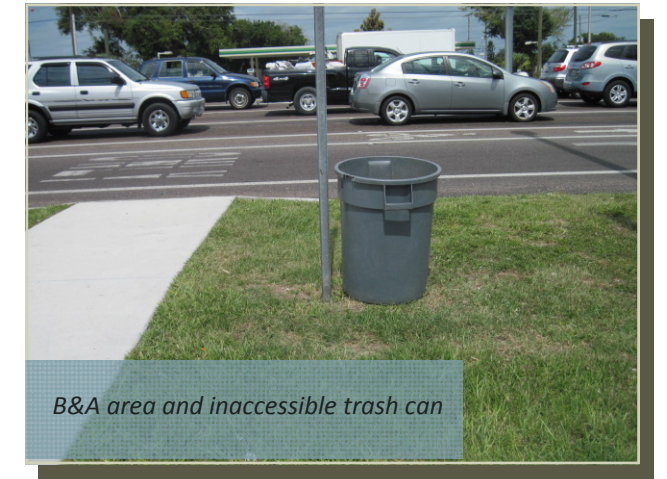
Located south of Mile Stretch Drive, on east side of US 19

This bus stop is located just south of the intersection of US 19 and Mile Stretch Drive in a continuous right-turn lane. The B&A area is connected to the existing pedestrian infrastructure via a sidewalk.

The bus stop access route needs to be repaved so that the slope is no greater than 5% from the sidewalk to the B&A area, as measured perpendicular to the road. The existing trash can must be moved or replaced so that it is on or directly adjacent to the concrete bus stop area. It must be placed so that a 30in x 48in area of clear space exists to allow for individuals who use a mobility aid to the trash can. There must be no more than a 20in horizontal reach for a forward approach and no more than 10in horizontal reach for a side approach.

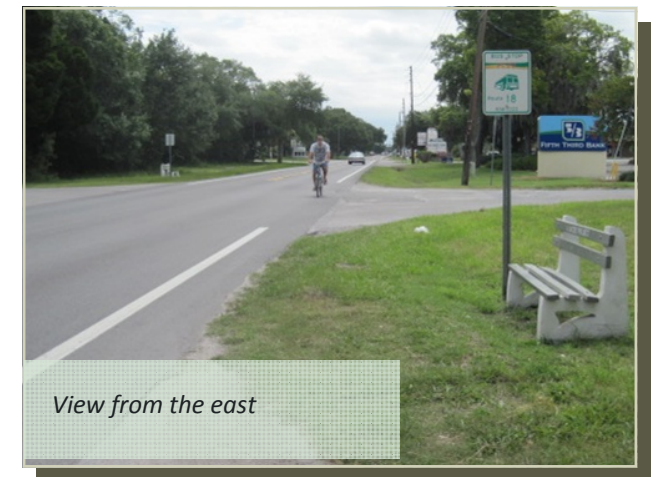
Located on Mile Stretch Drive, across street from library driveway

18N-12 bus stop is located on a grass area across from the library driveway. It has no sidewalk or B&A area. The bus stop has a sign and bus bench. There is no midblock crossing or pedestrian infrastructure along the south side of Mile Stretch Drive. If a mid-block pedestrian signal is desired, additional research must be conducted to determine if there is need for such a device.

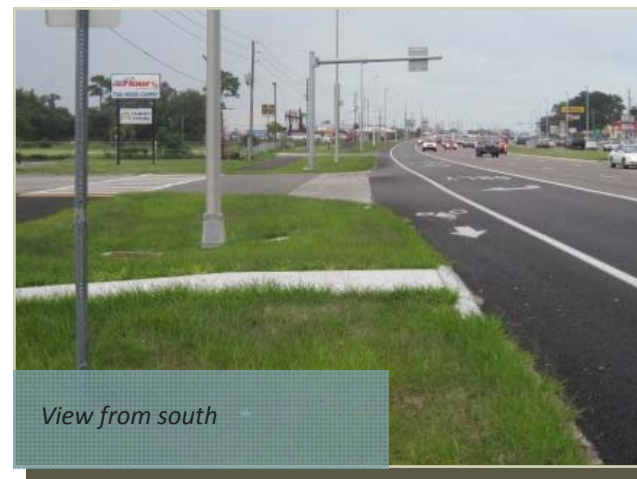
Located on US 19, mid-block, north of Moog Road

Bus stop 19S-38 is located approximately 680ft north of the US 19 and Moog Road intersection in a continuous right-turn lane on the west side of US 19. The bus stop includes a concrete B&A area connected to the existing pedestrian infrastructure. This bus stop has a bus stop sign and bench, but no other amenities are present.

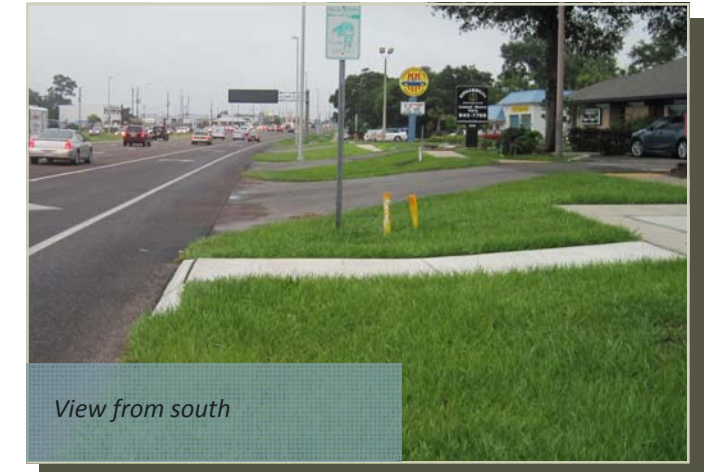
Located on US 19, mid-block, on west side of street north of Moog Road

Bus stop 19N-19 is located on the far side of the intersection of US 19 and Moog Road in a continuous right-turn lane on the east side of US 19. The stop has a bus stop sign and bench but no other amenities. The bus stop is connected to existing pedestrian infrastructure

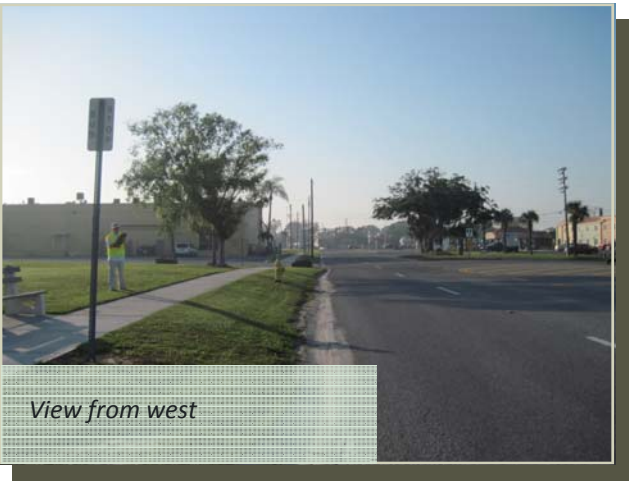
Located on Marine Parkway, east of Gemstone Drive

This bus stop is near-side of the intersection of Marine Parkway and Gemstone Drive. It has a bus bench and sign as bus stop amenities. The stop has sidewalk connectivity that connects it to US 19. This stop is also connected to multiple adjacent condominiums and apartment complexes, including Gulf Harbors Condos and Harbor Villas Condo.

A 5ft x 8ft B&A area should be constructed that connects to the existing sidewalk. The bench can remain where it is and would be considered an accessible placement of a bus bench.

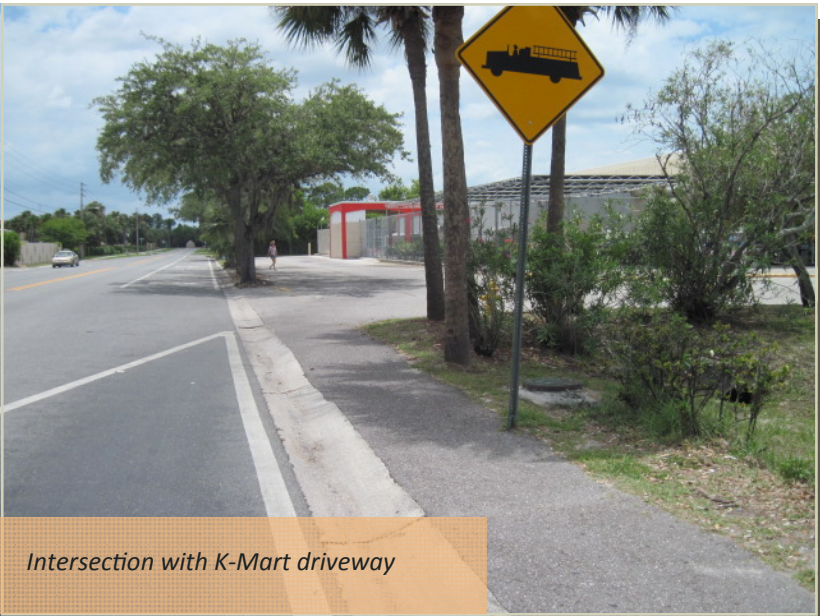
Intersection with K-Mart driveway

A sidewalk should be constructed along Cross Bayou Boulevard to connect to the new B&A area. This would consist of approximately 280 LF of 5ft-wide sidewalk. Additional pedestrian crosswalk striping should be provided at the driveways of K-Mart.

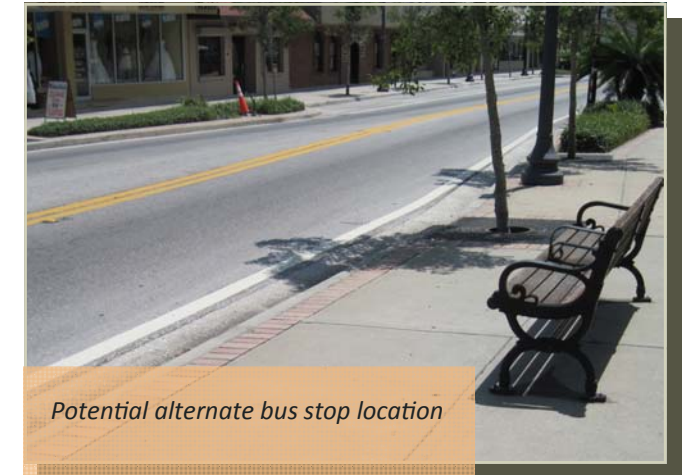
Located on Main Street, west of Bank Street

This stop provides access to the Sims Park and Downtown New Port Richey from northbound Route 14. The stop consists of a sign post in the ground marking the stop location, but no other amenities.

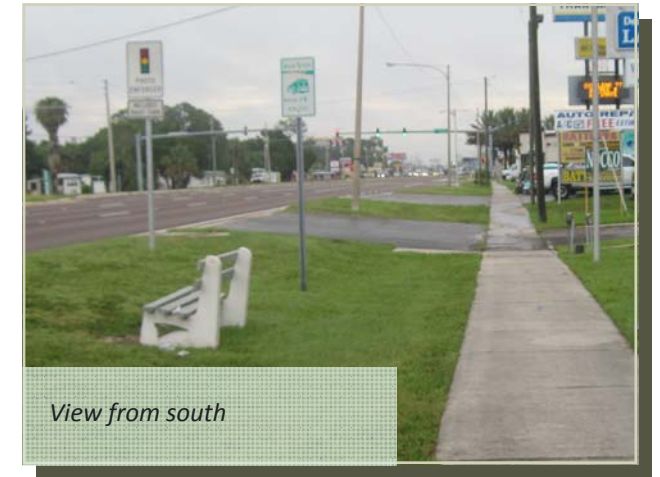
Located on US-19, south of Grand Boulevard, on east side of street

This stop provides access to the SunCruz Casino from northbound Route 19. The stop consists of a sign post and bus bench as passenger amenities.

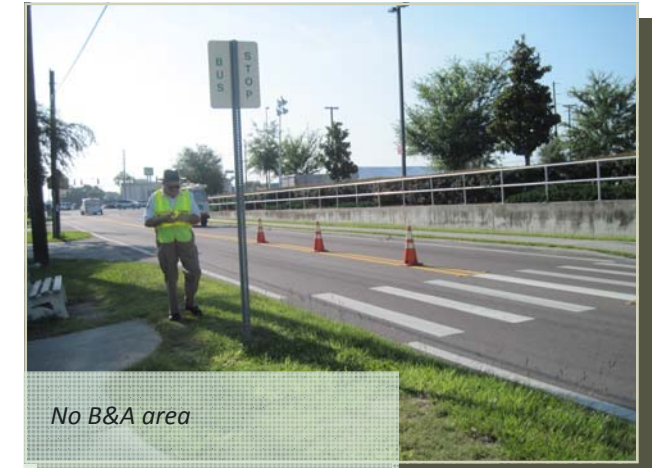
Located west of US 19 on Hudson Avenue

This bus stop is located on the west side of US 19, mid-block and beyond the intersection of US 19 and Hudson Avenue. The stop consists of a sign post in the ground and a bus bench.

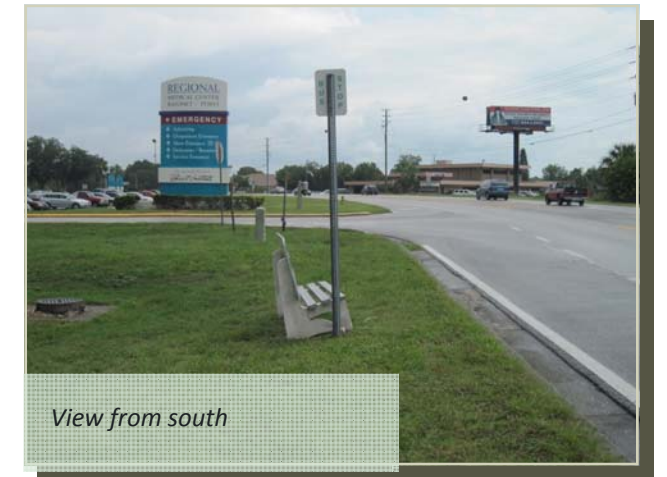
Located south of Hudson Avenue and Fivay Road

The stop consists of a sign post in the ground and a bus bench. It is located far-side of the intersection of Fivay Road and Medical Drive. There is no sidewalk present along Fivay Road.

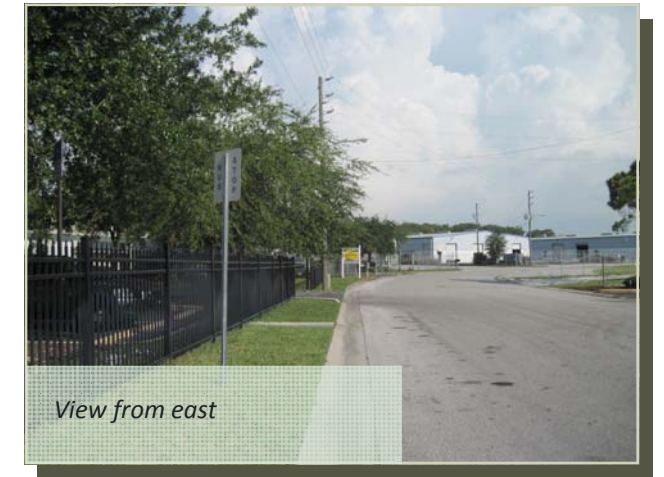
Located on Scheer Boulevard, approximately 575ft west of US 19

This stop provides no accessible connection to the Scheer Commerce Center. It is located in front of a metal fence, and a bus stop sign is the only infrastructure at the stop. There is no B&A area and no sidewalk connectivity. Additionally, this stop is not recorded on the bus stop inventory received from PCPT.

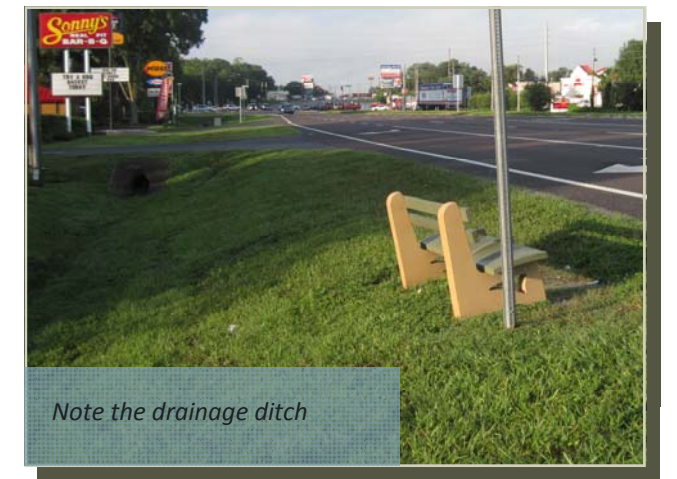
Located north of intersection of Gall Boulevard and Eiland Boulevard

This stop is located just south of the driveway of the Florida Medical Center along the east side of Gall Boulevard. It is a mid-block stop with a bus bench and sign for amenities. There is no existing pedestrian infrastructure that connects to this bus stop.

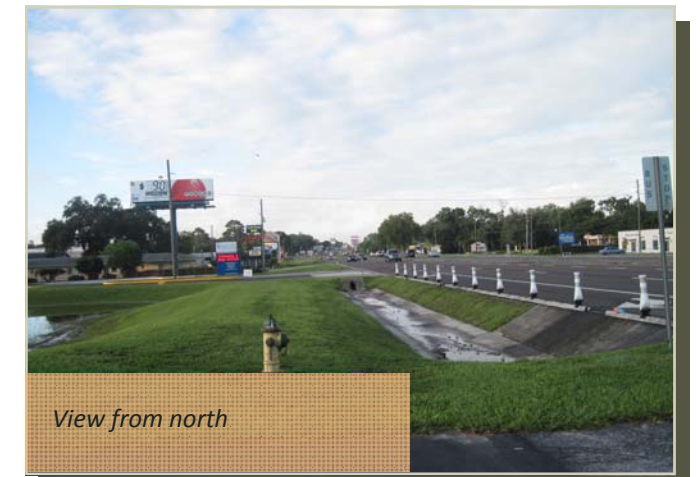
Located south of intersection of Gall Boulevard and Daughtery Road

This stop is located mid-block in relation to the intersection. It is directly south of the Pin Chasers driveway. It has a bus stop sign but no other amenities and is not connected to any pedestrian infrastructure.

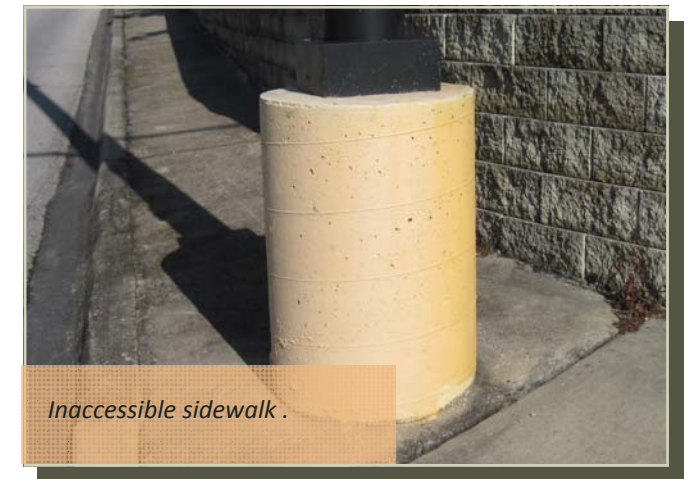
Inaccessible sidewalk .

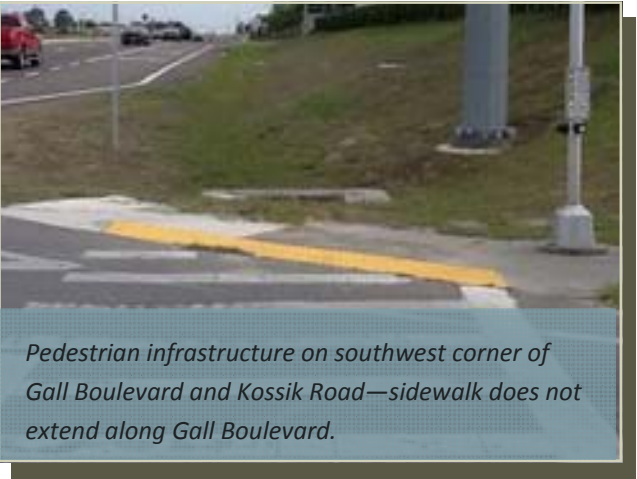
Pedestrian infrastructure on southwest corner of Gall Boulevard and Kossik Road—sidewalk does not extend along Gall Boulevard.

This stop needs a 5ft x 8ft B&A area with a raised curb.

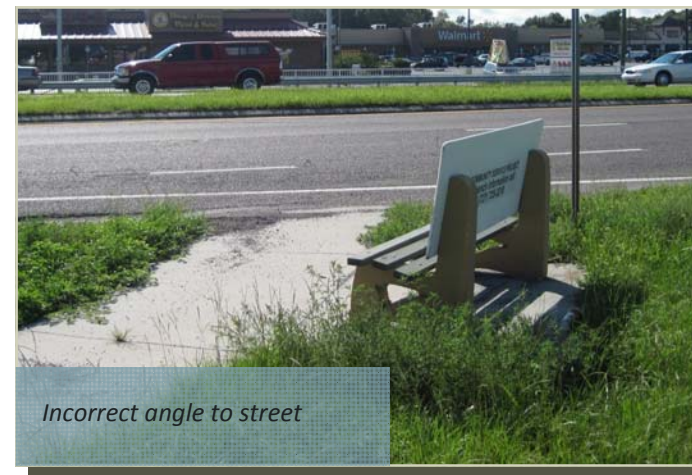
Located at Morningside Drive and Gall Boulevard, in front of Winn Dixie

This stop is located in the beginning taper of the right-turn-only lane that leads into the Winn Dixie parking lot. It has a bus stop sign and bench and is on a paved concrete area. There are no other amenities.

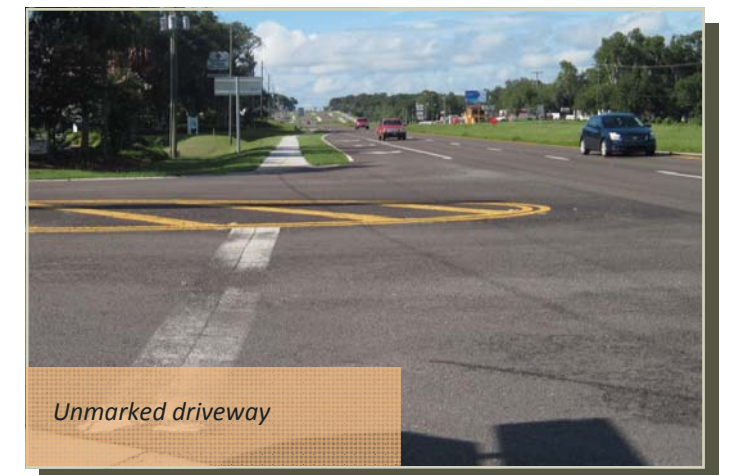
Located south of Morningside Drive and on Gall Boulevard, across from Rene Street

Stop 30N-35 is located in right-turn-only lane that leads into Morningside Plaza, south of the main entrance of the facility along Gall Boulevard. It has a bus stop sign and bench and is on a paved concrete area. There are no other amenities.

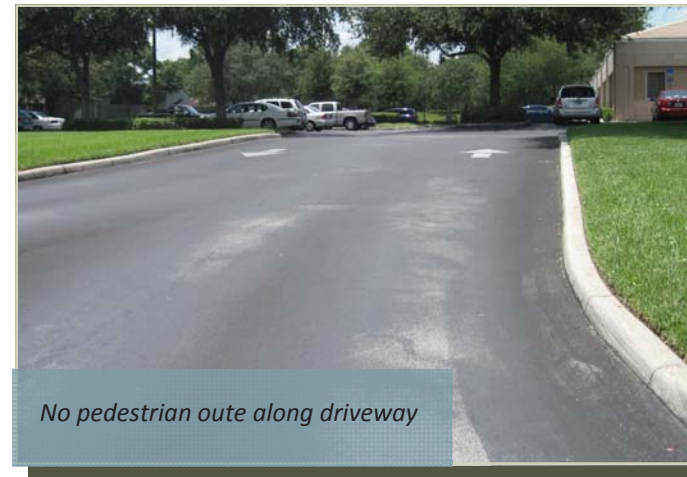
No pedestrian route along driveway

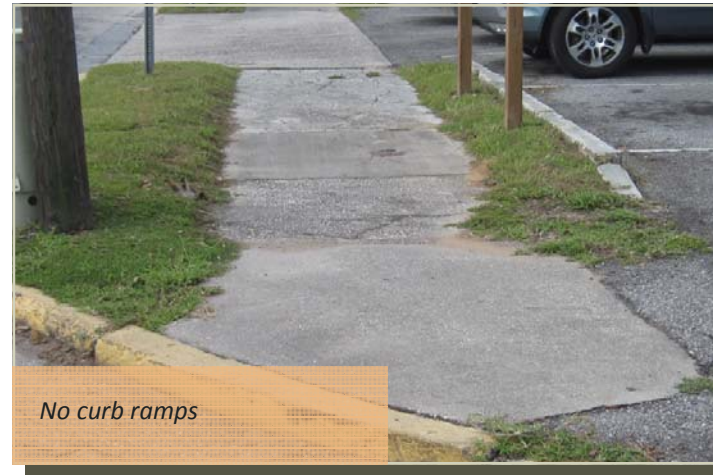
No curb ramps
