Town of Arlington

Roads Maintenance Report 2020

**The Town of Arlington
Department of Public Works
Roads Maintenance**

FINAL PAVEMENT MANAGEMENT PROJECT REPORT

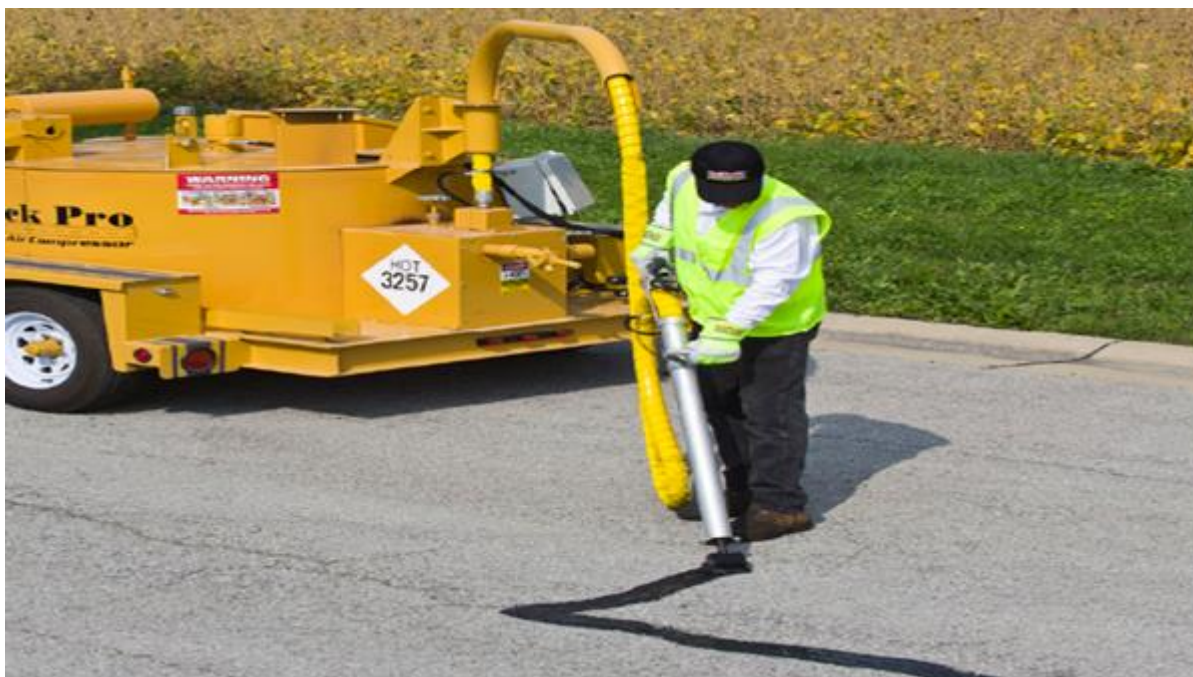
Crack Sealing

One of the first steps we took, being recommended as a first line of defense against asphalt deterioration, was to implement a crack sealing program. Crack sealing is much like repairing a leaking roof. If a leak is not sealed in a timely manner, the moisture can degrade the integrity of the entire structure. In fiscal budget year 2019/2020, Public Works purchased a new crack sealing machine. This machine is much safer, more efficient and can cover much more area in a shorter span of time than the old machine. Between July of 2019 and May of 2020, the Public Works Crew crack sealed the streets of 6 complete subdivisions and partial sections of several other roads and streets. This equates to approximately 16 lane miles. They used 18,000 pounds of material at a cost of \$11,700. It is estimated that crack sealing extends the life of pavement by 3 to 5 years.

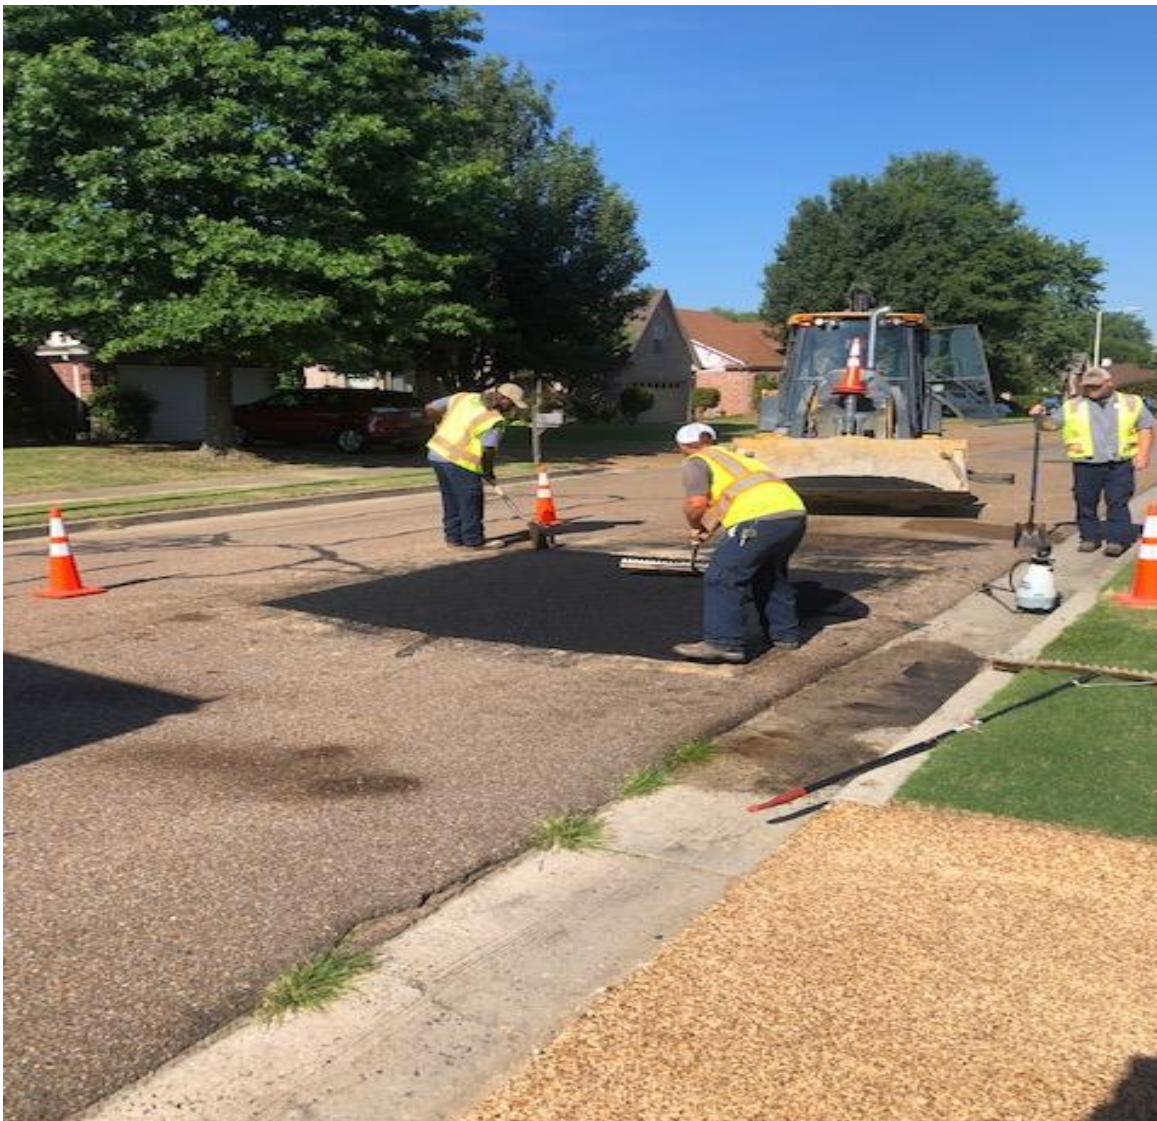
Public Works Crew Applying a Surface Coat of Hot mix Asphalt in a Patch

Patches are used as a method of treating areas of localized distress. Depending on the extent of the failure, patches may be excavated to a depth at which a good foundation is reached. At that point, the layers of aggregate are replaced and properly compacted, and the surface layers of asphalt replaced. Where the underlying base structure is sound and the failure is in the surface layer of asphalt, the surface layer is milled and replaced with hot mix asphalt. In fiscal year 2019/2020, Public Works Crews used over 310 tons of hot mix asphalt patching localized failures at a cost of approximately \$16,190. We have also begun to implement crack sealing of our patches to prevent moisture from entering around the edges. This should help extend the life of the patched areas.

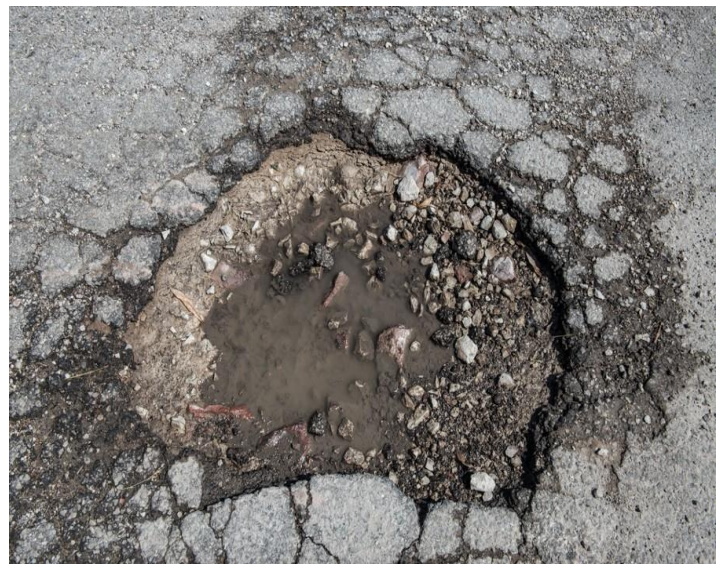
Pothole

Potholes are enemy number 1. They create the most complaints and have immediate potential to cause damage to tires, wheels, vehicle alignment and could even cause a vehicle to leave the roadway. While they can appear at any time, they seem to arise most often during the freeze/thaw periods of winter and during rainy weather of spring and fall. Public Works Crews put potholes as a top priority due to safety and vehicle damage concerns. During the times when potholes appear most, every Public Works truck is stocked with bags of cold mix asphalt. This allows us to address potholes immediately as we find them while conducting our daily business.

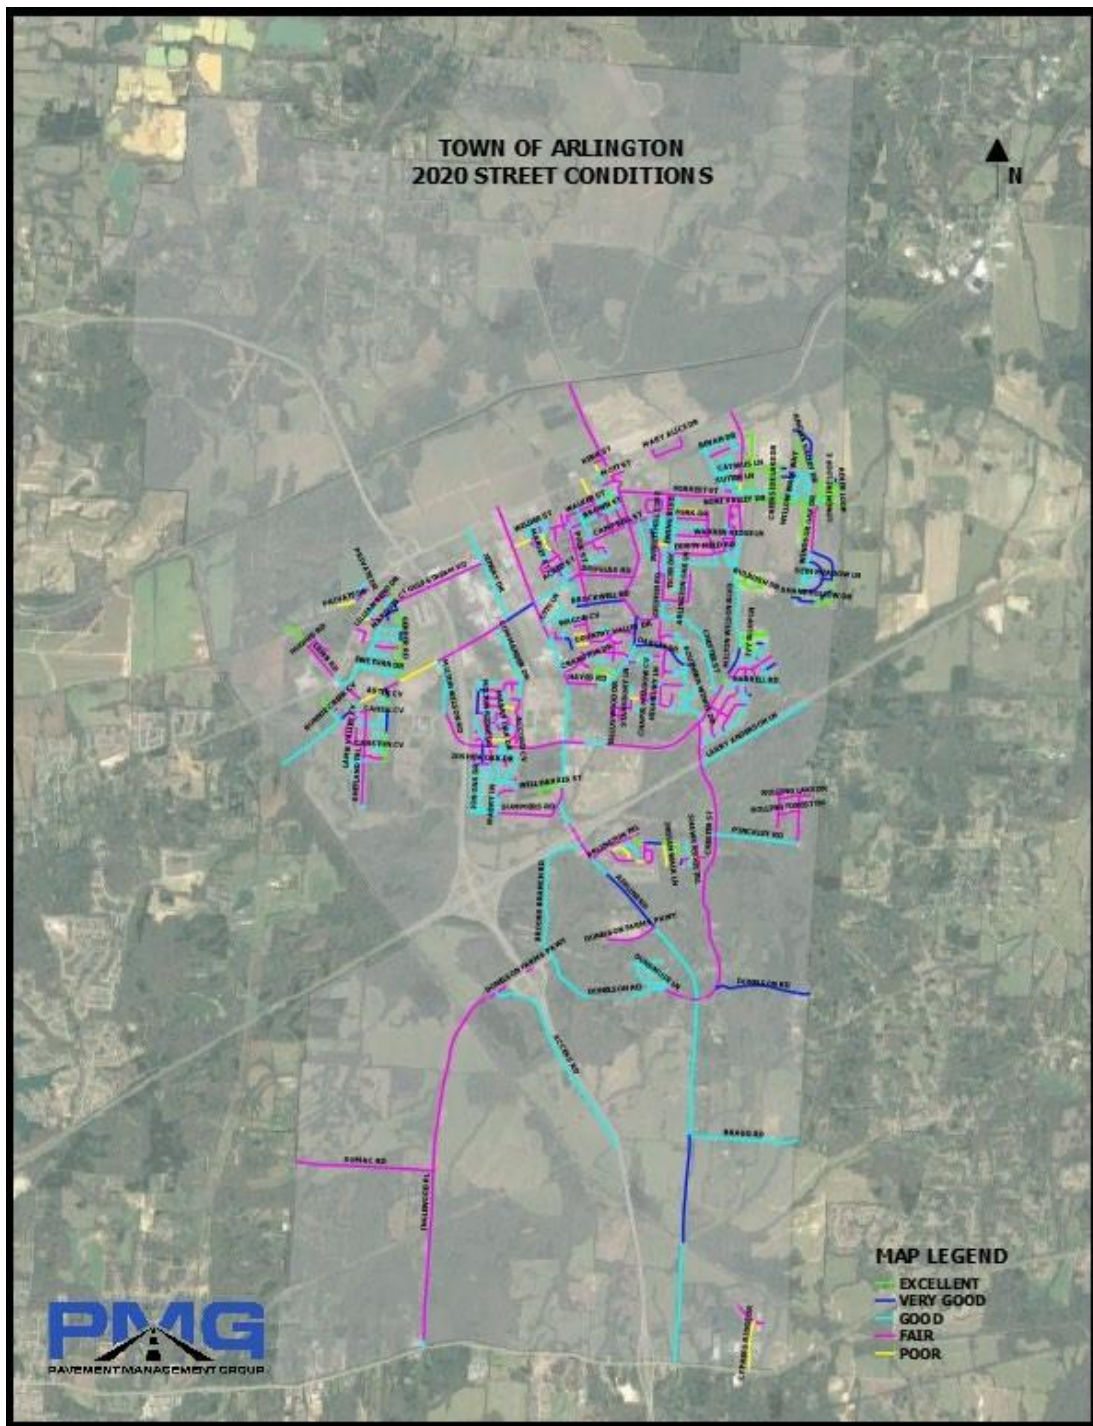
Figure 4. Street Section Latest Condition Maps

As part of this project, PMG received the street centerline shapefile from the client and was able to assign all pavement management data to the correlating GIS segments. Through GIS assignment, PMG can produce map driven project deliverables such as the latest condition GIS map example shown in Figure 4 below. PMG also created and provided a PDF file format of this map for plotting purposes upon the conclusion of the project.

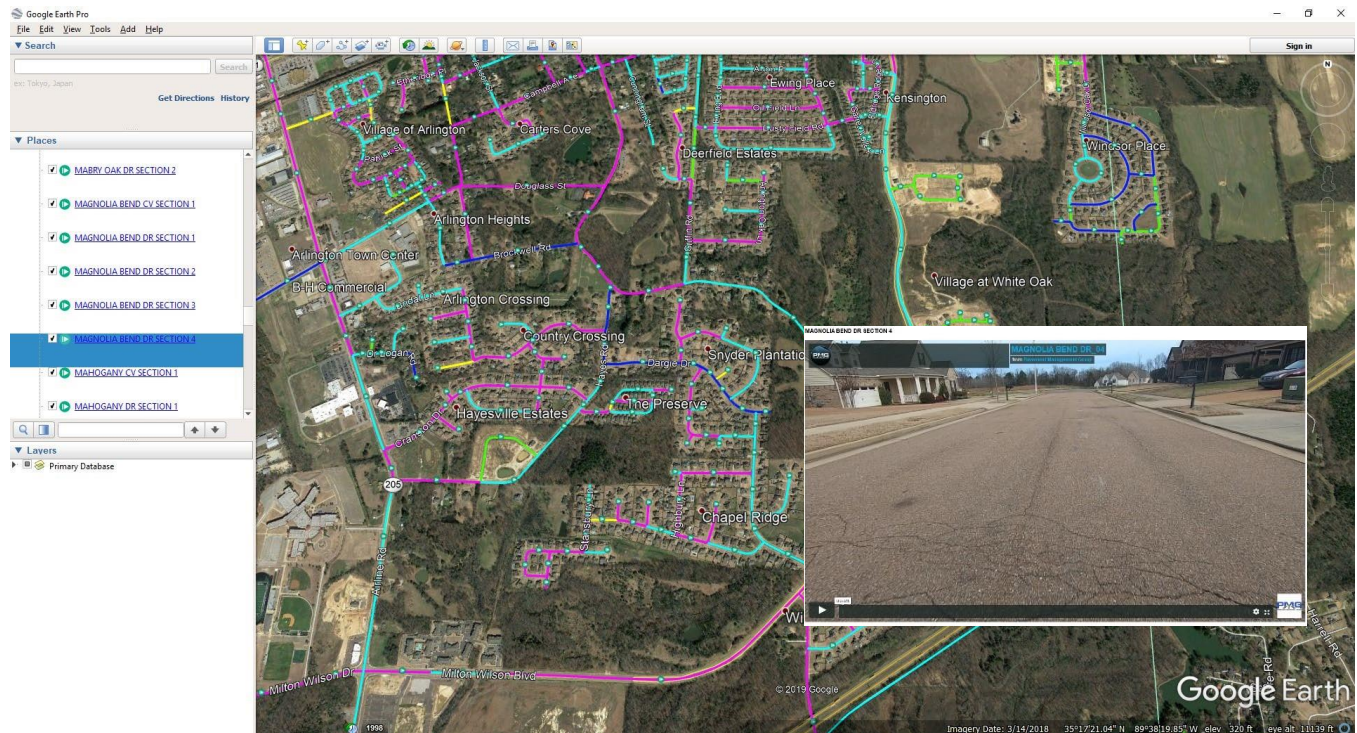
Figure 5. Google Earth Condition Layer with Video Streaming

Figure 5 illustrates the Google Earth condition mapping with streaming video capability:

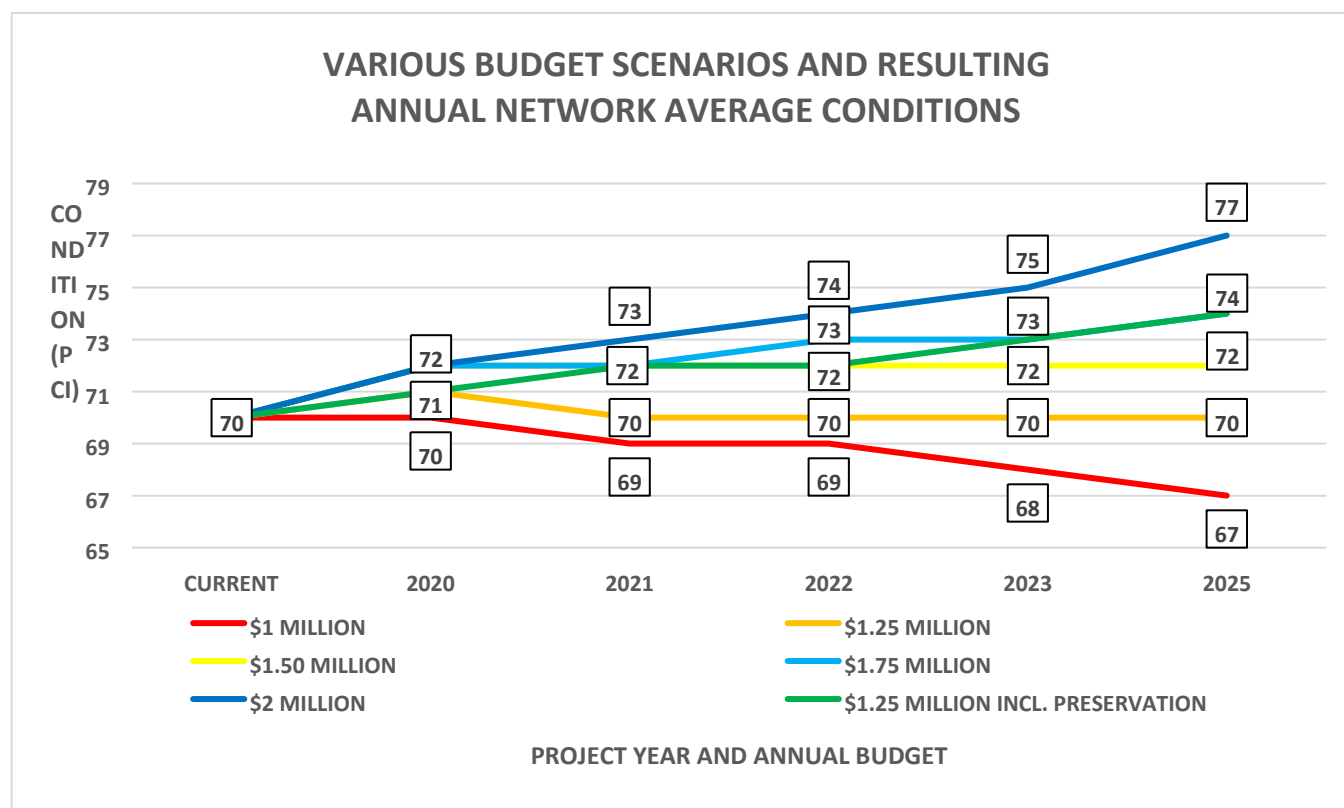
Figure 6. Five Year Analysis of Various Budget/Target Driven Scenarios

For initial project reporting purposes, PMG took a look at the following five budget scenarios over the next five years and charted the results below in Figure 6.

In operating from a “Worst to First” major maintenance and repair strategy, and with a continued crack seal program, the network average condition will drop approximately three PCI points over the next five years, spending \$1,000,000 each year. PMG recommends an annual budget of \$1,750,000 to reach and maintain an average network PCI of 74 over the next five years with this strategy.

If pavement preservation opportunities become available within the area, PMG would recommend a \$1,250,000 annual maintenance repair budget with 70% of the budget going towards Poor roadways, and 30% going towards Fair and Good roadways utilizing preservation treatments and a continued crack seal program. Over the next five years, the Town would experience the same condition increase as in the \$1,750,000 “Worst to First” recommendation strategy above. This would yield a greater impact of treatments each year while saving \$2,500,000 over the five years.
