# Report: Four Firefighters Injured In Lithium-Ion Battery Energy Storage System Explosion - Arizona

# Four Firefighters Injured in Lithium-Ion Battery Energy Storage System Explosion - Arizona

# Dispute Erupts Over What Sparked an Explosive Li-ion Energy Storage Accident > The April 2019 accident near Phoenix put plans on hold to further deploy battery-storage systems across Arizona

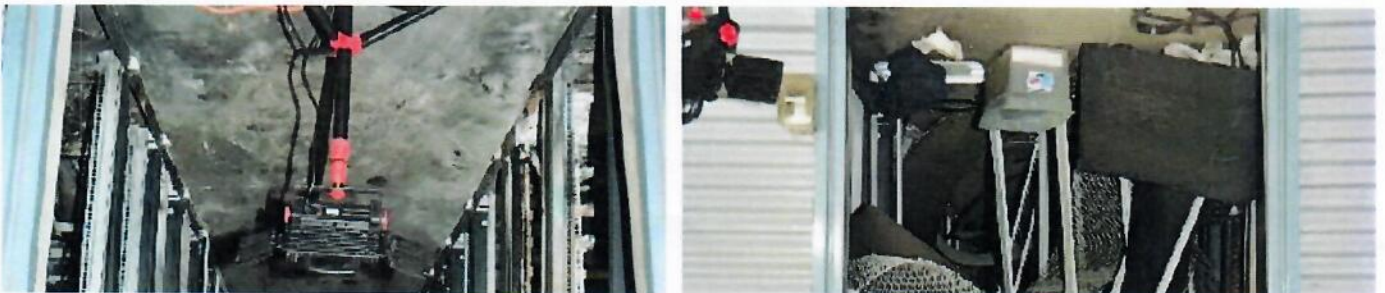
Interior damage to the BESS after the explosion [left], and after debris was removed to gain access to begin the forensics analysis [right].  
PHOTOS: ARIZONA PUBLIC SERVICE
