**Town of Ware
Self-Evaluation and Transition Plan
June 30, 2023**

**Center for Living & Working, Inc.
Michael Kennedy, ADA Access & Advocacy Coordinator
18 Chestnut Street – Suite 540, Worcester, MA 01608
and
James M. Mazik, AICP - Consulting Services
188 Lower Westfield Road, Holyoke, MA 01040**

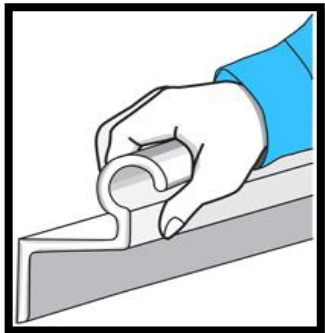
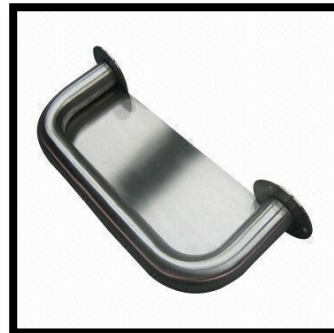
Both the 2010 ADA Standards (S. 604.5 Exception #3) 521 CMR (S. 15.8) provide exceptions for the requirement of grab bars in cells that are specifically designed without protrusions for purposes of suicide prevention. However, in recent years grab bars have been designed so they do not increase suicide risk. As shown, there are several ways for grab bars to be designed with adequate gripping surfaces, while ensuring that nothing can be tied onto them (see below). Consideration should be given, but not required, to install suicide proof grab bars in the accessible cell.

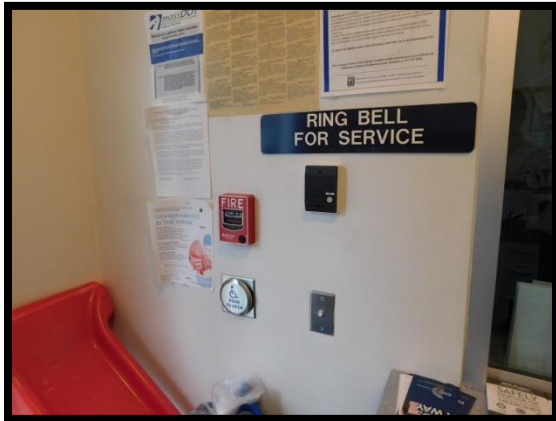
See Photo Police 1

General Description of Obstacle	2010 ADAAG	MAAB 521 CMR	Type of Action to be Taken	P	F	TF	Cost Estimate
Lobby Airphone Buzzer The airphone buzzer in the lobby is 2" too high under the 2010 ADA Standards. See Photo Police 1.	308.2 308.3	6.5 6.6	Lower the buzzer to a height of no more than 48" a.f.f.	2	3	I	TBD – up to \$250
Door Signage Tactile designation signage is not provided at the following locations: <ul style="list-style-type: none"> • Meeting room (2) • Sergeant's Office • Break Room • Janitor's closet • Booking • Sallyport Tactile designation signage is improperly located over the door and not on the latch side: <ul style="list-style-type: none"> • Storage #4 • Records • Front Desk/Lobby • Chief's Office • Evidence • Storage • Evidence #2 • Evidence #3 • Storage • Storage #3 Tactile designation signage is improperly located on the door and not on the latch side: <ul style="list-style-type: none"> • Men's Bathroom • Women's Bathroom See Photos Police 2 and 3.	703	41.1	Install and/or relocate accessible compliant signage so they are on the latch side of each door (where allowable) with appropriate finish and contrast and character height and proportions, raised and brailled characters should also be included. Under 521 CMR, signage s/b 60" a.f.f. to the centerline of the sign. Tactile characters on signs s/b 48" min. a.f.f. from the baseline of lowest character and 60" max. a.f.f. to baseline of highest character. Characters must meet the ADA Standards for character height, finish and contrast, accompanied by Grade 2 Braille (703 ADA Standards).	2, 3	2	I	\$350

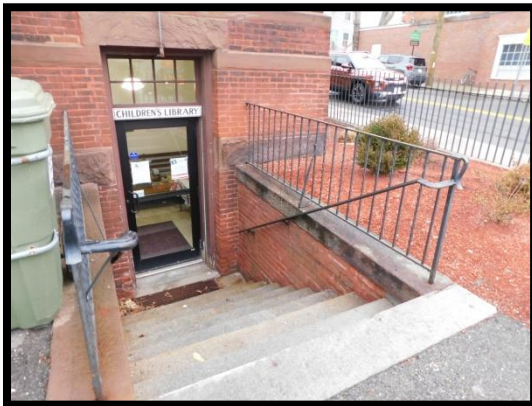
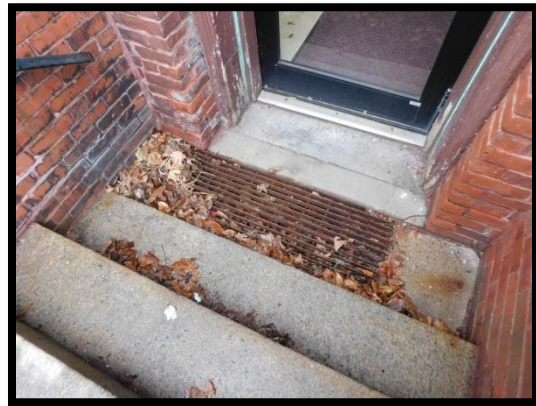
Photo Library 1

<p>A grate at the base of the stairs has 4 foot long by 1¼" wide grates.</p> <p>See Photos Library 1 and 2.</p>	302.3	25.4	Grate openings cannot exceed ½" and must be perpendicular to the route of travel. Replace or modify grates to comply with maximum ½" opening requirement.	1	2	N	Up to \$350+
<p><u>Book Return Drop Box</u></p> <p>The book return drop box located near the front egress only doors to the building is not on an accessible route of travel.</p>	206 403	20 22	Relocate the drop box to either the landing of the accessible entrance.	2	2	I	\$0
<p><u>Door Operating Forces and Closing Speeds</u></p> <p>Exterior and interior doors with closers do not comply with the minimum closing speed requirement of 6 seconds or the maximum operating force of 15 lbs. for an exterior door and 5 lbs. for an interior door.</p>	404.2.8 404.2.9	26.9 26.8	Adjust the door closers such that the closing speed is at least 6 seconds and the operating force does not exceed 15 lbs. for exterior door and 5 lbs. for the interior doors.	1	2	I	\$0

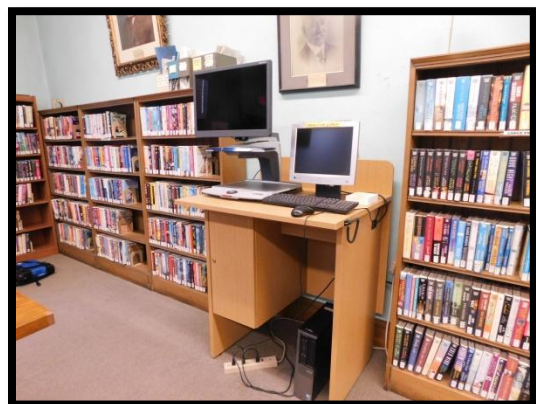
Photo Library 4

<p><u>Card Catalogue Height</u></p> <p>The computer card catalogue in the meeting room is on a table/desk that is 40" a.f.f. to the top of the table/desk.</p> <p>See Photo Library 4.</p>	226.1 902.3	35.1 35.6	Replace the table/desk with one that is 28" to 34" a.f.f. to the top. In addition, there s/b a minimum of 27" knee clearance, 19" knee depth, and 30" clear width.	2	2	I	Up to \$350

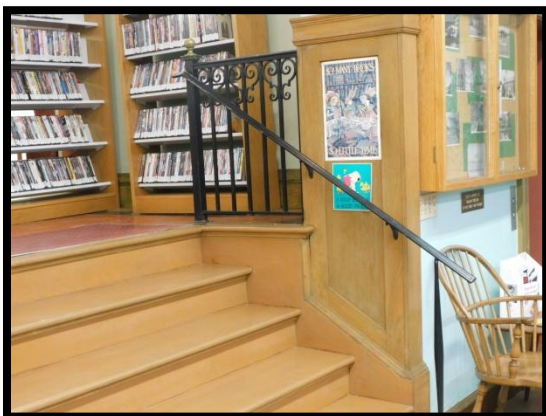
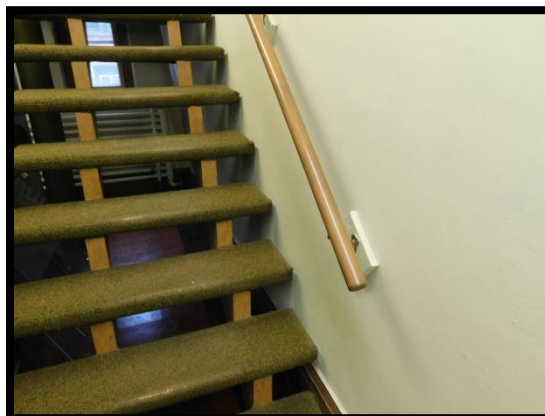
Photo Library 5

The stairs (2 sets) to the Mezzanine Stacks have open risers, a railing on one side only, and lack top and bottom extensions. See Photos Library 5 and 6.	504.3 505.3 505.2 505.10	27.2 27.4.1 27.4.3	Modify or replace the stair railings such that they there are railings on both sides of the stairs that are round or oval in shape or x-section, are 34" to 38" a.f.f. to the top of the gripping surface, and have top extensions 12" parallel to the floor and bottom extensions the slope distance of one tread then 12" parallel to the floor. The stairs must be modified by installing risers.	2	3	N	TBD – up to \$15,000+
<u>Staff Only</u> The stairs from the Main Level to the Mezzanine Staff/Historical Room have 8" risers (maximum allowed is 7") and railings that lack bottom extensions, located on one side only for one segment of stairs, and railings that are 5" to 11" too low.	504.2 505.10 505.2 505.4	27.2 27.4.3 27.4.1 27.4.2	As these stairs are closed to the public and solely for staff, modifications would only be required as a result of a reasonable accommodations request or if the area was opened for public use.

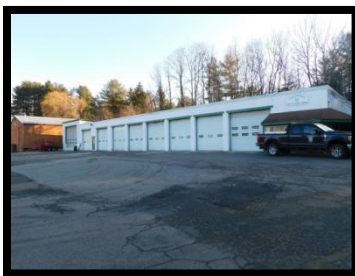
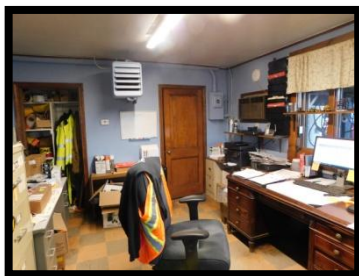
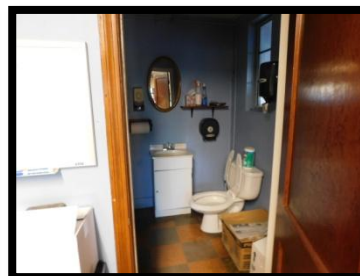
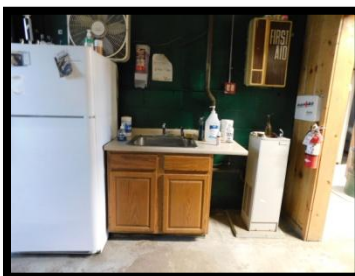
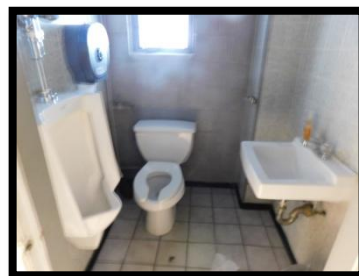
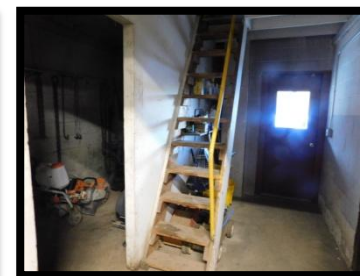
The Highway Garage area consists of a main building with 9 bays and an office along with 4 to 5 storage buildings and sheds. The main building also has a small bathroom for the office, a bathroom for department employees, a small kitchenette for employees, and a mezzanine storage area.

It is recommended that signage be placed at the entrance to the Highway Garage Office noting that the building is closed to the public and that all public interactions and transactions occur at the DPW Administration Building. The DPW Administration Building location and contact information should also be provided on the sign.

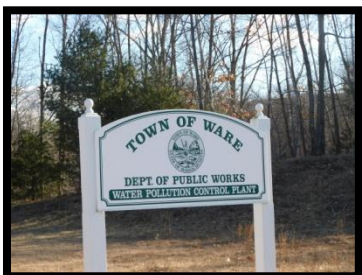
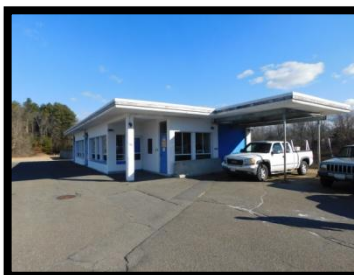
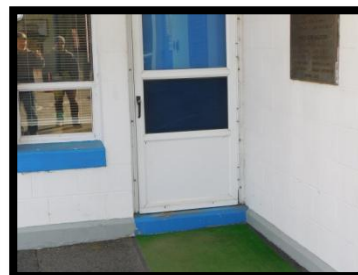
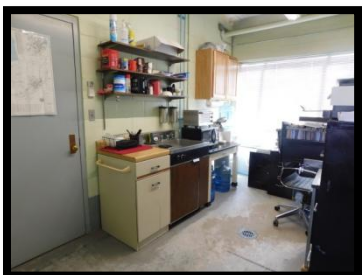
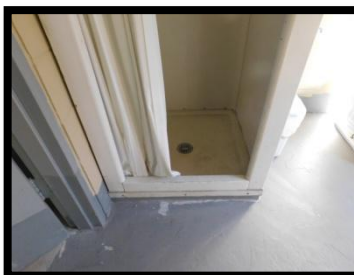
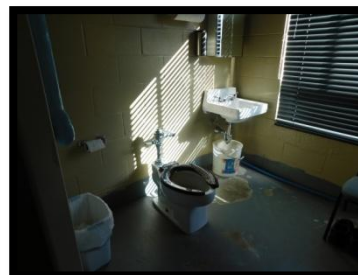
The Wastewater Treatment Facility Main Building includes a small office/break room and a bathroom. There is no designated accessible parking on site. There is a 5" abrupt change in level surface to enter the building. The entrance storm door to the building requires pinching and twisting of the wrist. Interior doors have knob style hardware and lack tactile designation signage. A door has a glass pane that is too high and a first aid kit that is not within reach range. Both exterior and interior doors have excessive operating forces and too fast closing speeds.

It is recommended that signage be placed at the front entrance to the WWTF Office noting that the building is closed to the public and that all public interactions and transactions occur at the DPW Administration Building. The DPW Administration Building location and contact information should also be provided on the sign.

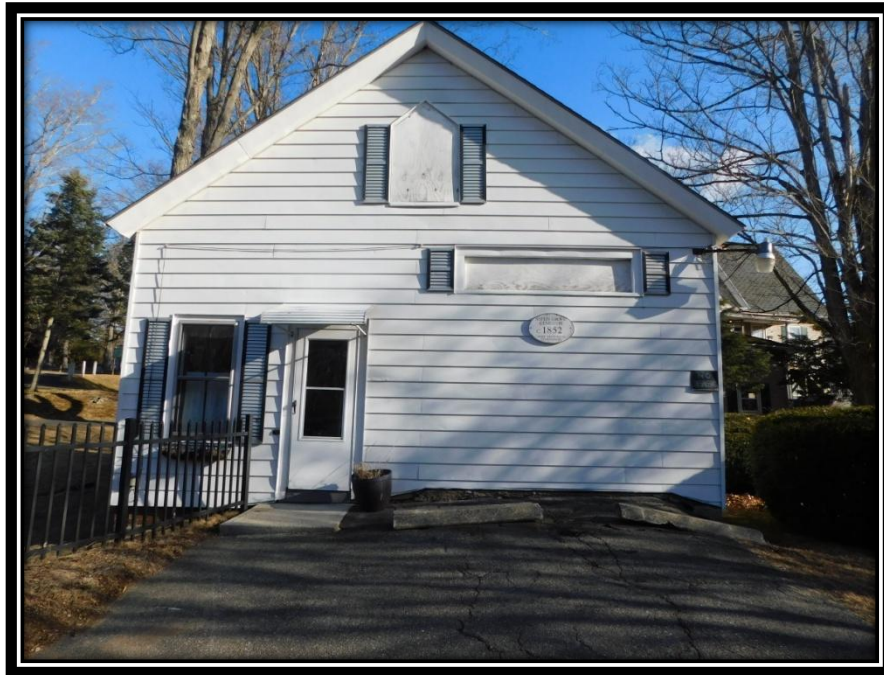
There is no designated accessible parking for the building. There is no accessible route of travel into the building as there is a 3" concrete pad at the front entrance followed by a 7" abrupt change in level surface into the building. The front entrance storm door hardware requires pinching and twisting of the wrist. The front entrance wooden door has knob-style hardware. The doorway has only 29½" of clear width.

The costs involved to modify the Cemetery Building for public access will be substantial, especially as residents or visitors rarely go to the building. According to Cemetery personnel, business is conducted over the telephone, computer, or at the DPW Administration Office. Rather than engage in the above described modifications, signage should be posted at the entrance to the Cemetery Building and on the town's website noting that all cemetery related business will be conducted at the DPW Administration Office. Contact and location information should be provided on the signage and website.

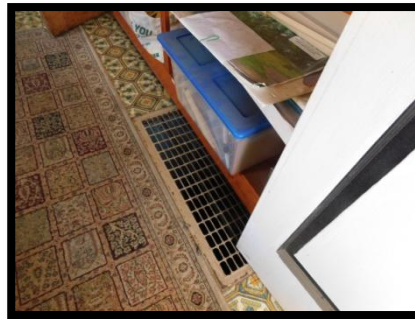
Photo Cemetery 2

Floor Grates A floor grate near the front entrance has grates with 1" by 2" openings. See Photo Cemetery 2.	302.3	25.4	Grate openings cannot exceed ½" and must be perpendicular to the route of travel. Replace or modify grates to comply with maximum ½" opening requirement.	2	2	N	Up to \$150+
Bathroom The latch-style locking mechanism requires pinching and use of the fingers. The doorway has only 26" of clear width.	404.2 404.2.3	26.11 26.5	Due to the cost to expand and reconstruct the bathroom, the bathroom should be for employee use only with no public or visitor usage. Costs to renovate and expand the bathroom could approach \$50,000 or more. Modifications would only be required as a result of a reasonable accommodation request.	3	1	I	\$0

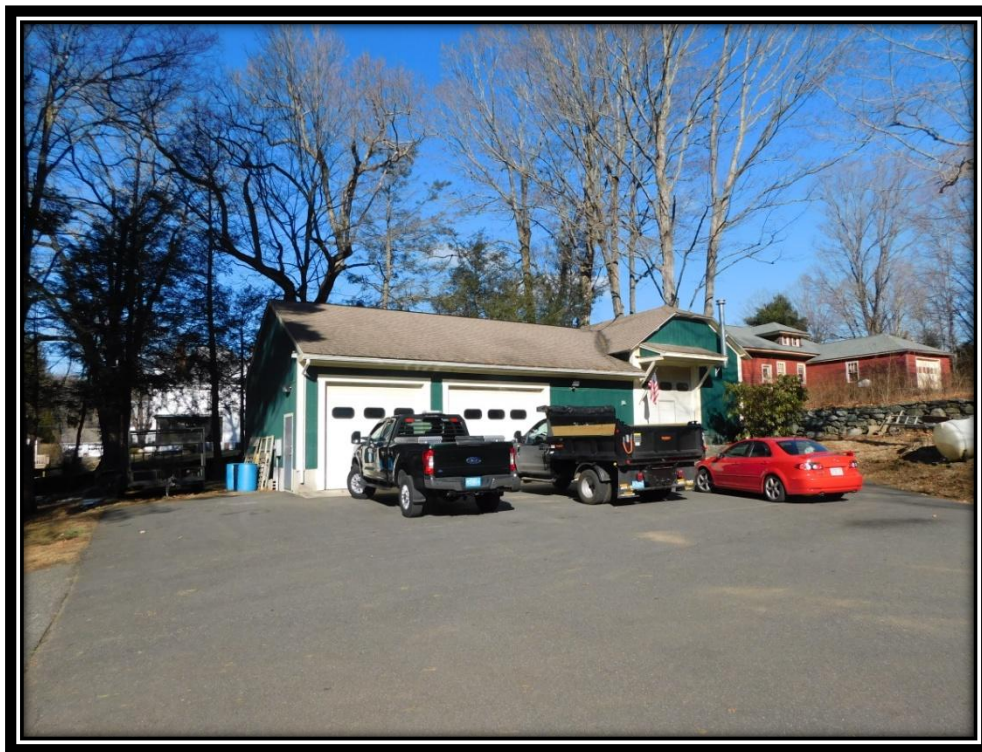
There is no designated accessible parking for the building. There is no level landing at the doorway to the office as the running slope approaches 9.2%. The drop box near the entrance is 13½" too high. The door from the office to the bay area lacks tactile designation signage.

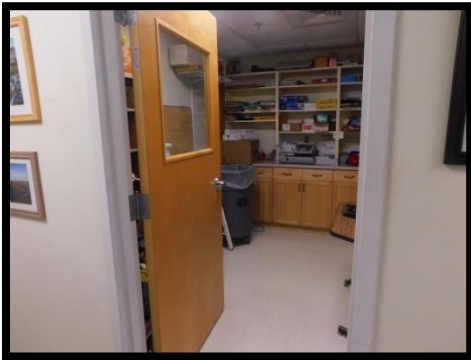
Photo Admin 5

<u>Doors with Glass Panes</u> Interior doors with glass panes (8) are up to 6½” too high. See Photo Admin 5.	404.2.11	NA	Doors, gates, and side lights adjacent to doors or gates, containing panels that permit viewing through the panels shall have the bottom of at least one panel located 43 inches maximum a.f.f. Rather than modify the door to lower the viewing area to comply with the maximum height restriction, the panes can be blocked or frosted.	4	2	I	\$0
<u>Kitchenette</u> The sink counter is 1½” too high and lacks knee clearance. The towel dispenser is 6 ½” too high. See Photo Admin 6.	804.3.2 306.3 308	32.2 32.6 32.7 6.5 6.6	Modify the counter and sink so that the counter/sink is no more than 34” a.f.f. and there is a minimum of 27” knee clearance at the sink with guarded, wrapped, or insulated piping. Lower the dispenser to a height of no more than 48” a.f.f.	4 4	2 2	N I	Up to \$2,500 \$0

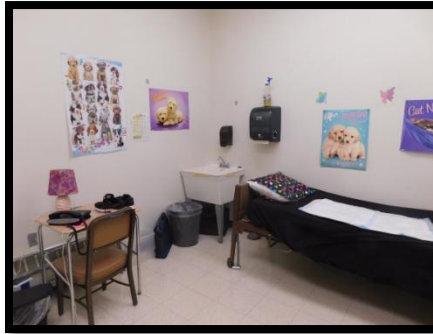
Photo High School 26

<p>Classroom Sinks</p> <p>Classroom #152 sink lacks knee clearance. Classroom #169 sink lacks knee clearance and can only be operated using a foot device.</p> <p>See Photos High School 26 and 27.</p>	606.3 306.3	32.7	<p>Modify and/or replace the sinks so that they are no more than 34" a.f.f. at the top and there is a minimum of 27" knee clearance at the sink with guarded, wrapped, or insulated piping. Operating mechanisms s/b through the use of a closed fist or loose grip.</p>	4	3	N	Up to \$5,000

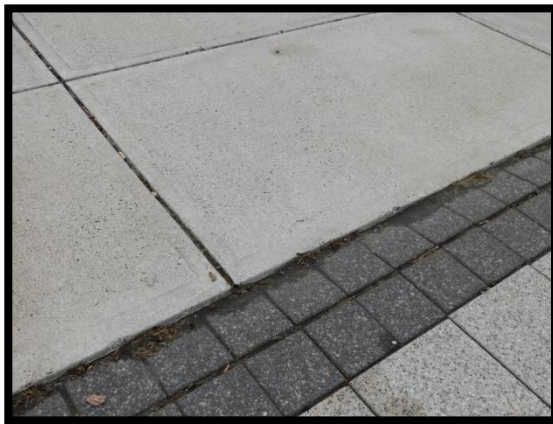
Photo Veteran 1

General Description or Obstacle Which Limits Mobility or Access: The "van" designated accessible parking lacks compliant access aisles as they are 4' too narrow. There are abrupt changes in level surface in various locations of the park at the transition from paver to concrete. The paver sloped access into the grassed area has running slopes that vary from 9.4% to 10.8%. There is no accessible route of travel within the grassed area.

403.206.2	22.20	As this area is used for various local events and activities, it is recommended that roll out matting be purchased to be used when needed.	2	2	I	\$1,500

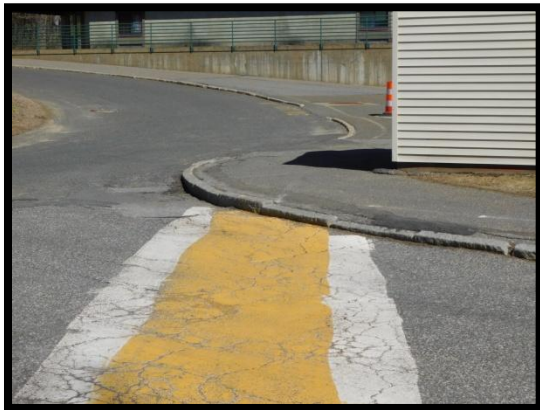
Photo Playground 1

General Description or Obstacle Which Limits Mobility or Access: The crosswalk from the school side has up to a 5” granite curbing. The asphalt walkway to the playground from the crosswalk has up to an 8.3% running slope with deteriorated asphalt and abrupt changes in level surface. There is no accessible route of travel fully around the playground and to play components. Woodchips are the primary surface throughout the play areas. There are no accessible play components. The picnic tables provide only 14” of clear width.

The current playground has a number of swings so if they are remaining, the purchase of an accessible swing is recommended.

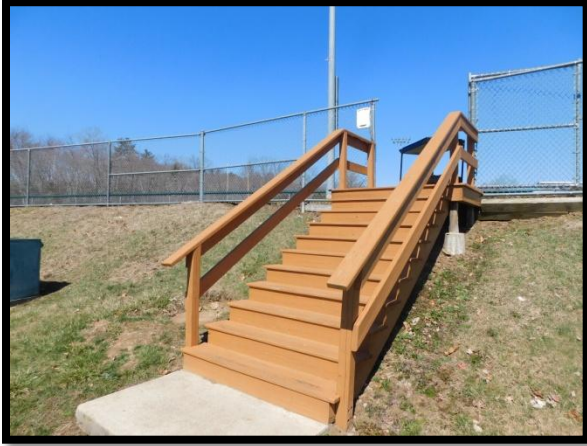
Photo Softball 1

General Description or Obstacle Which Limits Mobility or Access: The stairs to the softball field from Veteran's Field have treads with nosings that have abrupt undersides. The stair railings are 3½" wide, rectangular in shape, lack bottom extensions, and have one railing that is 1½" too low. There is no accessible route of travel from the school parking to the field area with a loose stone and compacted dirt and gravel driveway surface as the only route of travel. There is no accessible route of travel to the bleachers, player's seating, softball field, and portable "accessible" toilet. There are no level areas for a wheelchair at the bleachers. The accessible toilet is not ADA compliant as there is a 2" abrupt change at the entrance, the door closes too fast, the soap dispenser is 5" too high, the toilet paper dispenser is 3" too close to the front of the toilet, the toilet is 1½" too far from the near wall and 10" too close to the door in front of the toilet, and the grab bars are ½" to 1" too high.

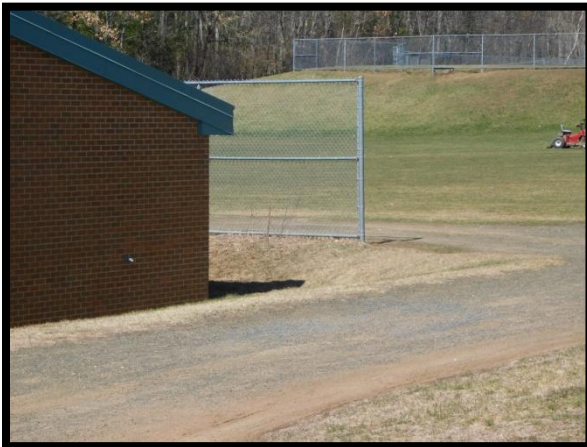
Photo Softball 3

Portable Accessible Toilet The accessible toilet is not ADA compliant as there is a 2" abrupt change at the entrance, the door closes too fast, the soap dispenser is 5" too high, the toilet paper dispenser is 3" too close to the front of the toilet, the toilet is 1½" too far from the near wall and 10" too close to the door in front of the toilet, and the grab bars are ½" to 1" too high.	404.2.5 404.2.8 308 604.7 604.2 604.3 609.4	26.10 26.9 30.12 30.7.6 30.7.2 30.8.2	Replace the existing portable "accessible" toilet with an ADA Compliant toilet such that soap/towel dispensers are no more than 42" a.f.f.; the toilet paper dispenser s/b a minimum of 24" a.f.f. and s/b 7" min. to 9" max. in front of the water closet measured to the centerline of the dispenser; the height of the water closet s/b 17" to 19" a.f.f. to the top of the seat; the water closet s/b 18" from the nearest sidewall, at least 42" from the farthest sidewall, and 42" from the front of the water closet to the nearest wall or fixture; and a door closing speed that is at least 6 seconds. The grab bars should be 33" to 36" a.f.f. to the top of the gripping surface with nothing mounted over the grab bars.	3	2	I	TBD

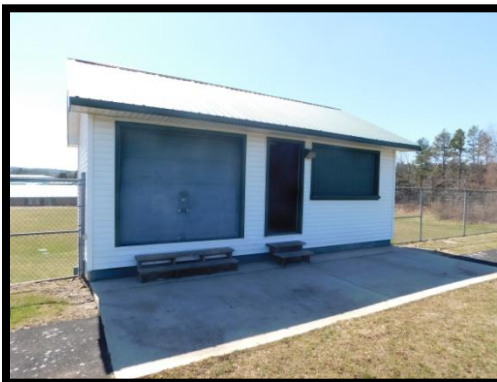
Photo Veterans' 5

The counter is 22" too high.	904.5	17.6.2	Create a 36" wide counter no higher than 34" a.f.f. below the existing counter.	2	2	I	Up to \$250
<u>Broadcast Booth</u> <u>Veterans Field Side</u> The stairs to the base of the broadcast booth from Veterans' Field has risers that vary in height and railings on only one side of the stairs.	504.2 505.2	27.2 27.4	Replace the existing stairs with ones that are uniform in riser height and tread width and railings on both sides of the stairs that adhere to S.505 of the 2010 ADA Standards and S.27.4 of 521 CMR.	2	3	N	Up to \$10,000
The railings are 3½" too wide, rectangular in shape, up to 1" too high, and without top and bottom extensions.	505.7 505.4 505.10	27.4.4 27.4.5 27.4.2 27.4.3	Install and/or modify the stair railings such that the railings comply as follows: Continuous stair railings on both sides of the stairs. Railings s/b between 34" – 38" a.f.f. to the top of the railing, circular or oval in x-section, 1¼" – 2" in outside diameter, and with extensions at the top (12" parallel to the ground) and bottom as feasible (slope distance one tread then 12" parallel to the ground).	2	3	N	Included in above

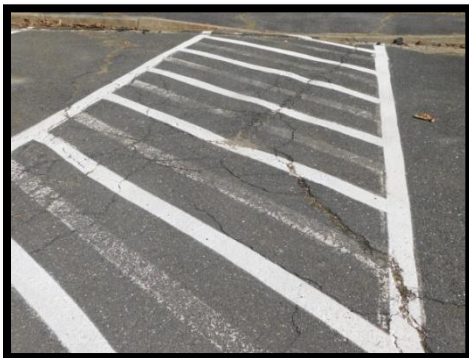
Photo Fields 1

The 2 designated accessible parking spaces have signage that is 19" too low. Although the spaces and shared access aisle meet the requirements for a van accessible space, "van accessible" signage is not provided. The asphalt of the spaces and access aisle is deteriorated and heaving.

<u>General Description of Obstacle</u>	<u>2010 ADAAG</u>	<u>MAAB 521 CMR</u>	<u>Type of Action to be Taken</u>	<u>P</u>	<u>F</u>	<u>TF</u>	<u>Cost Estimate</u>
<p>Parking</p> <p>The 2 designated accessible parking spaces have signage that is 19" too low.</p> <p>Although the spaces and shared access aisle meet the requirements for a van accessible space, "van accessible" signage is not provided.</p> <p>The asphalt of the spaces and access aisle is deteriorated and heaving.</p> <p>See Photo Fields 1.</p>	502.6	23.6	Signage must be set such that the signage height should be a minimum of 60" high at the bottom (2010 ADAAG Standards) and a maximum of 96" at the top (MAAB 521 CMR). As the spaces meet the requirements for van accessible parking, "van accessible" signage s/be provided.	1	2	I	\$20

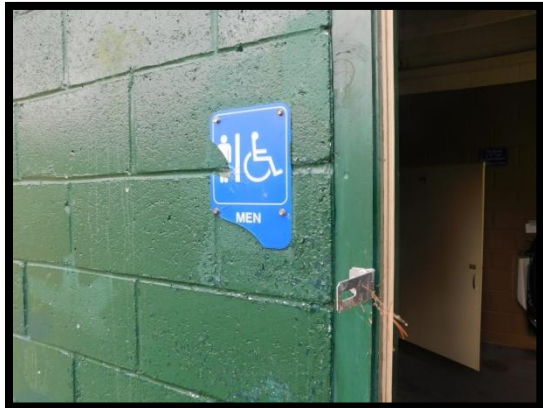
Photo Grenville 12

<u>Men's Bathroom Only</u> The water closet flush control is on the wrong side.	604.6	30.7.5	Replace or reverse the flush control so that it is on the wide or open side.	3	3	N	Up to \$500
<u>Women's Bathroom Only</u> The entrance door closes in only 4 seconds.	404.2.8	26.9	Modify the door so it takes at least 6 seconds to close.	3	2	I	\$0
The sink piping is not wrapped or insulated	606.5	30.9.5	Wrap or insulate the piping.	3	2	I	\$75
The water closet is 1" too far from the near wall and 1" too close to the far wall.	604.2	30.7.2	Modify the water closet so that it is 18" o.c. to the near wall and at least 42" o.c. on the wide or approach side of the water closet.side	3	3	N	Up to \$3,000
The rear grab bar is ½" too high.	609.4	30.8.2	Lower the grab bar so that it is 33" to 36" a.f.f. to the top of the gripping surface.	3	2	I	\$0
See Photos Grenville 12, 13, and 14.

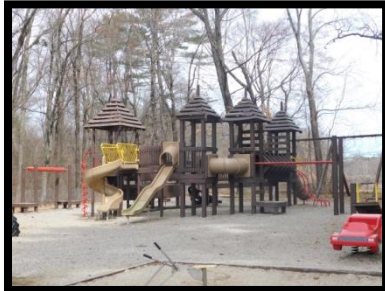
Park 1

General Description or Obstacle Which Limits Mobility or Access: There is no designated accessible parking solely for the Park. There is no accessible route of travel to the playground and its multiple components or to the picnic tables. Pea stone is the surface throughout the entirety of the playground. Wood timbers 2" to 4" in height restrict access to the picnic tables, sand box, porch-style swing. Concrete pads leading to the picnic table and swing have severe heaving resulting in abrupt changes and unstable surfaces.

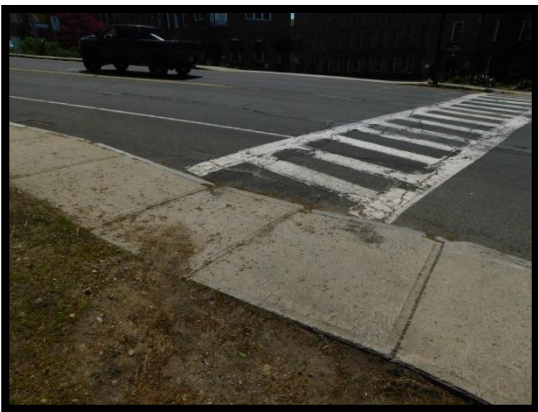
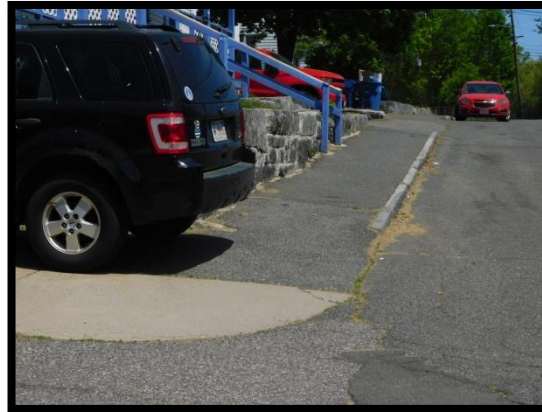
- The curb ramps for the cross walk across East Main Street from Dulak's to Berkshire Blanket lack detectable warning strips.
- The curb ramps at Otis Avenue lack detectable warning strips and a level landing.

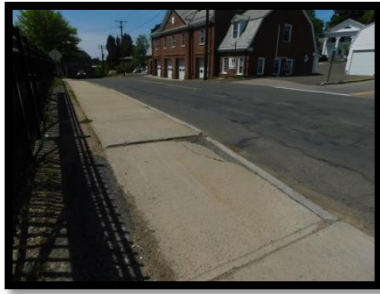
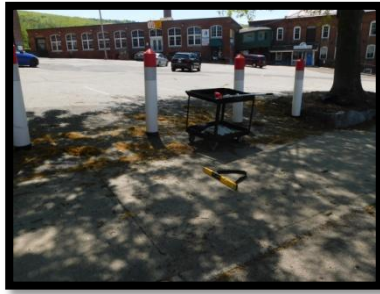
- The sidewalk at the Millyard driveway across from Canal Street has a cross slope of up to 5.0% for approximately 34 feet. There are also abrupt changes in level surface of up to 3" and surface deterioration.
- The sidewalk at the Galaxy Industries Driveway has a cross slope of up to 5.0% for 30 feet to 40 feet.
- The sidewalk in front of the bollards at the Mill Complex has a cross slope of up to 6.0% for approximately 30 feet. There is also a ½" abrupt change in level surface, deteriorated concrete, and heaving.
- There is severe concrete pad heaving in front of Stone Mill Antiques with up to a 2" abrupt change in level surface on one side and up to a 5" abrupt change in level surface on the opposite side. There are also cross slopes of up to 8.0%. There are also general areas of deterioration and abrupt changes of up to ½" for the remainder of the sidewalk to South Street.

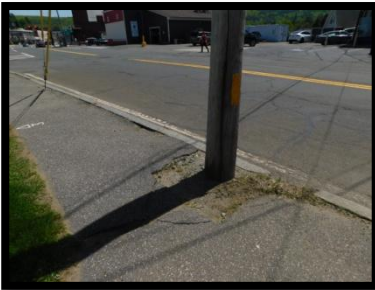
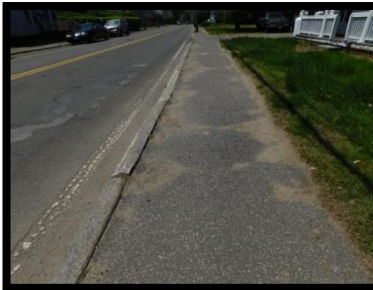
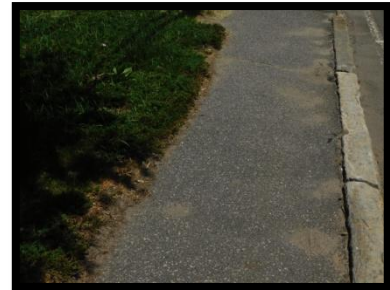
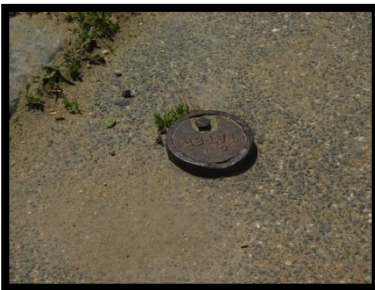
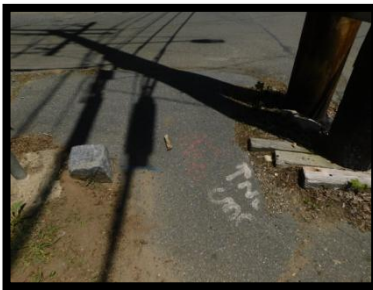
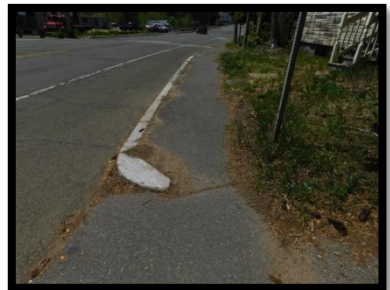
- The sidewalk from #23 West Main Street to Vernon Street is overall in fair to poor condition with asphalt deterioration, heaving, abrupt changes in level surface and reduced clear width due to vegetative overgrowth.
 - There is severe sidewalk deterioration of the sidewalk at the driveway of #97.
 - A water cover near #55 is a 1" abrupt change in level surface.
 - The sidewalk clear width is reduced to only 32" at telephone poles #15/16 and #17/18.
 - Sidewalk clear width is reduced to only 26" past the driveway of #45.
 - Sidewalk cross slopes vary from 5.4% to up to 18.4% at driveways #85/87, #95, Rick's Style Shoppe, #47, #53 (shared), #59 (shared), and # 63. In addition the cross slopes of the sidewalk in front of #95 are up to 5.4%.

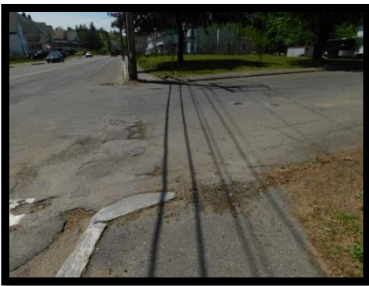
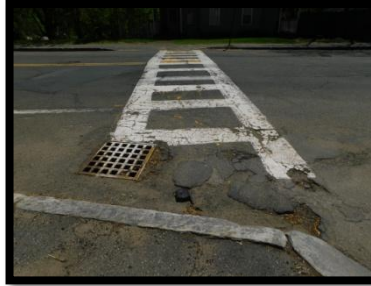
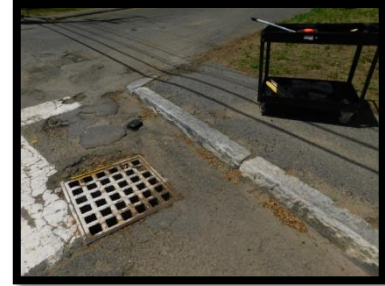
- The curb ramps at Storrs and West Main Street lack detectable warning strips. The curb ramp on the laundromat side has a running slope of up to 15.8% and no level landing. The curb ramp on the QVCDC side has up to a ½" abrupt change in level surface at the transition from asphalt to granite.

- The crosswalk across Barnes Street lacks formal curb ramps on either side including detectable warning strips. The crosswalk is not striped or painted.

- The crosswalk at Barnes Street across West Main Street lacks curb ramps on either side, lacks detectable warning strips, and lacks level landings. There is up to 5" of granite curbing at the odd numbered side of the street at the transition to the sidewalk as well as a catch basin with excessive grate openings in the crosswalk. A water main cover with a 1" abrupt change in level surface is located on the sidewalk near the crosswalk on the even numbered side of the street

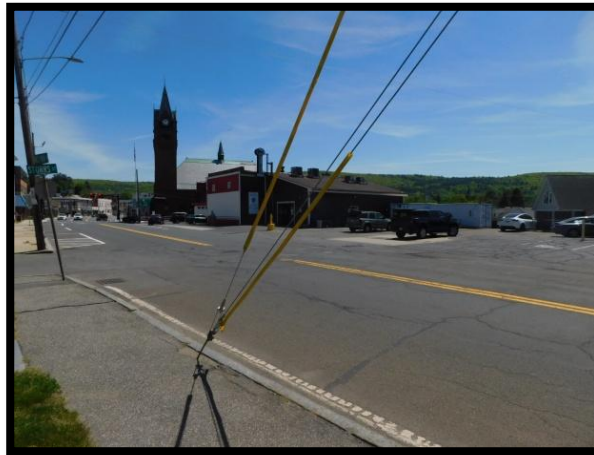
- Telephone pole #4/5 has a guy wire which restricts head clearance and is a protruding object.

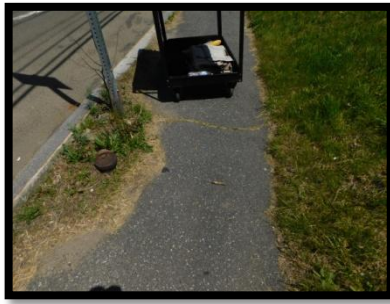
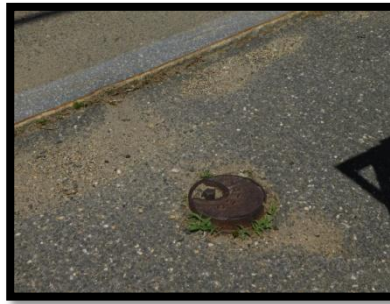
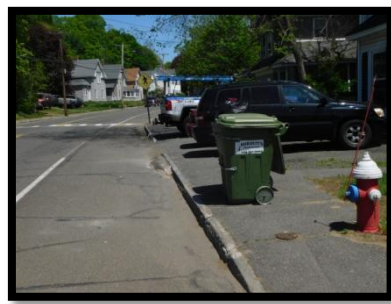
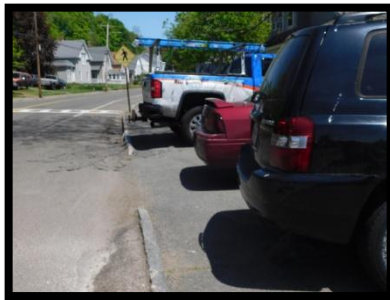
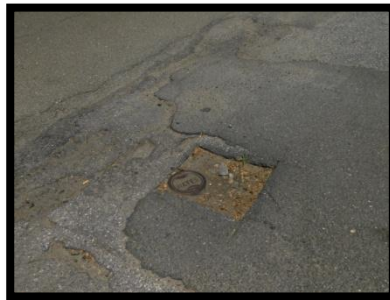
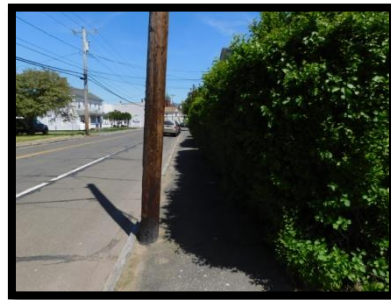
- The sidewalks overall are in fair to poor condition with asphalt deterioration, heaving, abrupt changes in level surface, reduced clear width due to vegetative overgrowth and/or items in the sidewalk, excessive cross slopes, and gaps in asphalt or concrete.

- There is sidewalk deterioration of the sidewalk in front of #48 and #50 with gaps and heaving.
 - A water cover near #100 has a 1" abrupt change in level surface. A water cover in front of Debbie Wong's is sunken with deteriorated asphalt creating an abrupt change in level surface. A utility manhole near Bruso's Liquors is sunken with deteriorated asphalt an up to a 2" abrupt change in level surface.

- The sidewalk clear width is restricted in entirety at #82 due to trash receptacles as well as vehicles parked in the sidewalk.
 - Vegetative overgrowth at #38 reduces pedestrian clear width.

- Sidewalk clear width is reduced to only 30" in front of #104 near the sign.
 - Sidewalk cross slopes vary from 6.4% or more at driveways #110, #100, #92/94, #74 (2), #70/72, #68, #62, #60, and Debbie Wong's (entire length). In addition the sidewalk in front of #84 and Bruso's has cross slopes that vary from 4.0% to 6.4%.

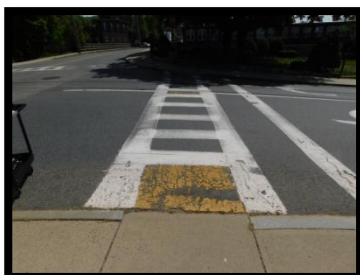
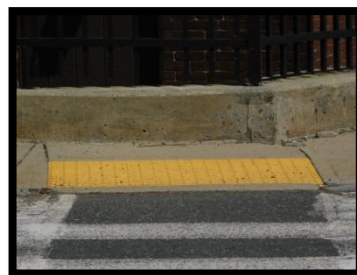
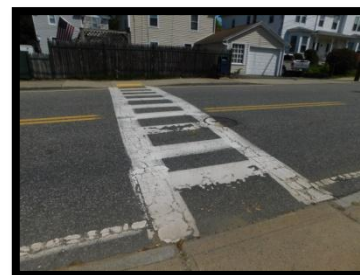
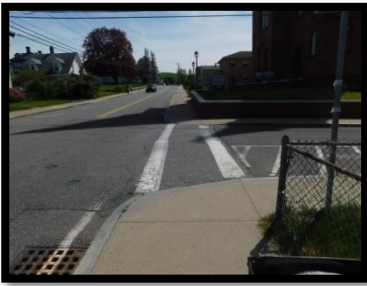
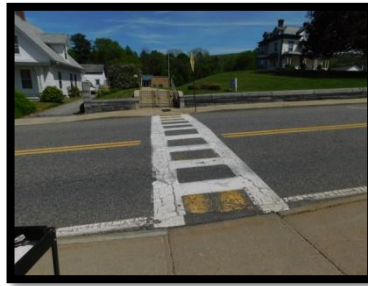
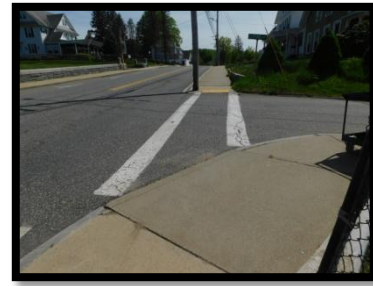
- The curb ramps in front of the steps to the former St. Mary's School and the former convent lack detectable warning strips and level landings. *Note: As these buildings are no longer in use as part of the church operations, the crosswalk should be formally discontinued.*

- The curb ramps at Clifford Avenue lack a detectable warning strip on the #63 house side and lack level landings on both sides.

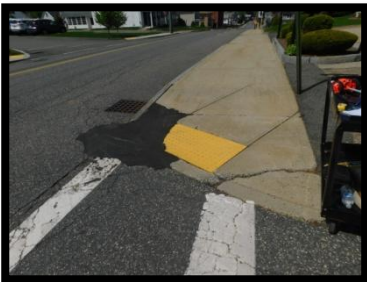
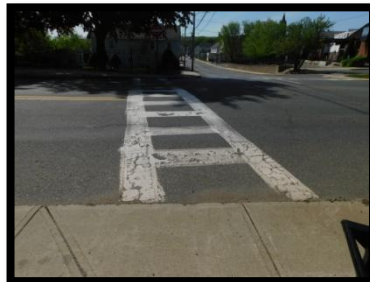
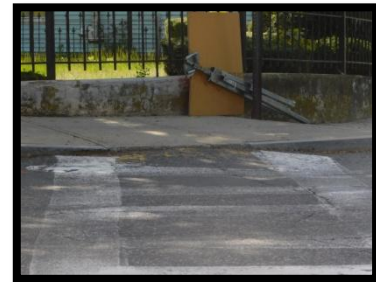
- The curb ramps at Union Street across Union Street lack a level landing on #74 side and lack a level landing, have up to a 1" abrupt change in level surface, and a partially covered detectable warning strip on the Cebula Funeral Home side.
- The curb ramp at the crosswalk across Maple Street lacks a level landing on the upper side (Mary Lane Hospital side).
- The crosswalk across South Street to Pulaski Street has curb ramps that lack detectable warning strips on both sides and a 1" abrupt change in level surface (granite curbing) and no level landing on the Pulaski Street side.

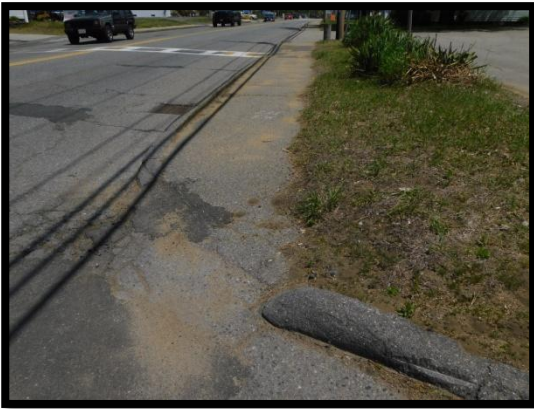
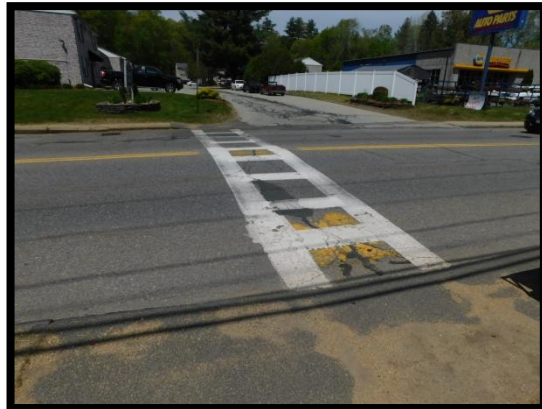
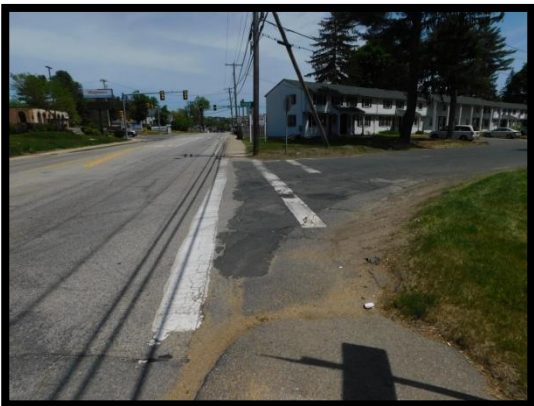
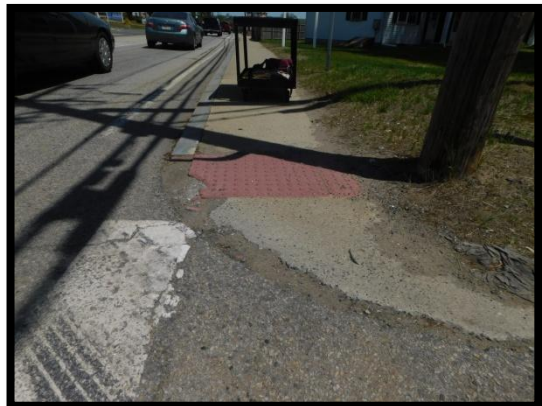
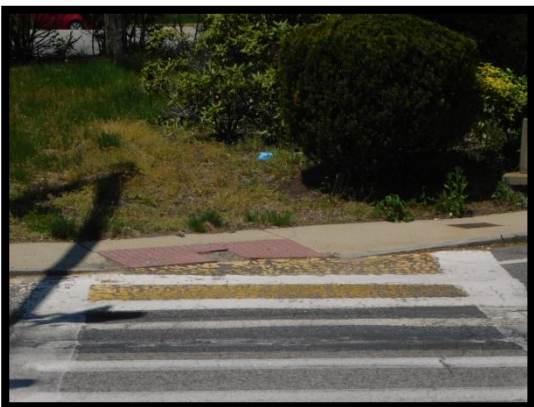
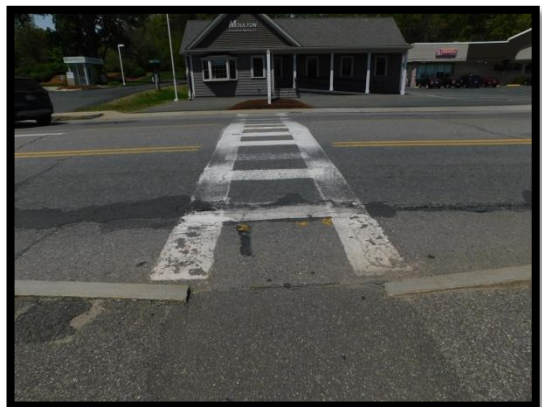
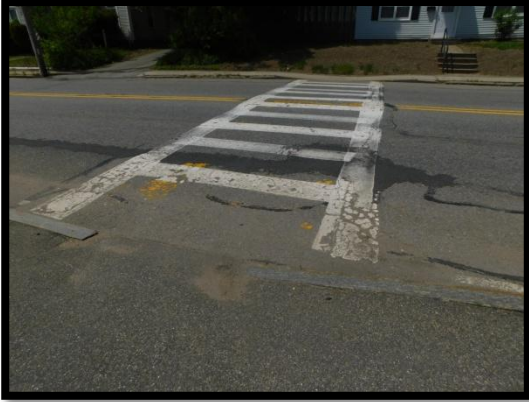
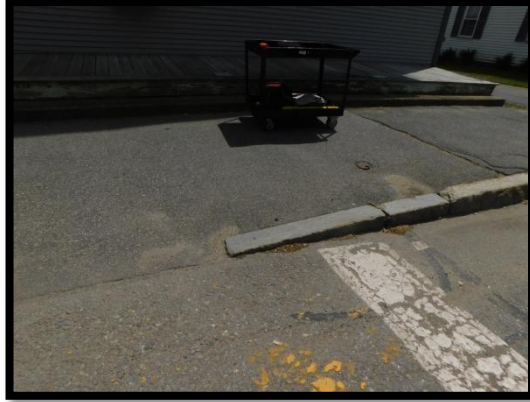
- The curb ramps (2) and crosswalk across Homecrest Avenue lack a detectable warning strip on the #170 side, have a 12.8% running slope on the #170 side, and severe deterioration of the curb ramp on the Homecrest Apartments side.

- The curb ramps and crosswalk across West Street at Walgreens and Crystal Springs have detectable warning strips that are deteriorated on both sides and lack level landings. The pedestrian signalization lacks audibles and the visual is difficult to detect.

- The curb ramp and crosswalk near #110 and across the CVS driveway lacks a level landing at the #110 side.
- The curb ramp and crosswalk across West Street at the CVS main entrance lacks a detectable warning strip. The level landing at the #103 side land has a ½" abrupt change in level surface at the transition to the curb ramp.

- The curb ramps (2) and crosswalk across West Street at Rohan's Plumbing lack formal curb ramps. The curb ramp on Rohan's side has up to a 3" abrupt change in level surface (granite curbing) and no level landing.
- The curb ramps (2) and crosswalk across Pulaski Street lack detectable warning strips and level landings.
- The curb ramps (2) and crosswalk across West Street at Pulaski Street lack detectable warning strips and level landings.

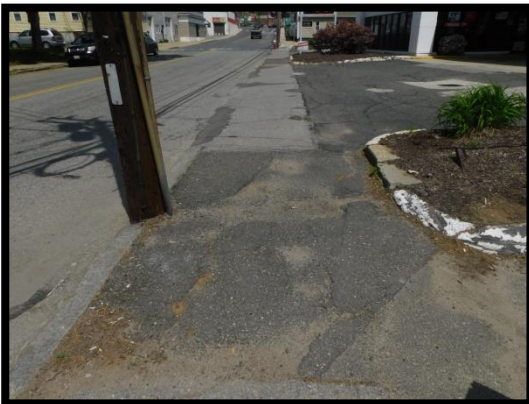
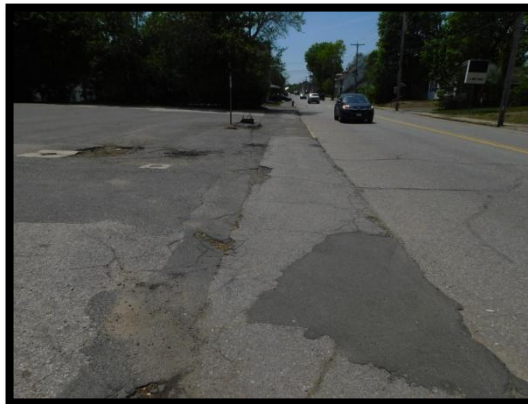
- The sidewalks overall are in fair to poor condition with areas of deterioration, abrupt changes in level surface, excessive cross slopes, and reduced clear width.
 - There are up to 1" abrupt changes in level surface at Crystal Springs due to a raised concrete pad and near Taco Bell at the transition from asphalt to concrete.
 - There is surface deterioration and/or gaps near Taco Bell, in front of #96, from #96 to Pulaski Street with more severe deterioration near Speedway and Rohan's.
 - Sidewalk cross slopes vary from 2.4% to 9.6% at segments of sidewalk in front of #86 and #64, and driveways for #110, #96, Jane Alden (2), Speedway, and the vacant lot next to Speedway.

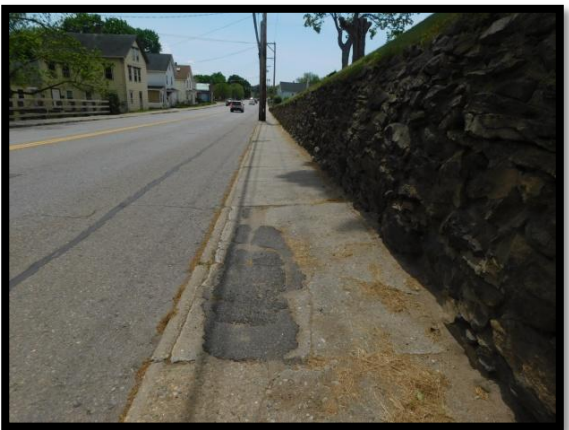
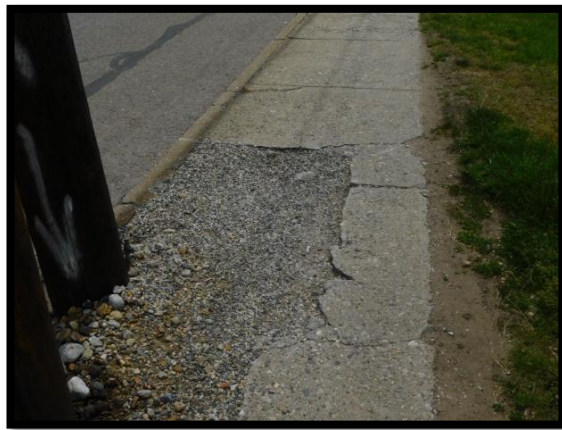
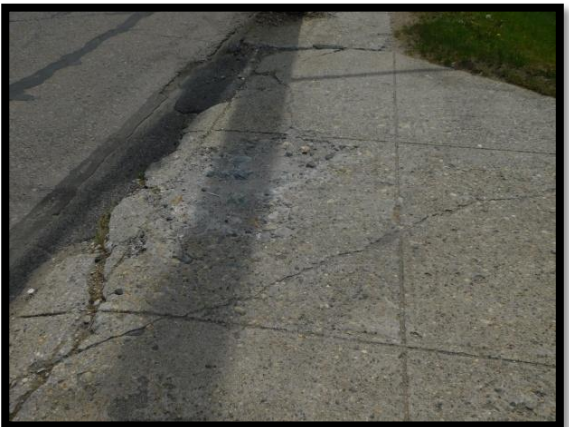
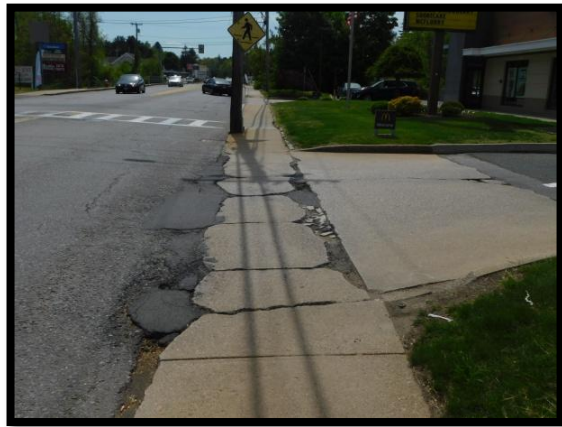
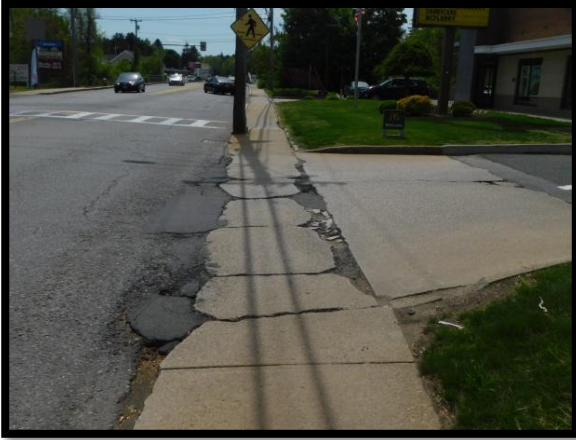
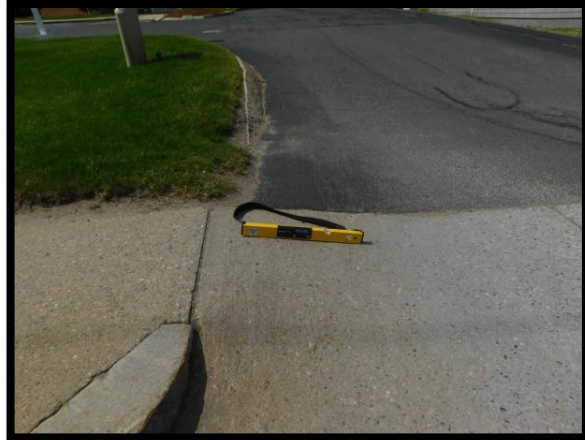
- The sidewalks vary in overall condition with some segments in good condition and other segments being fair to very poor condition with areas of deterioration, abrupt changes in level surface, excessive cross slopes, and reduced clear width.

- Sidewalks at the following location are deteriorated, have gaps in asphalt or concrete and in general poor to very poor condition: near Bruso's Liquors and #9, #23.5 to #35, sidewalk/driveway at Robert's Garage, #61 to #65, and McDonald's driveway/sidewalk.
- The transitions from driveway to sidewalk have excessive running slopes at the following locations: McDonalds (9.0% and 18.5%), Dollar General/Moulton's Insurance (8 locations up to 9.6%), Colonial Village Apartments (up to 11.5%).
